Marie Creek Feasibility Study

Prepared for Lower Mississippi River Watershed Management Organization

June 2006

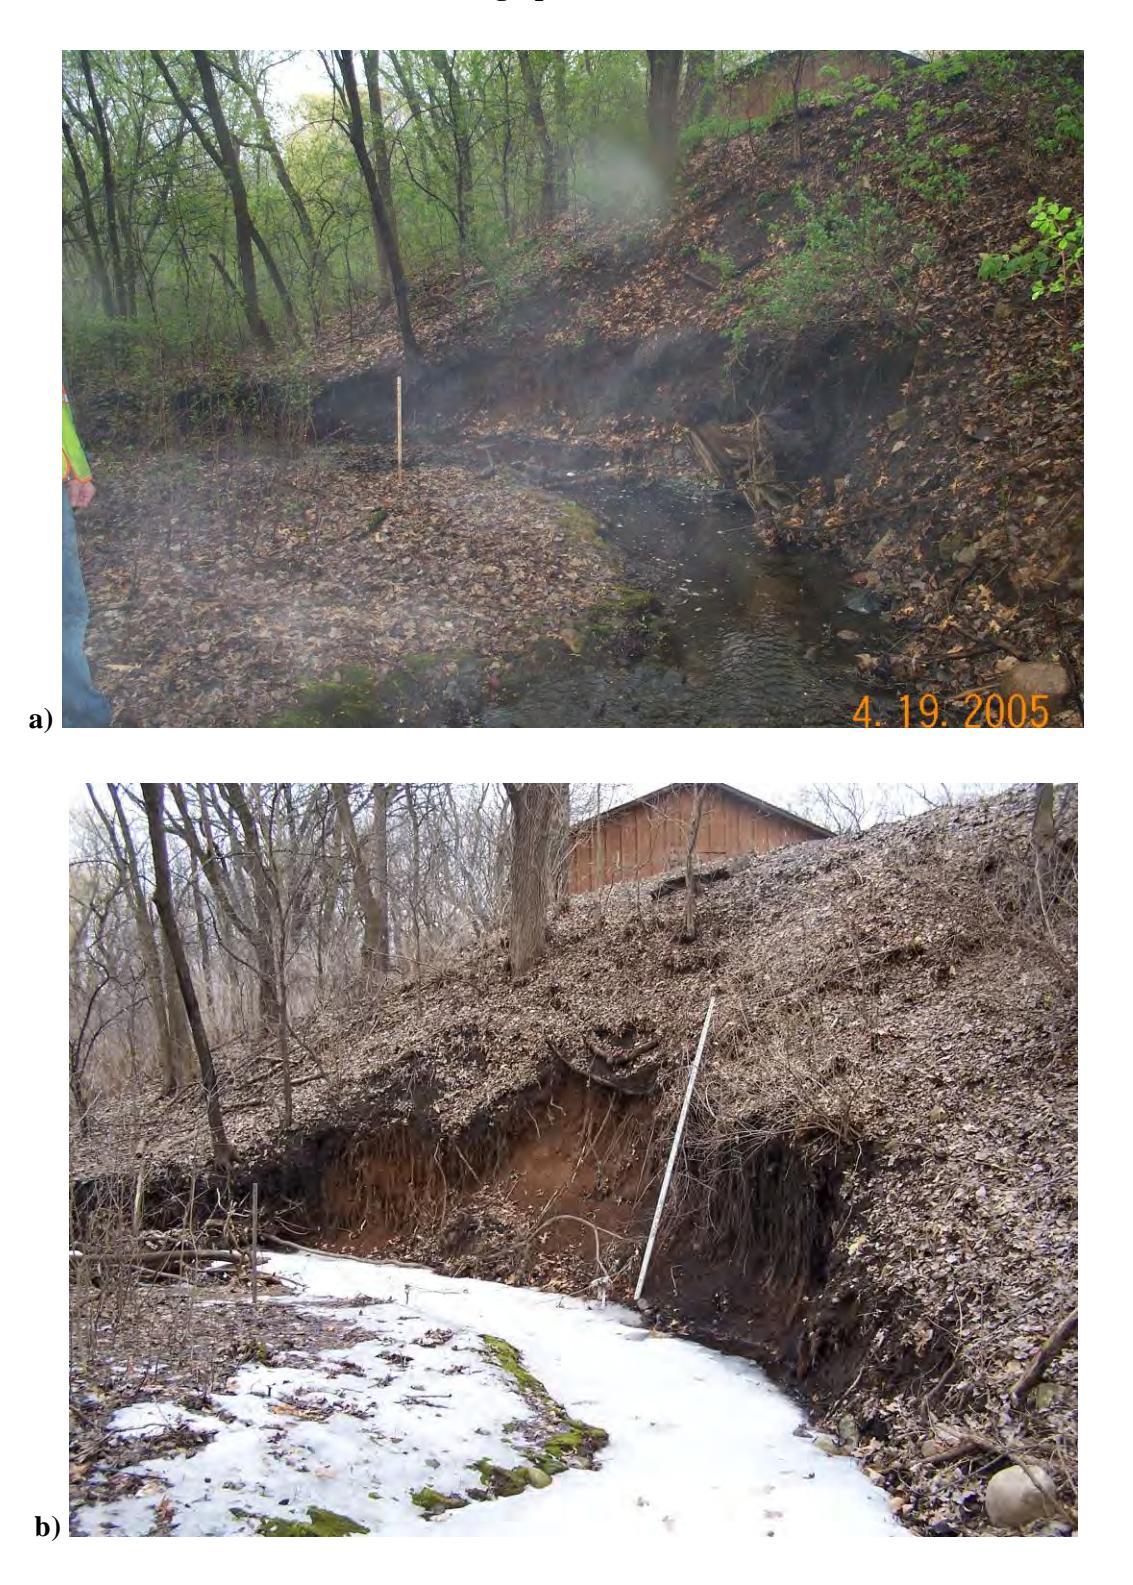
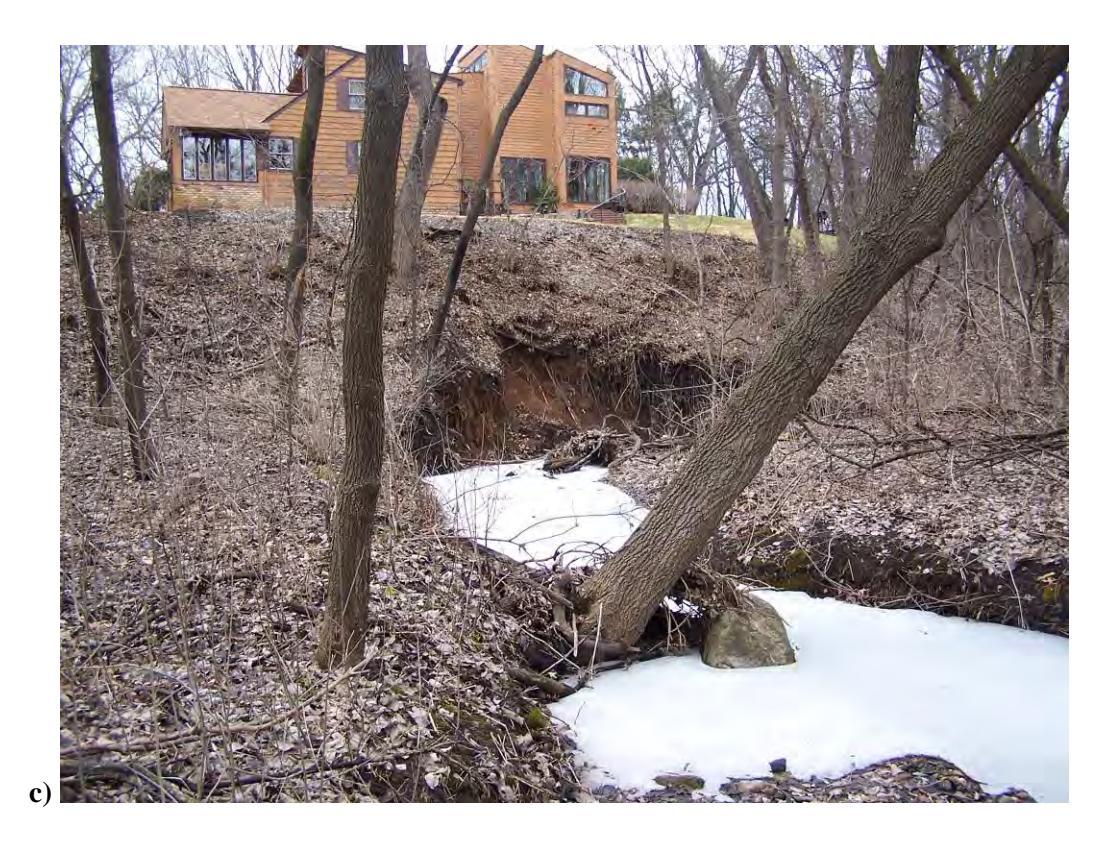
Erosion Site #1 – a) looking downstream (photo taken in 2005); b) looking downstream (2006); c) looking upstream (2006)

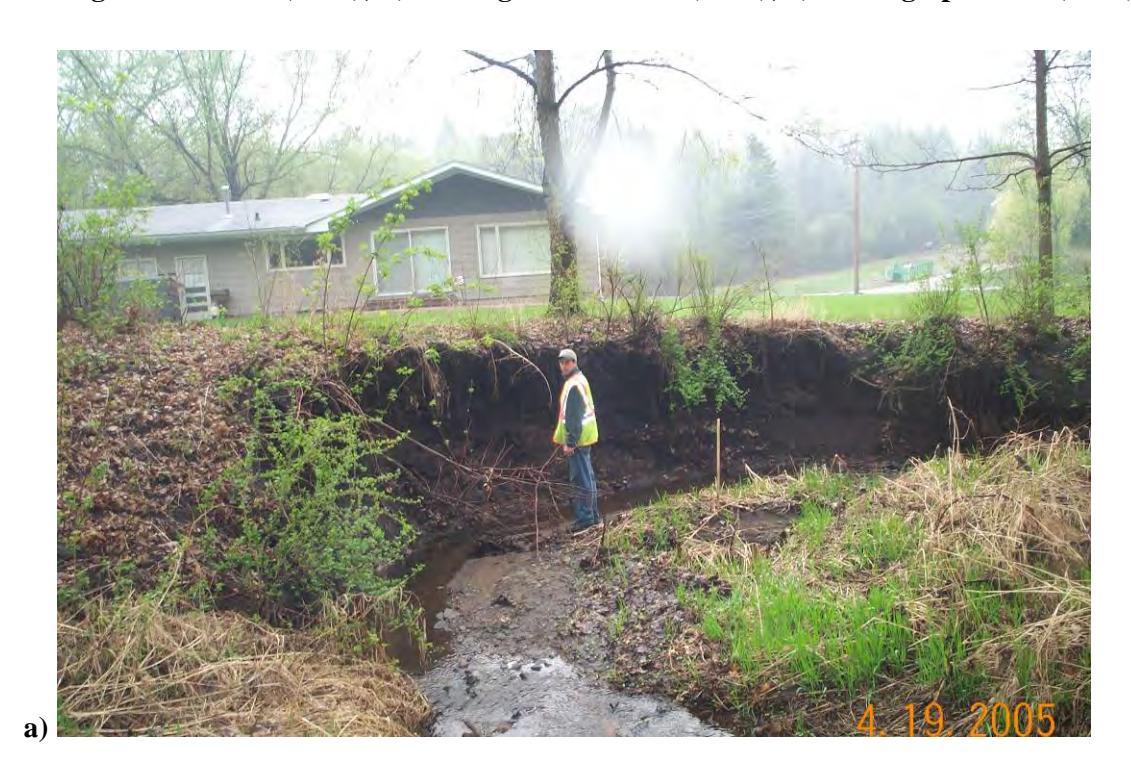
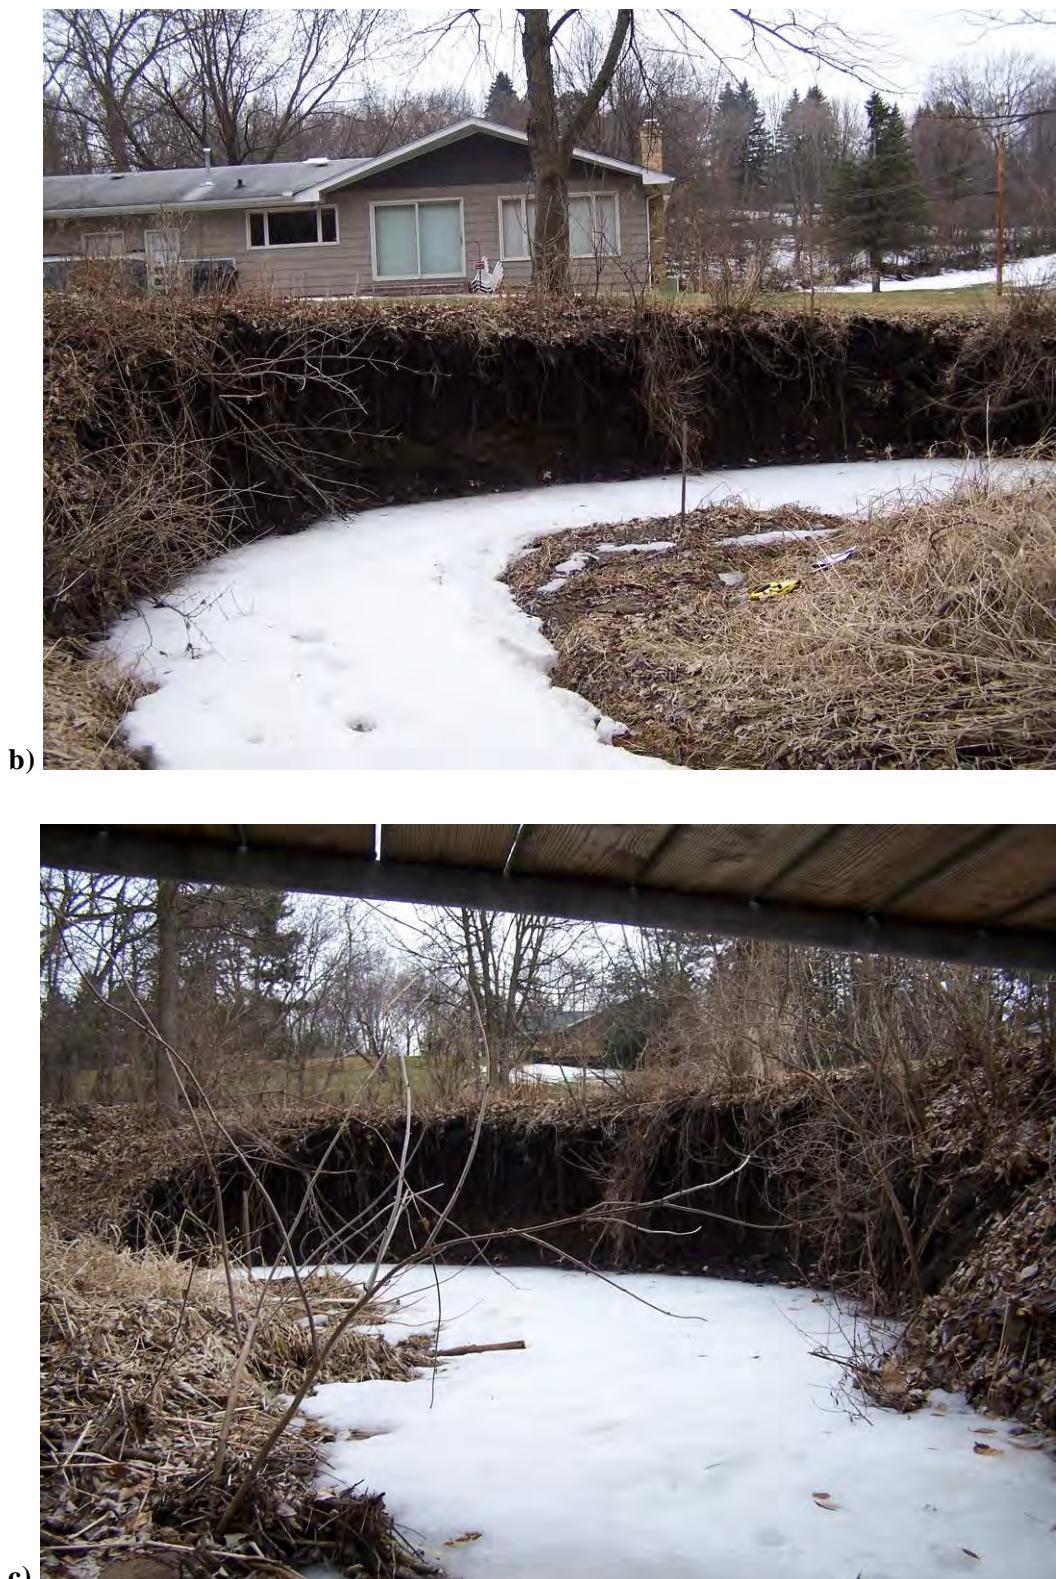
Erosion Site #2

a) looking downstream (2005); b) looking downstream (2006); c) looking upstream (2006)

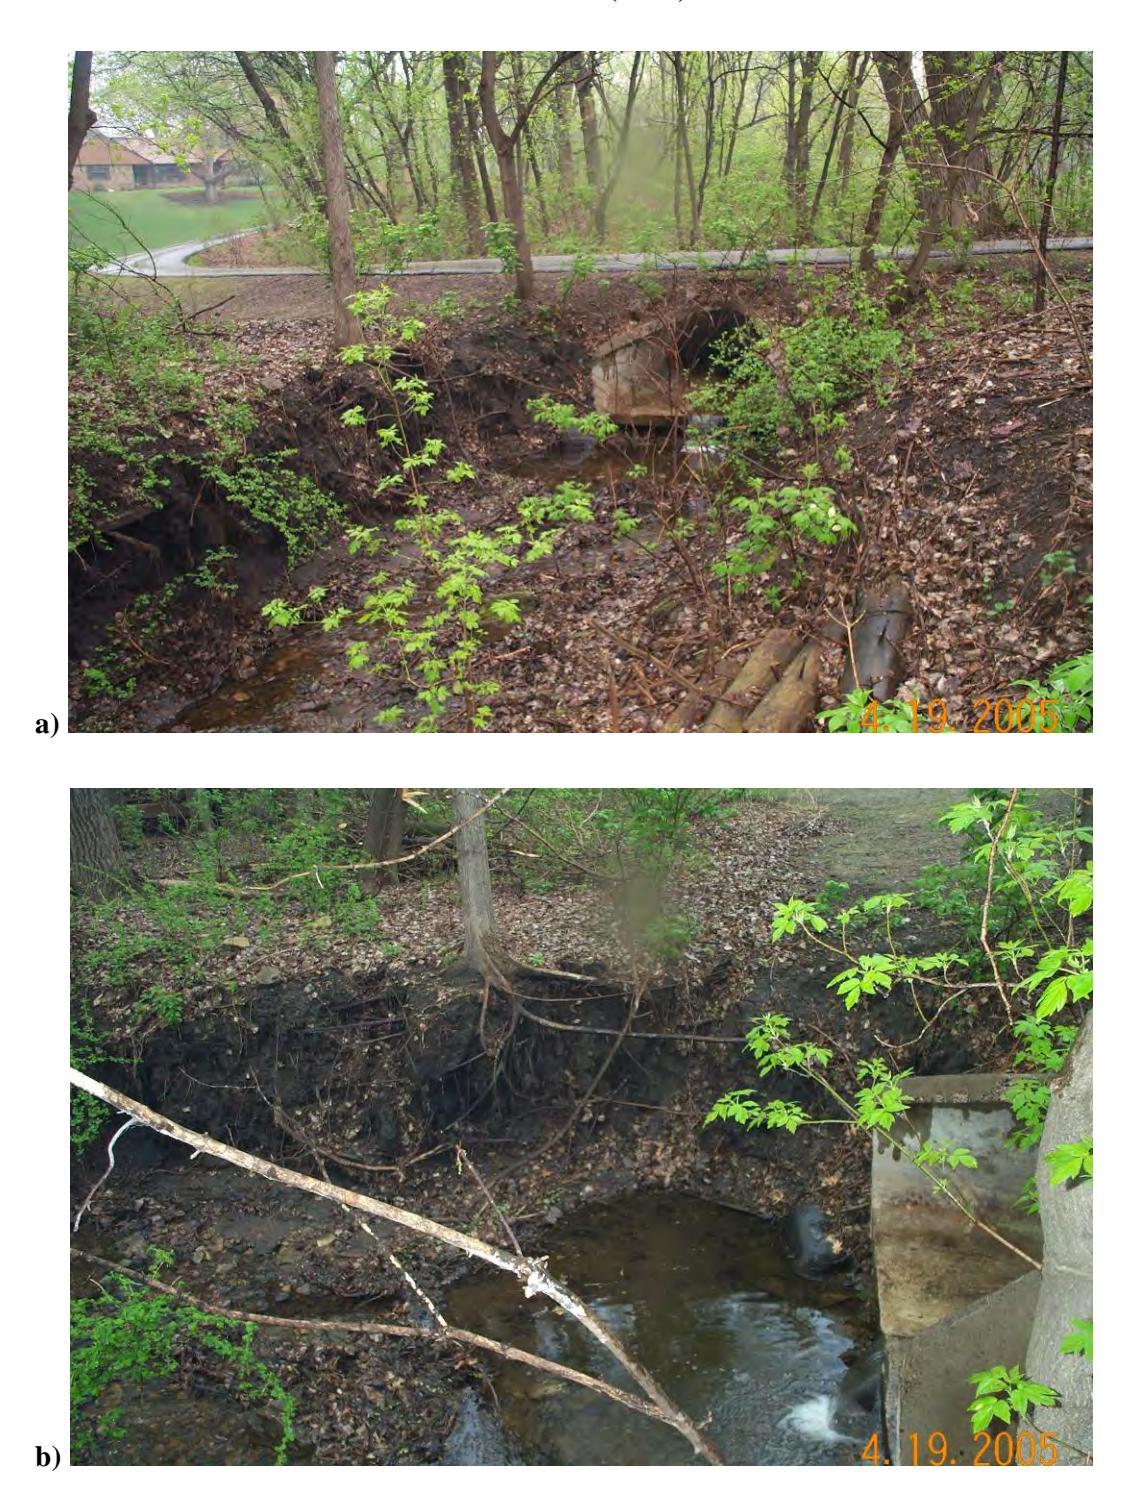
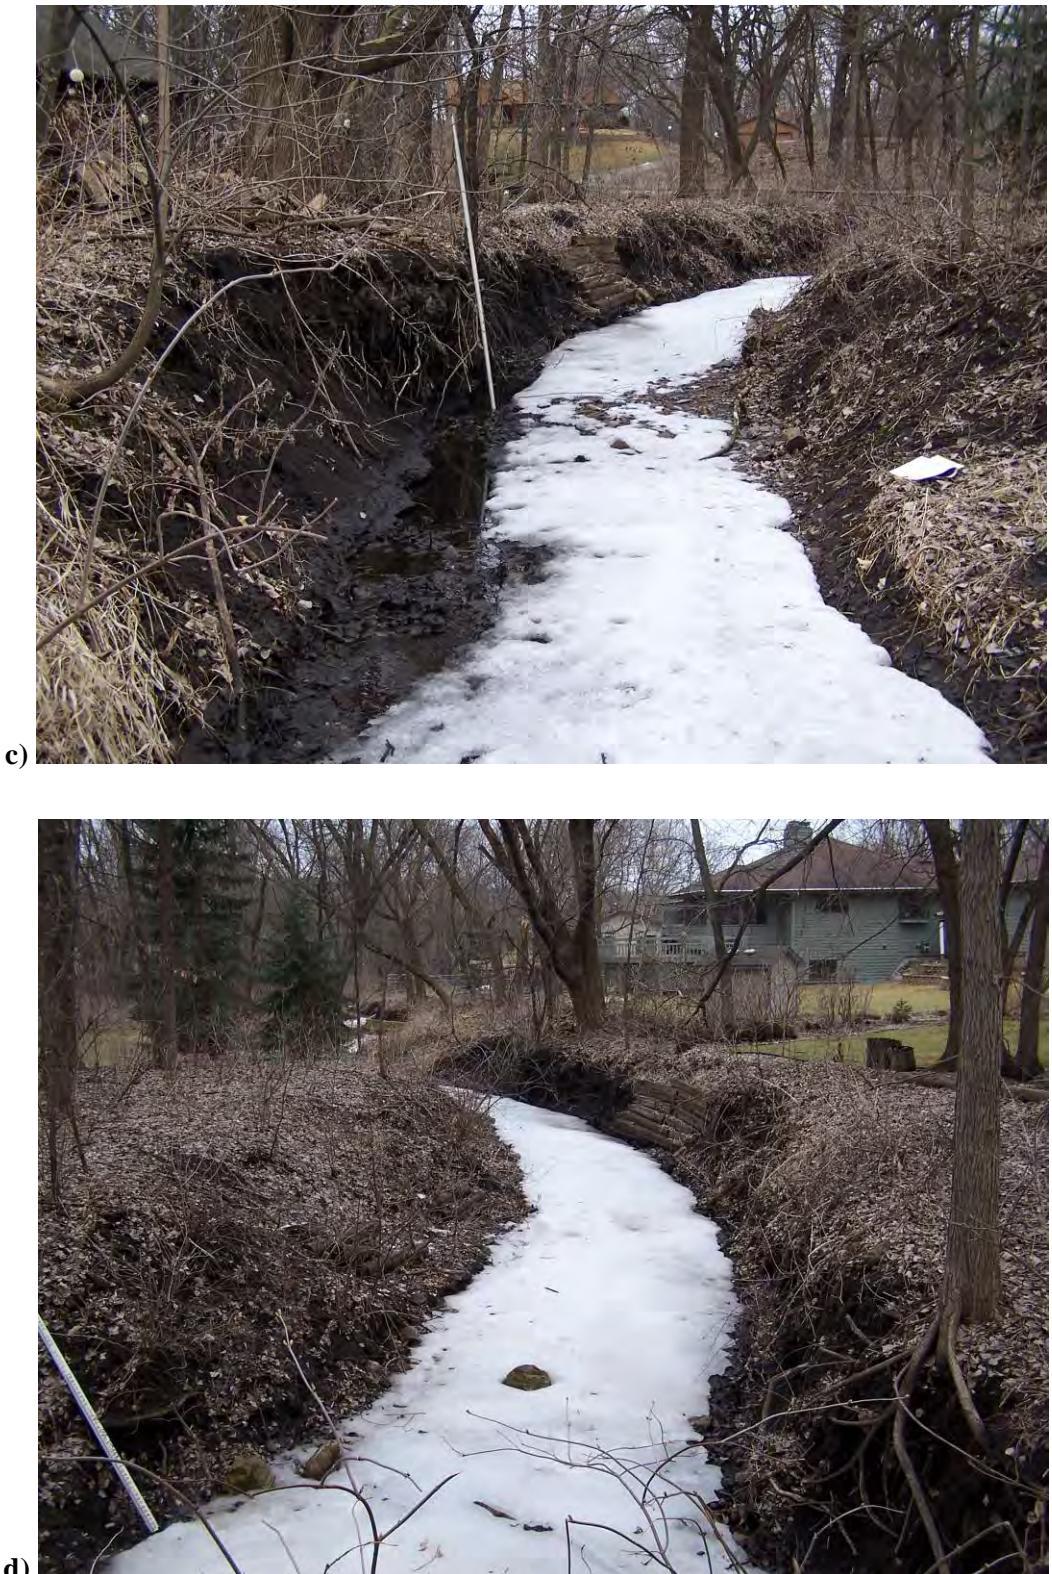
Grade control measures are recommended downstream of the culvert at Erosion Site #3 on Marie Creek. In general, the remaining stream has acceptably adjusted to the existing structures and to the artificial channel straightening that has occurred.

a) perched culvert (2005); b) erosion by culvert (2005); c) looking upstream (2006); d) looking downstream (2006)

The grade control measures should be constructed with boulders and coarse gravel. A V-shaped weir is constructed so that the flow is concentrated toward the center of the channel and away from the banks. Multiple weirs can be constructed to stabilize a longer reach.

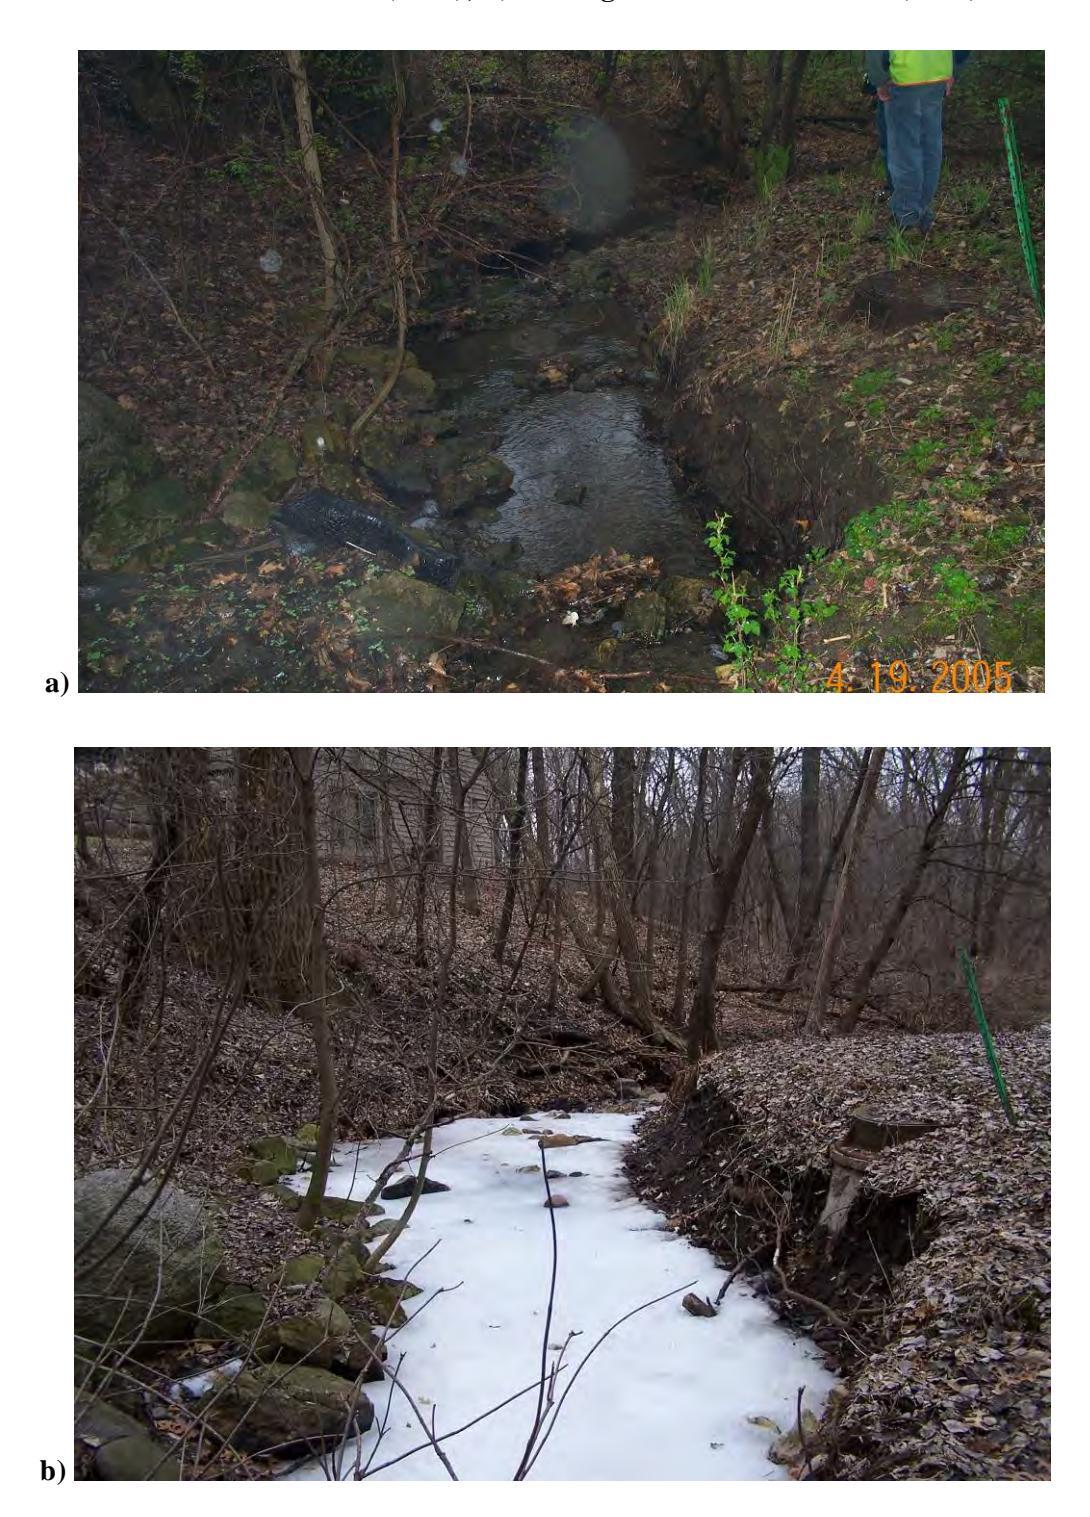
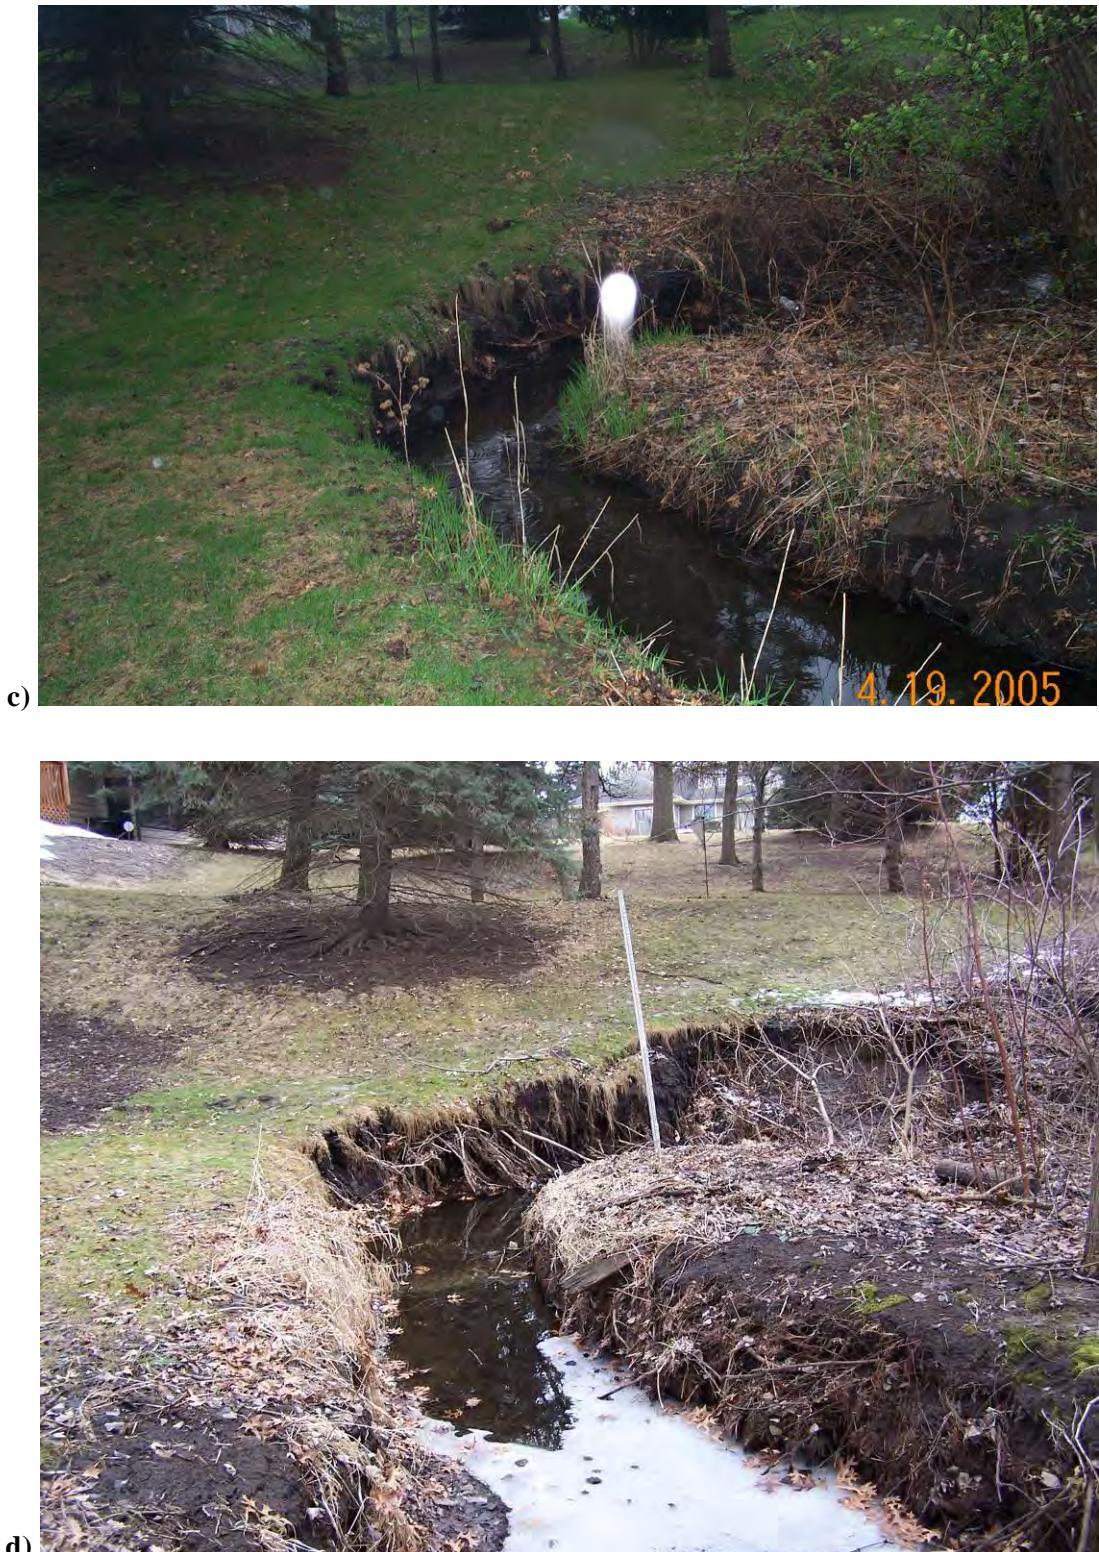
Erosion site #4

a) looking downstream at manhole (2005); b) looking downstream at manhole (2006); c) looking downstream at bank (2005); d) looking downstream at bank (2006)

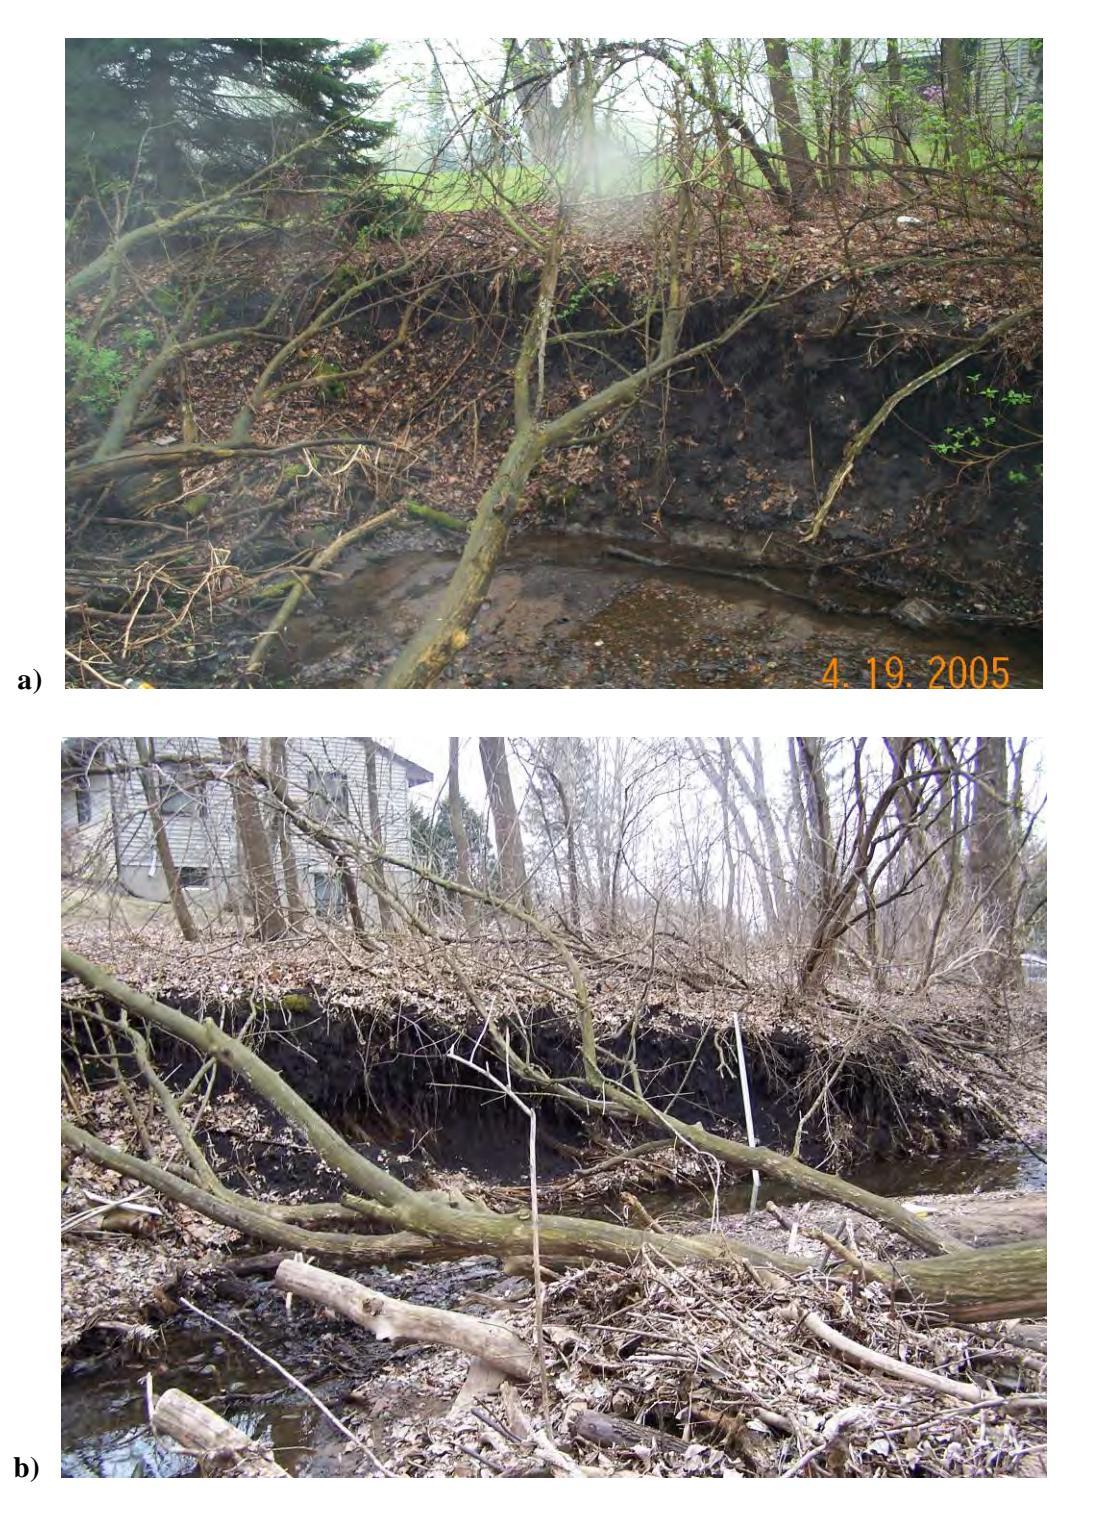
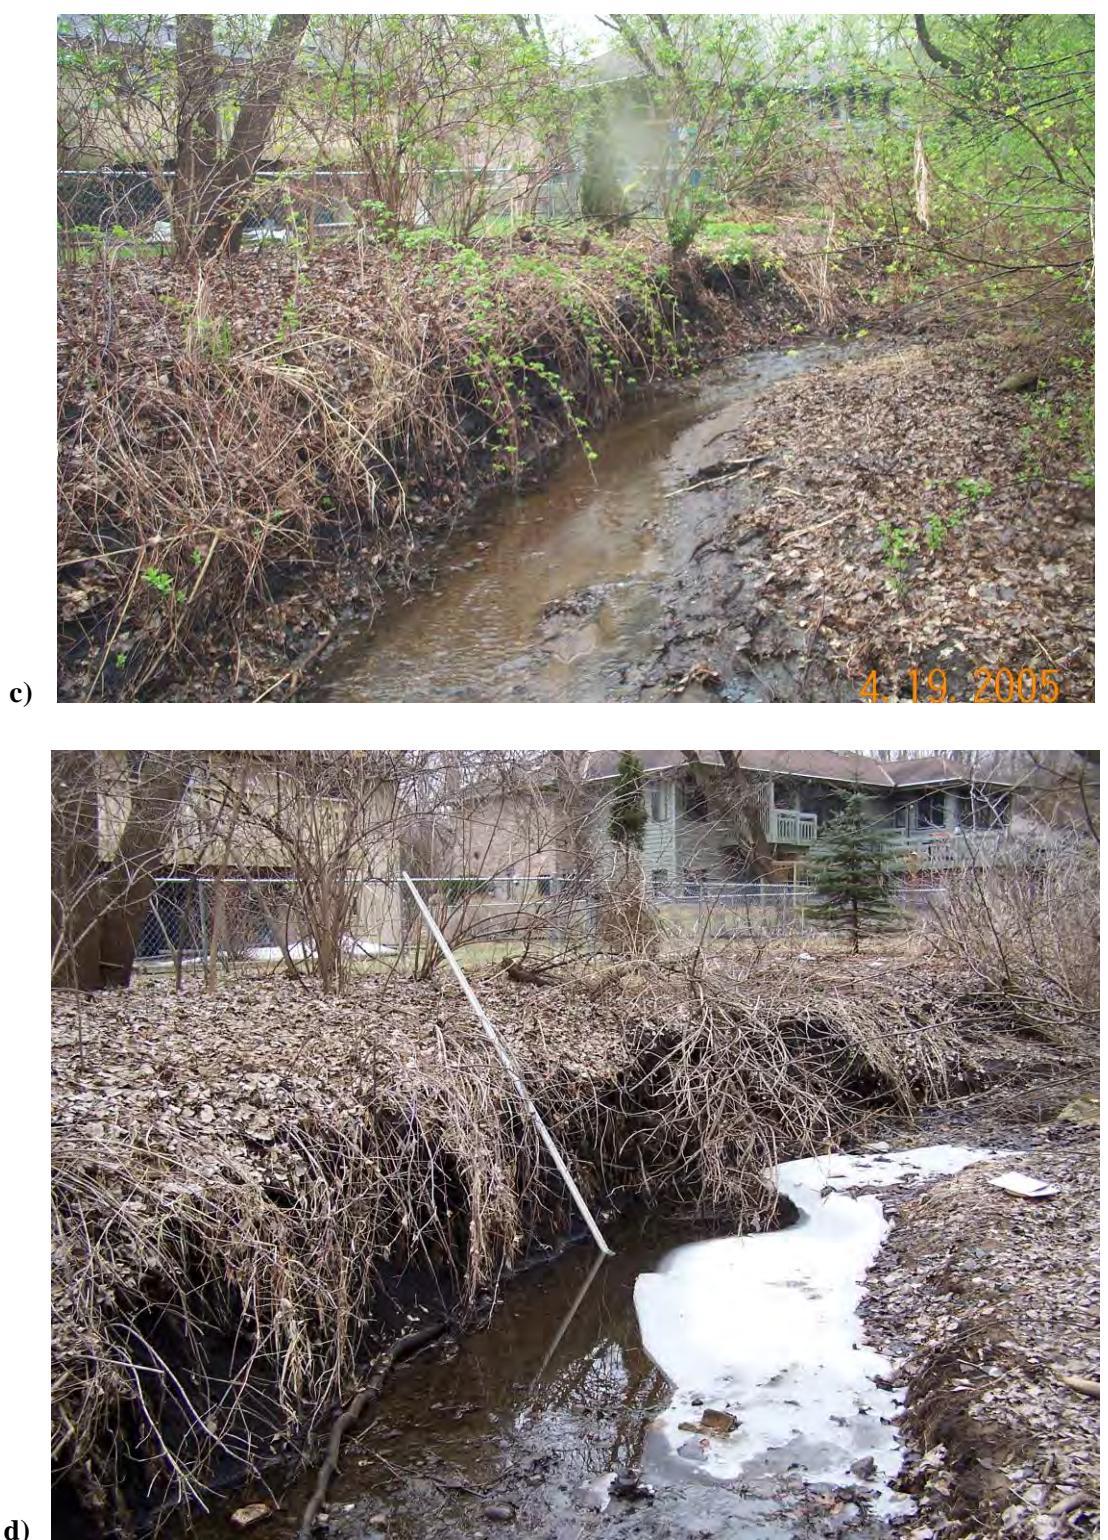
Erosion Site #5

a) looking downstream to meander (2005); b) looking downstream to meander (2006);c) looking upstream to eroding bank (2005); d) looking upstream to eroding bank (2006)

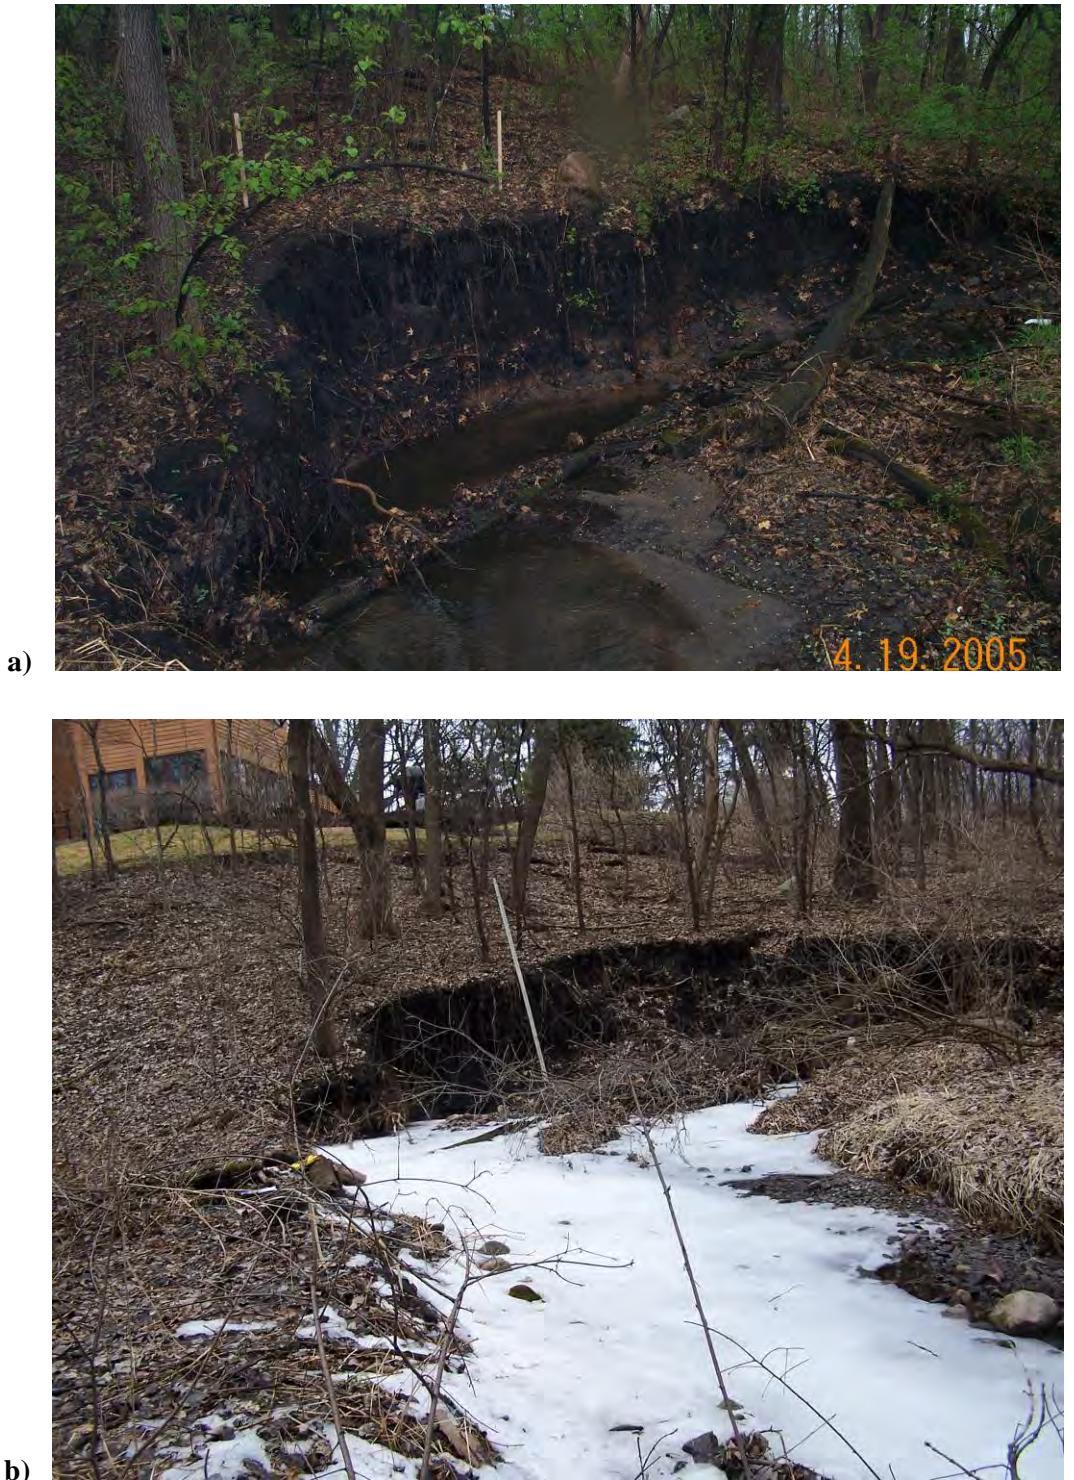
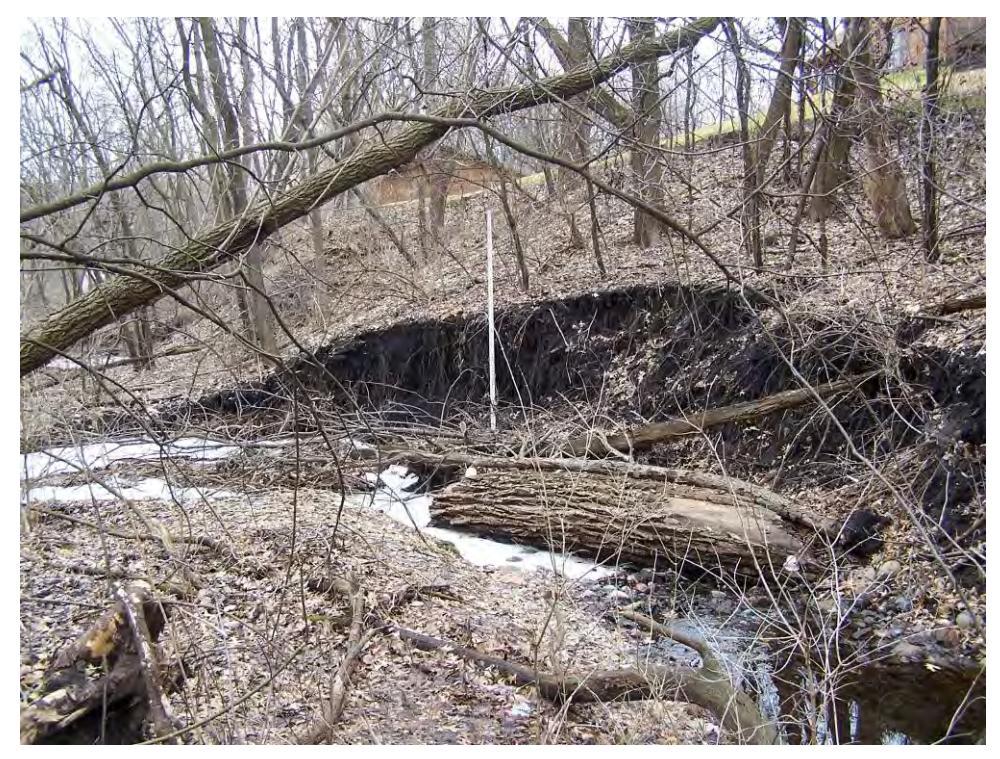
Erosion site #6

a) looking upstream (2005); b) looking upstream (2006); c) looking downstream (2006)

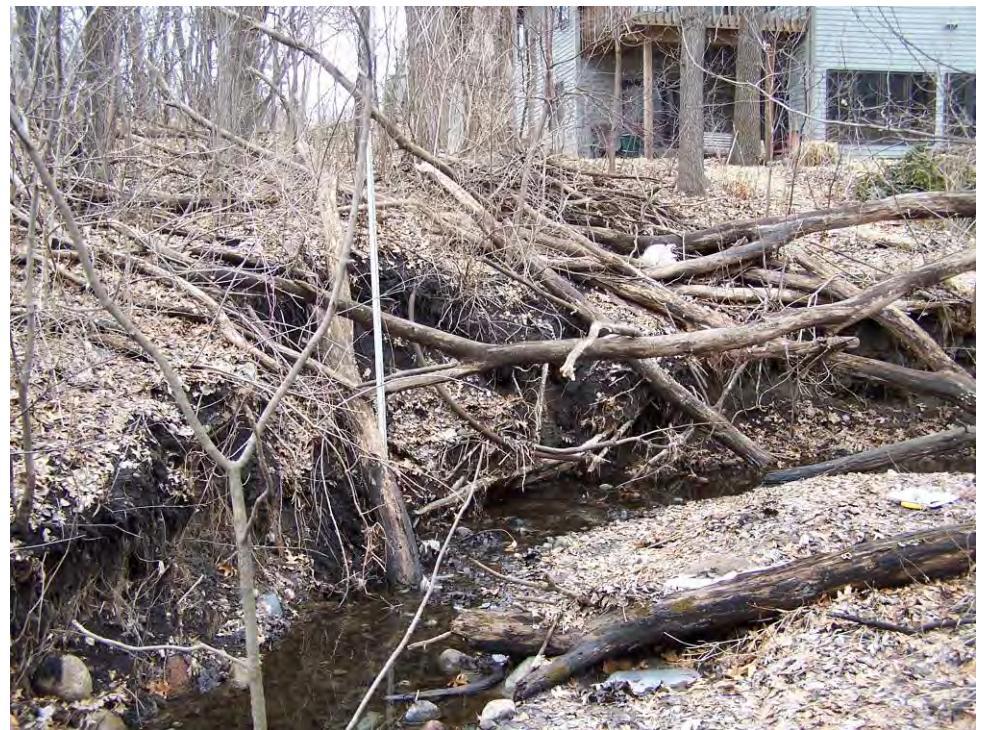
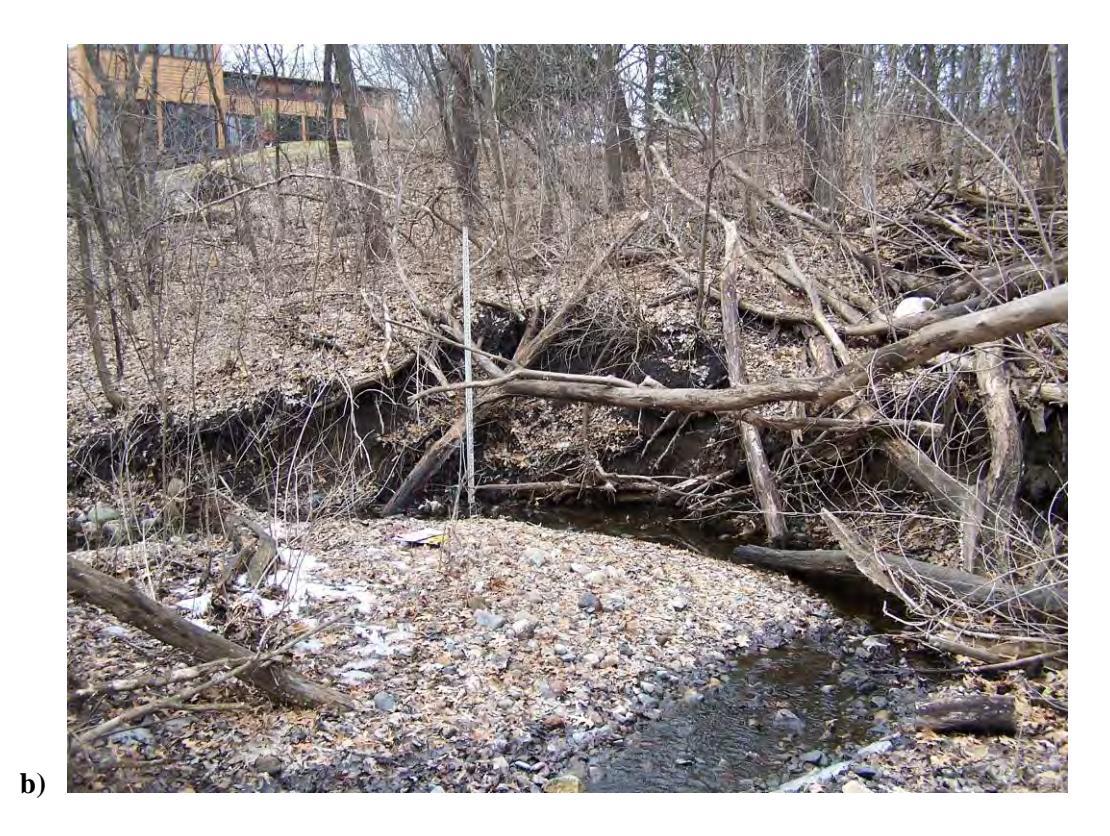
Erosion site #7

a) looking upstream (2006); b) looking downstream (2006)

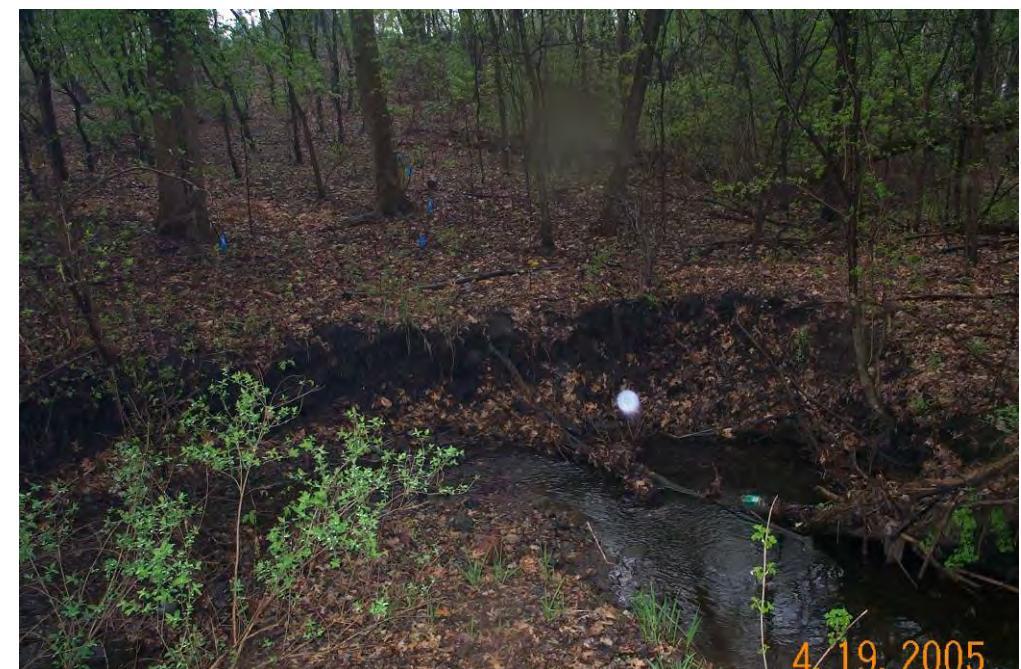
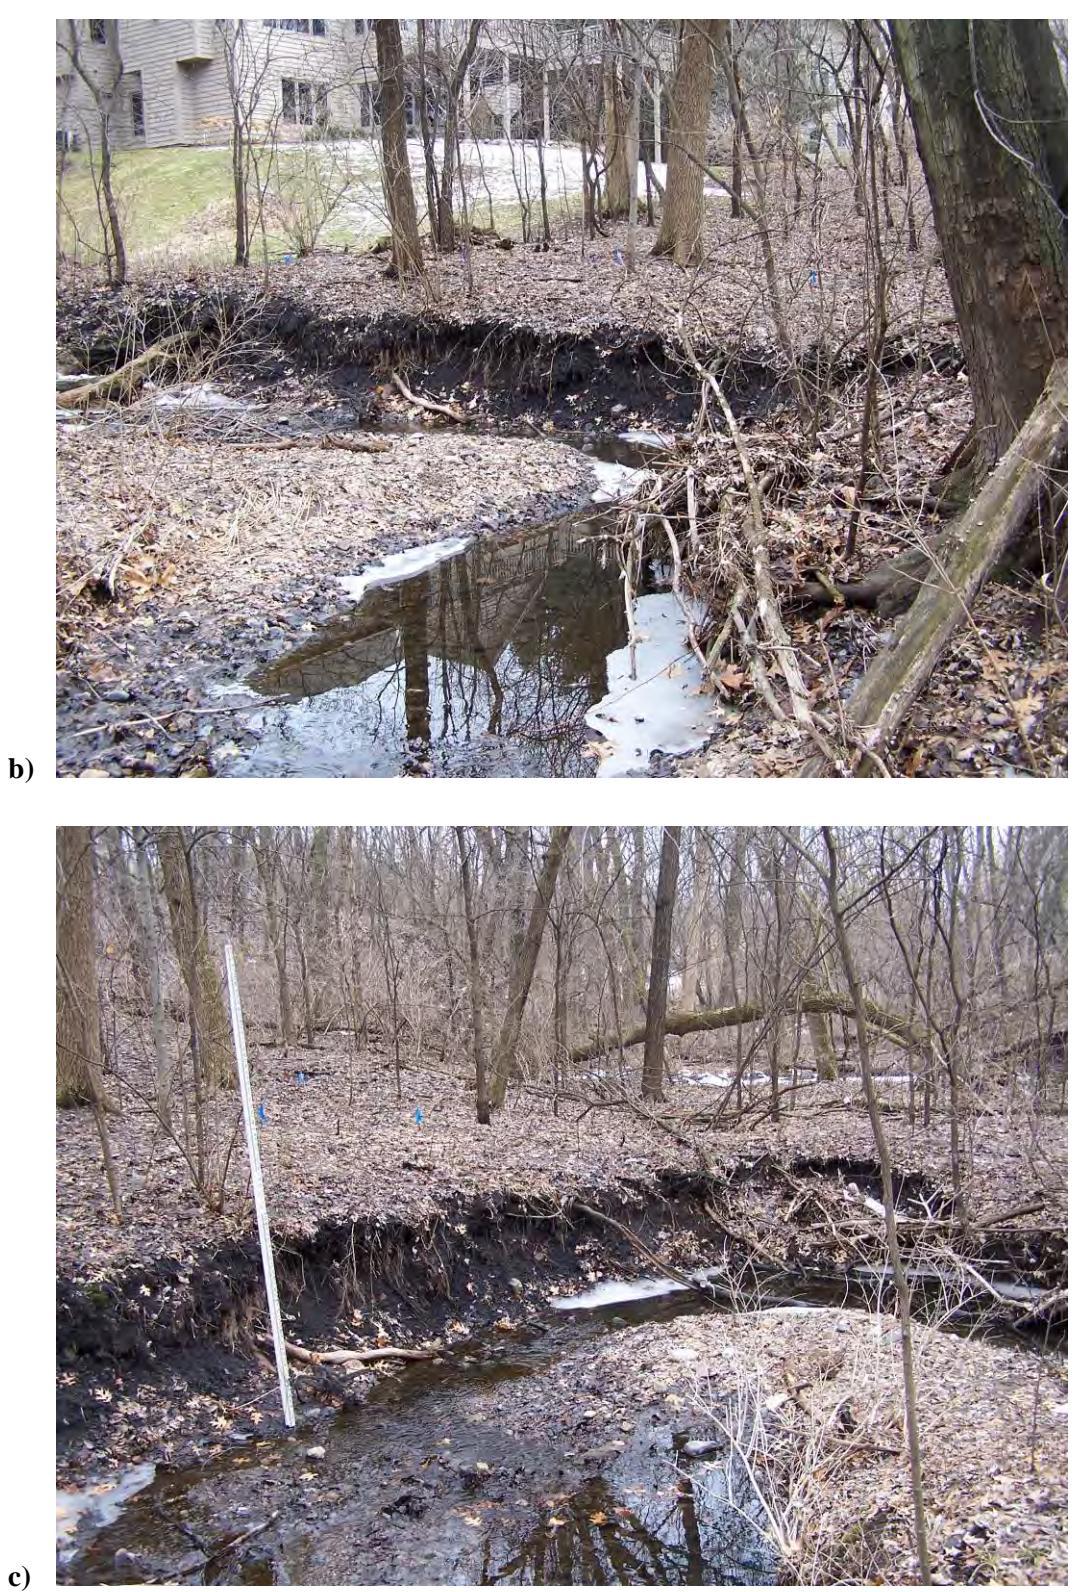
Erosion site #8

a) looking at meander (2005); b) looking upstream (2006); c) looking downstream (2006)

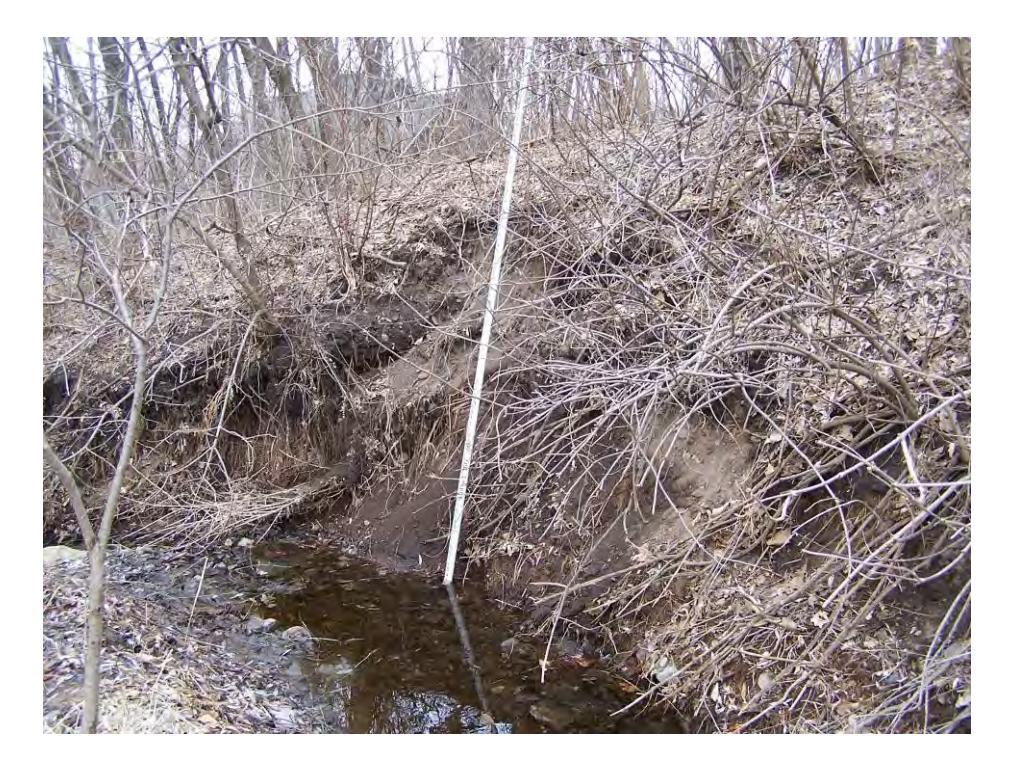
Erosion site #9 - Looking downstream (2006)
