Marie Creek Feasibility Study

Prepared for Lower Mississippi River Watershed Management Organization

June 2006

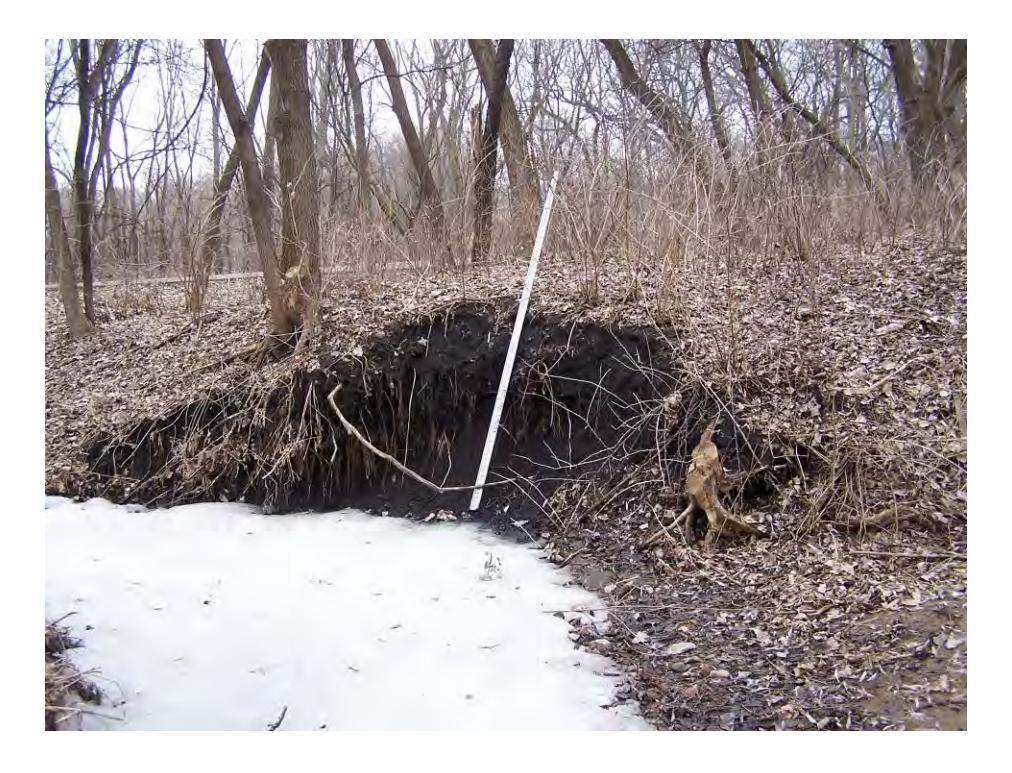
Erosion site #10 – looking downstream (2006)

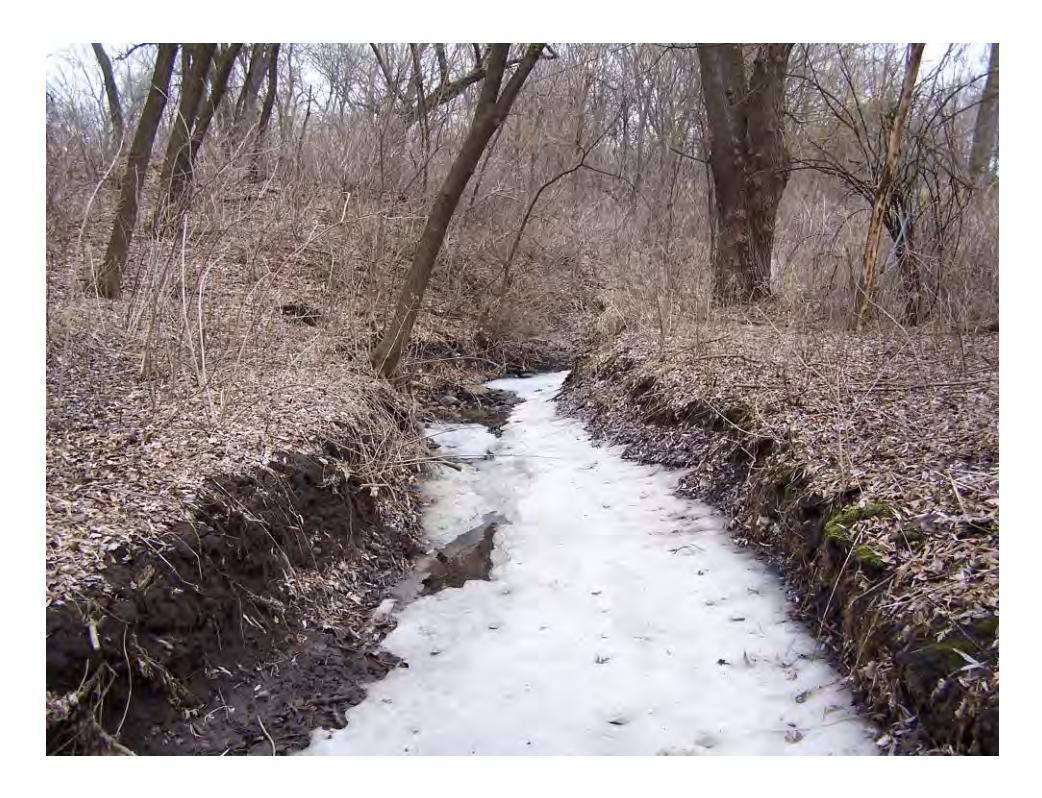
Erosion Site #11 – looking upstream (2006)

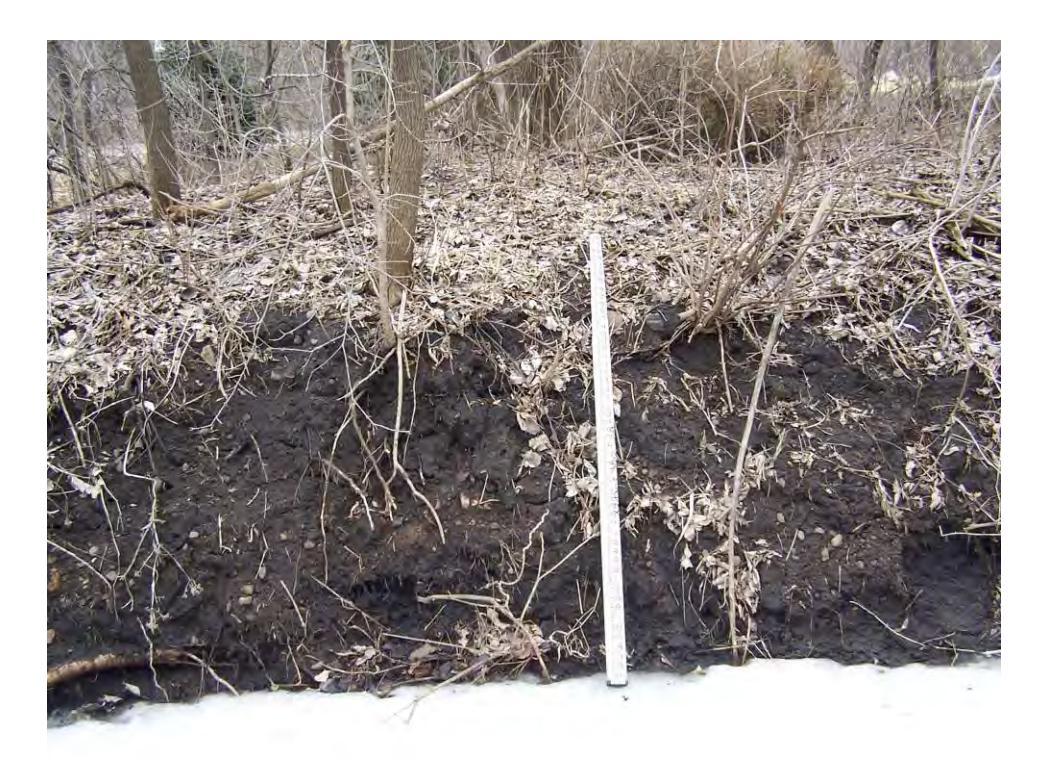
Erosion Site #12 – looking at eroding bank, flow in creek from left to right (2006)
