Sunfish Lake

2022 Water Monitoring Report

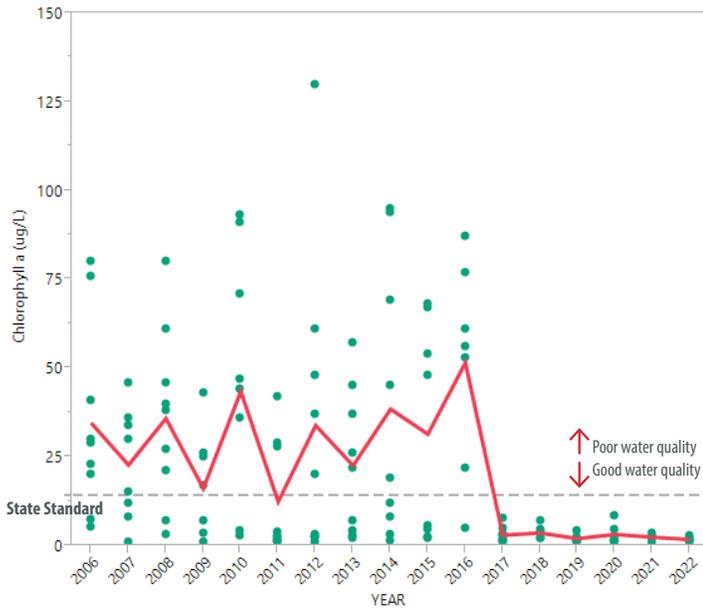
Chlorophyll-a*

Chlorophyll-a is the pigment that gives plants their green color. High levels indicate excessive algae from high nutrient levels in the lake. Low chlorophyll-a levels indicate good water quality. State standard is 14 ug/L (dashed line).

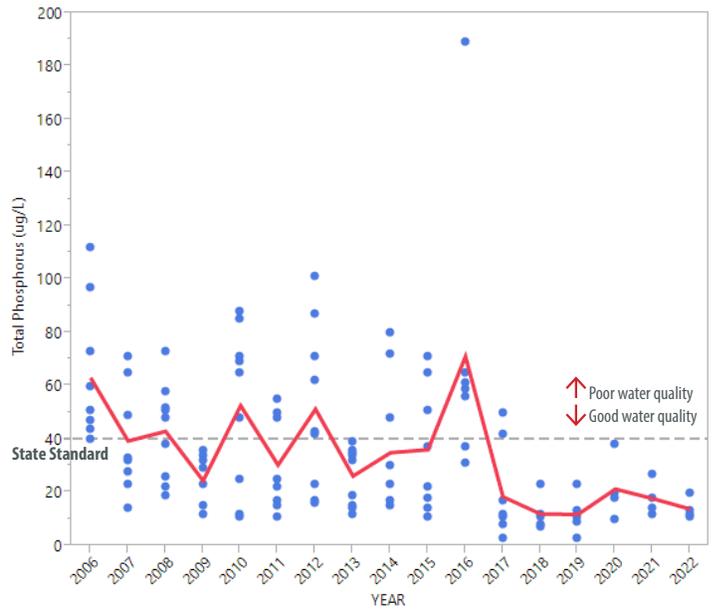
Phosphorus*

Phosphorus is a nutrient required for plant growth. High phosphorus levels can lead to algae blooms, turning water green. Low phosphorus levels indicate good water quality. State standard is 40 ug/L (dashed line).

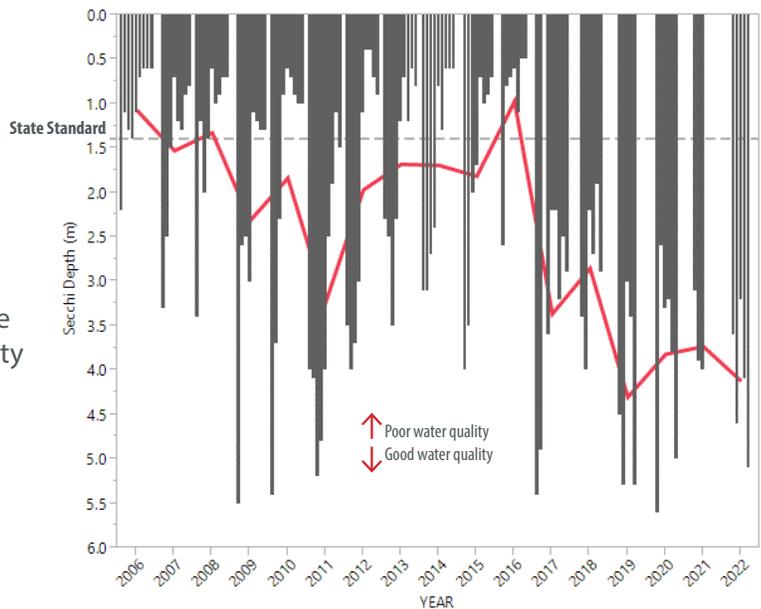
Secchi Depth

A black and white secchi disc is lowered into the water until no longer visible and measures water clarity. High secchi disc depths indicate good water quality. State standard is 1.4 m (dashed line).

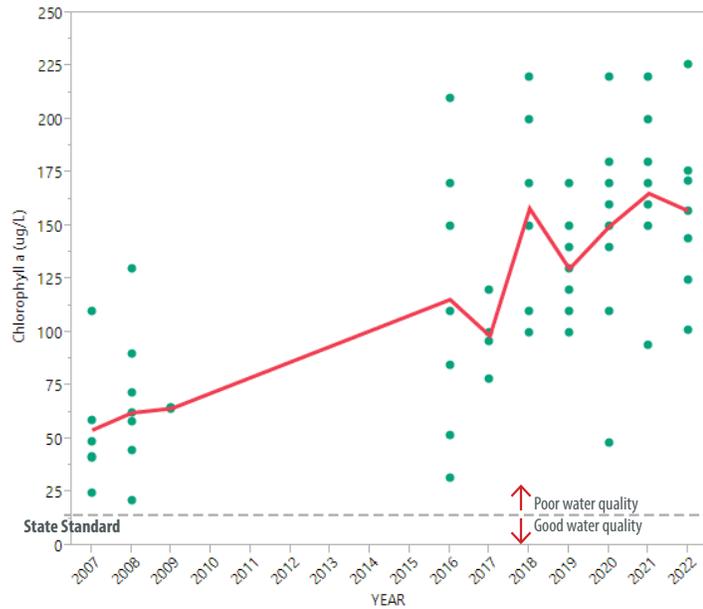
Chlorophyll-a*

Chlorophyll-a is the pigment that gives plants their green color. High levels indicate excessive algae from high nutrient levels in the lake. Low chlorophyll-a levels indicate good water quality. State standard is 14 ug/L (dashed line).

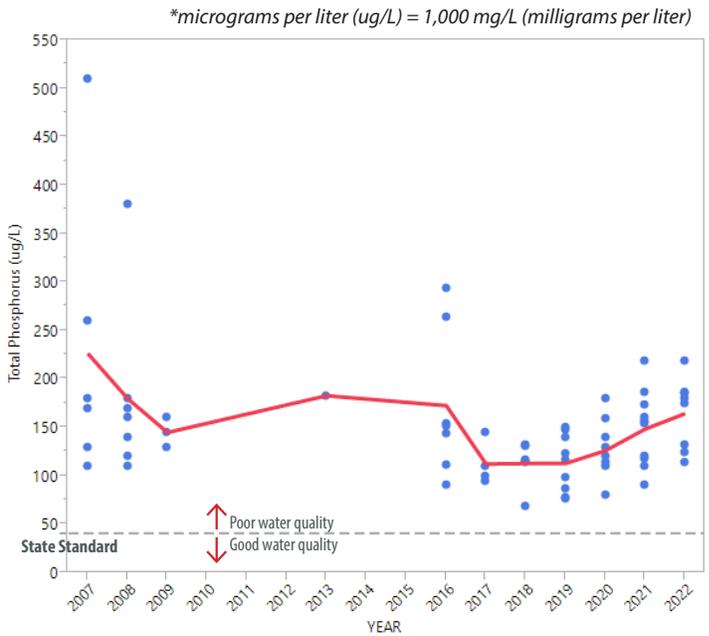
Phosphorus*

Phosphorus is a nutrient required for plant growth. High phosphorus levels can lead to algae blooms, turning water green. Low phosphorus levels indicate good water quality. State standard is 40 ug/L (dashed line).

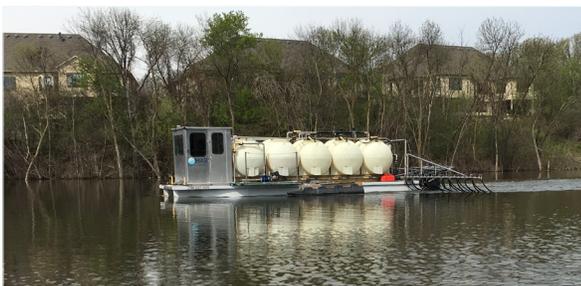
In 2017, the LMRWMO implemented an aluminum sulfate treatment (shown below) to improve water quality which provided slight phosphorus reductions.

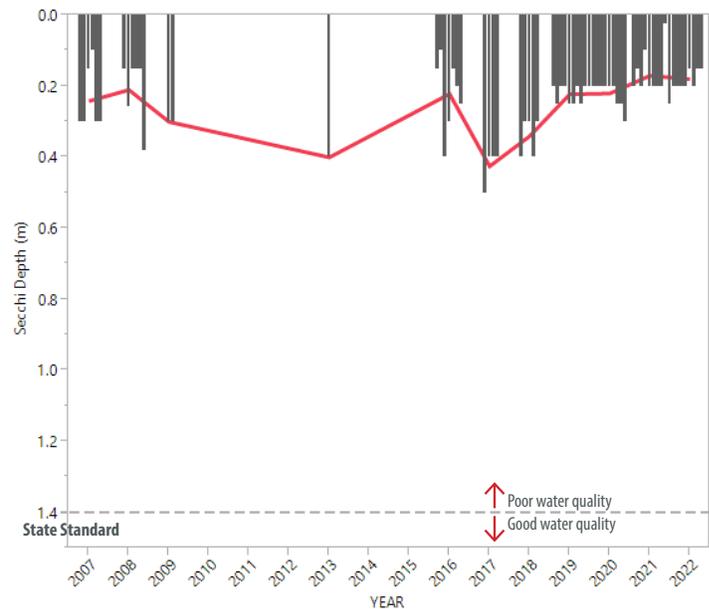
Secchi Depth

A black and white secchi disc is lowered into the water until no longer visible and measures water clarity. High secchi disc depths indicate good water quality. State standard is 1.4 m (dashed line).

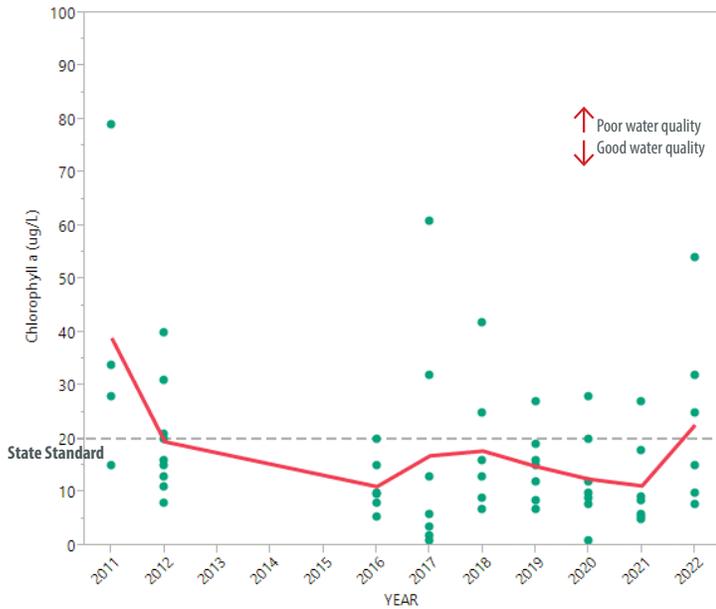
Chlorophyll-a*

Chlorophyll-a is the pigment that gives plants their green color. High levels indicate excessive algae from high nutrient levels in the lake. Low chlorophyll-a levels indicate good water quality. State standard is 20 ug/L (dashed line).

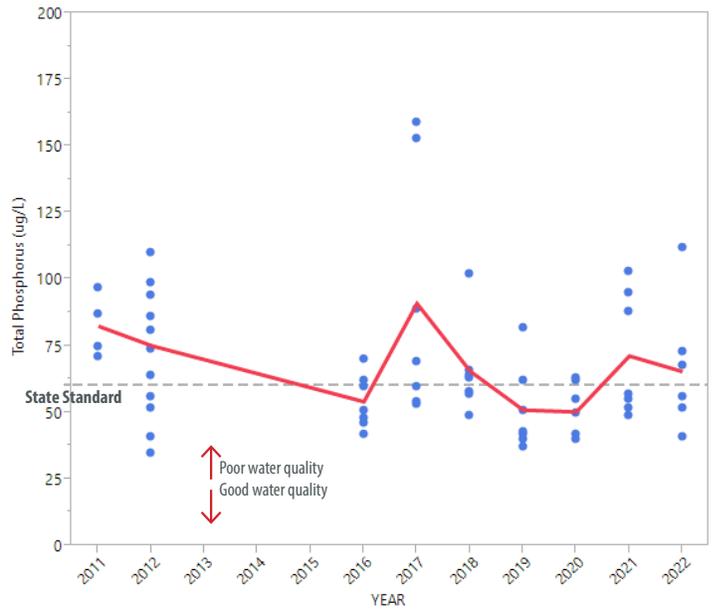
Phosphorus*

Phosphorus is a nutrient required for plant growth. High phosphorus levels can lead to algae blooms, turning water green. Low phosphorus levels indicate good water quality. State standard is 60 ug/L (dashed line).

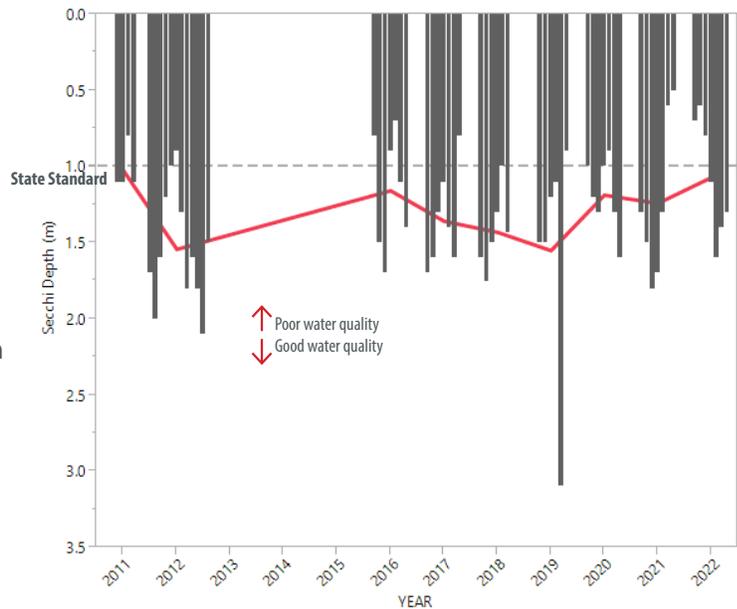
Secchi Depth

A black and white secchi disc is lowered into the water until no longer visible and measures water clarity. High secchi disc depths indicate good water quality. State standard is 1 m (dashed line).

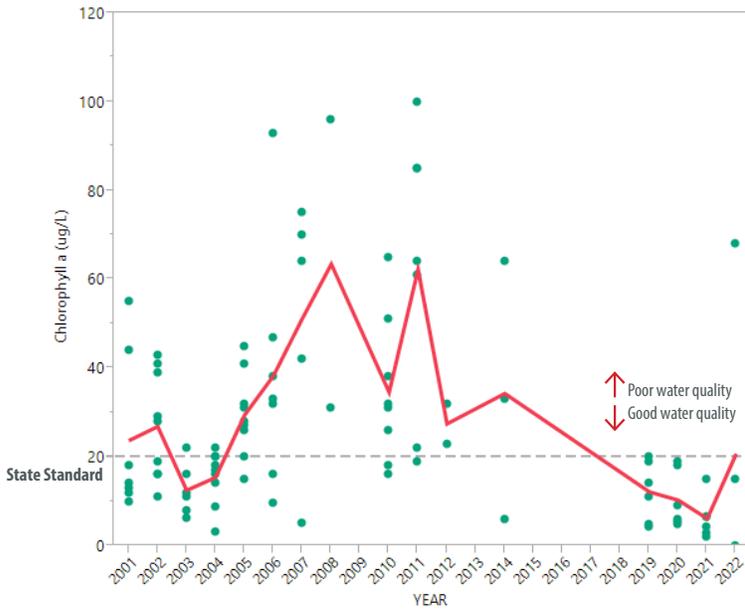
Chlorophyll-a*

Chlorophyll-a is the pigment that gives plants their green color. High levels indicate excessive algae from high nutrient levels in the lake. Low chlorophyll-a levels indicate good water quality. State standard is 20 ug/L (dashed line).

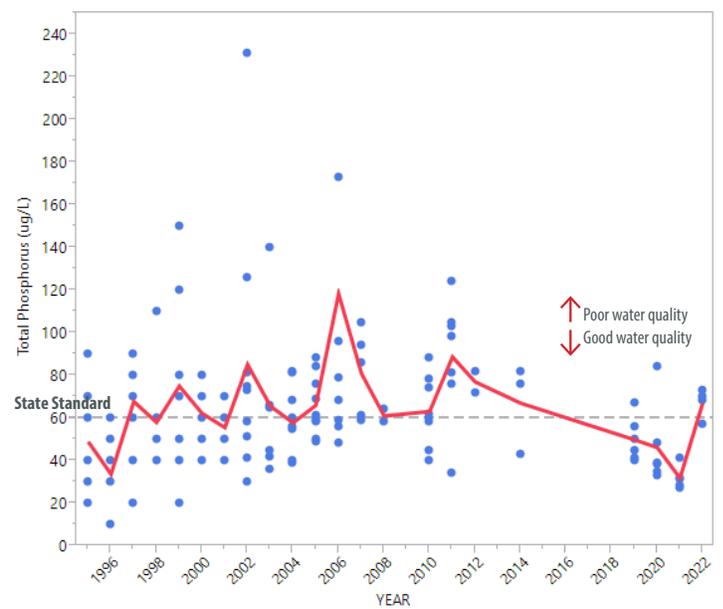
Phosphorus*

Phosphorus is a nutrient required for plant growth. High phosphorus levels can lead to algae blooms, turning water green. Low phosphorus levels indicate good water quality. State standard is 60 ug/L (dashed line).

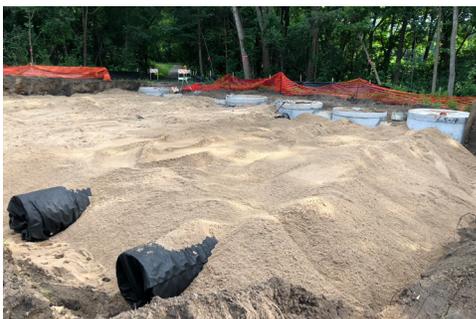
The LMRWMO partnered with the City of South St. Paul to install large buried pipes (shown below) in 2018 to clean and infiltrate stormwater before entering the Lake.

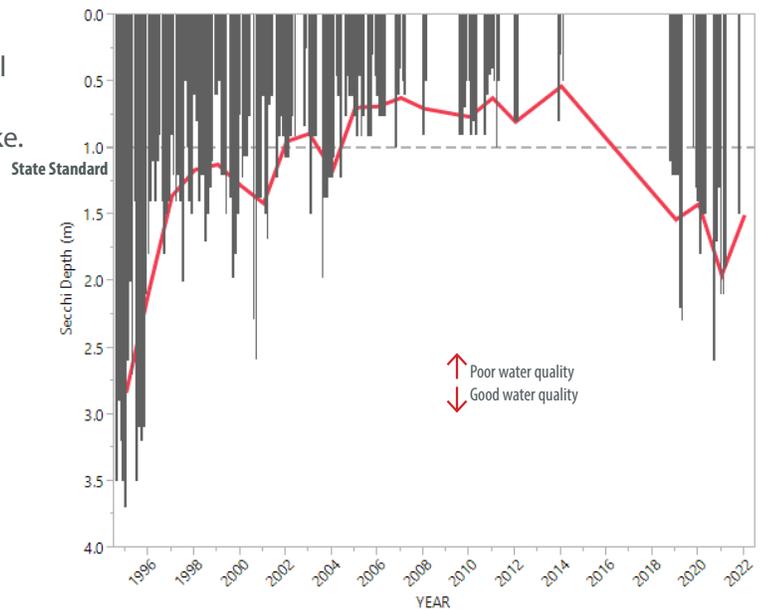
Secchi Depth

A black and white secchi disc is lowered into the water until no longer visible and measures water clarity. High secchi disc depths indicate good water quality. State standard is 1 m (dashed line).

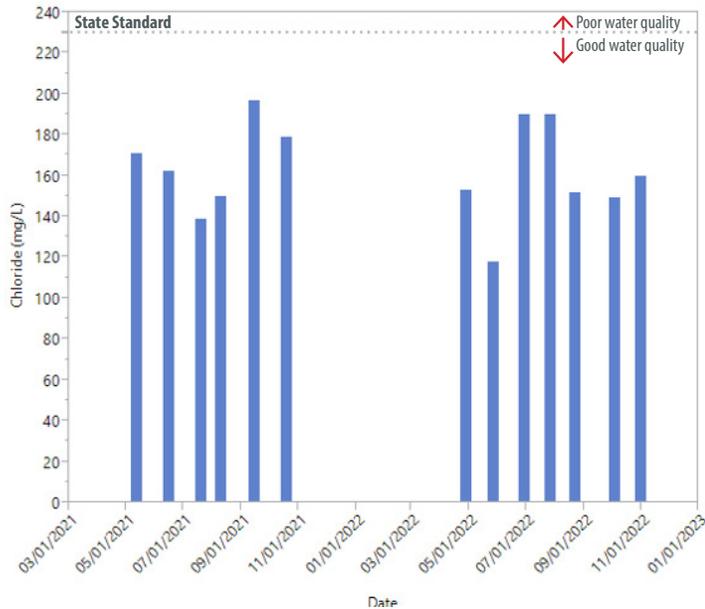
Chloride

Elevated chloride concentrations can be toxic to some aquatic life – altering community composition, as well as affecting mortality and reproduction capabilities. State standard for acute toxicity is ≤ 230 ug/L (dashed line).

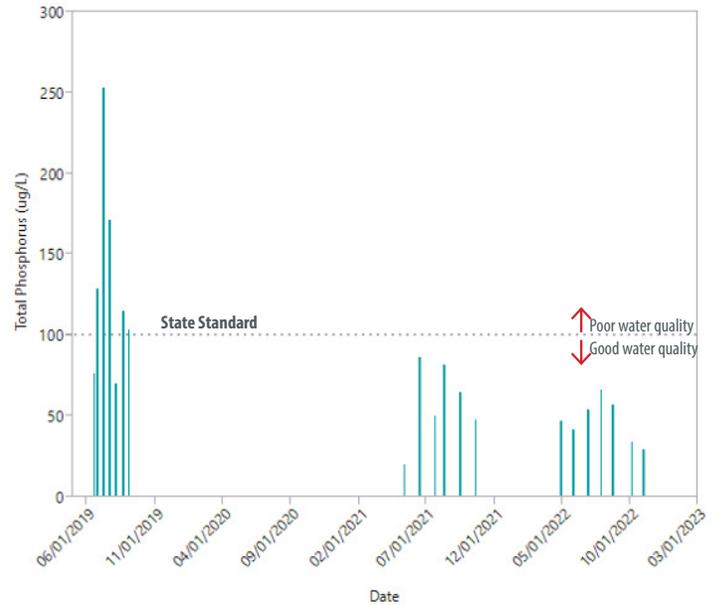
Phosphorus*

Phosphorus is a nutrient required for plant growth. High phosphorus levels can lead to algae blooms, turning water green. Low phosphorus levels indicate good water quality. State standard is ≤ 100 ug/L (dashed line).

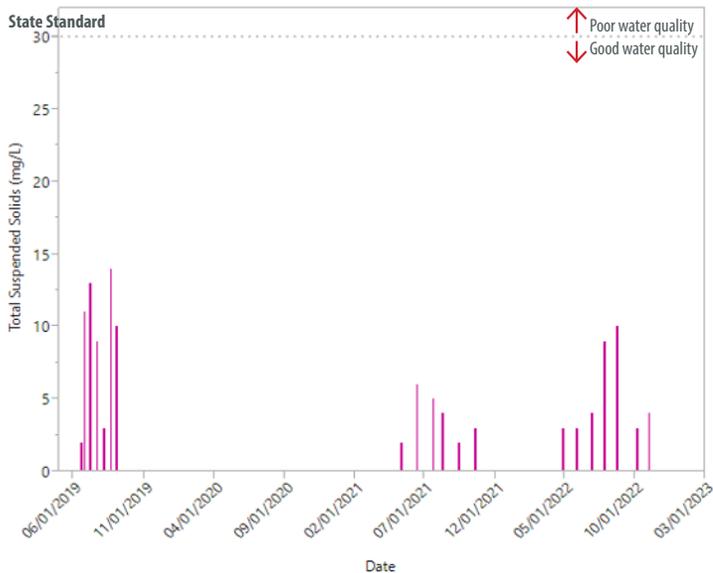
Total Suspended Solids

A measurement of all suspended particles in the water. Potential sources include field and streambank erosion and stormwater runoff. Excessive levels can impair water quality and usability. State standard is ≤ 30 ug/L (dashed line).

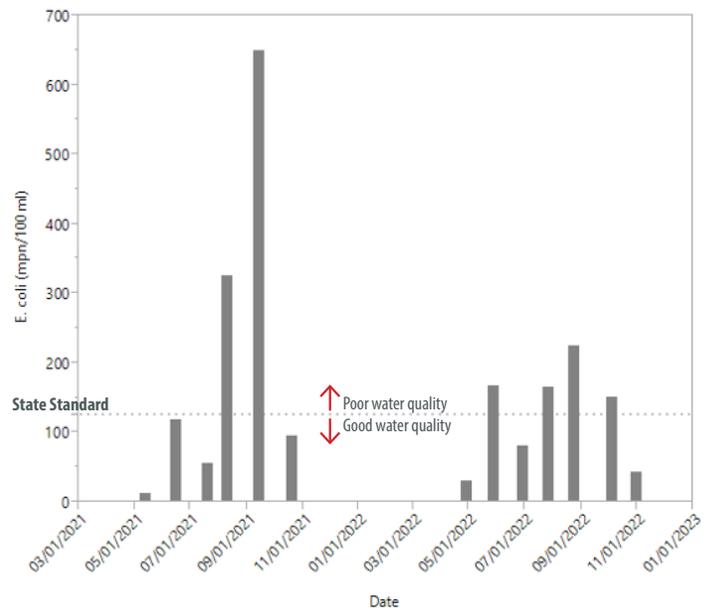
E. coli

Escherichia coli (E. coli) bacteria is a good indicator that disease-causing pathogens may be present in water. A standard of ≤ 126 MPN/100mL (dashed line) has been established (MPN = most probable number of organisms).

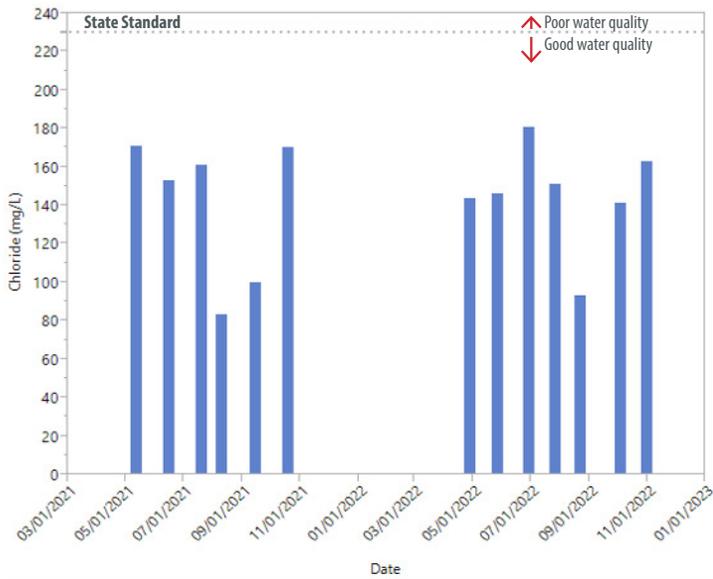
Chloride*

Elevated chloride concentrations can be toxic to some aquatic life – altering community composition, as well as affecting mortality and reproduction capabilities. State standard for acute toxicity is ≤ 230 ug/L (dashed line).

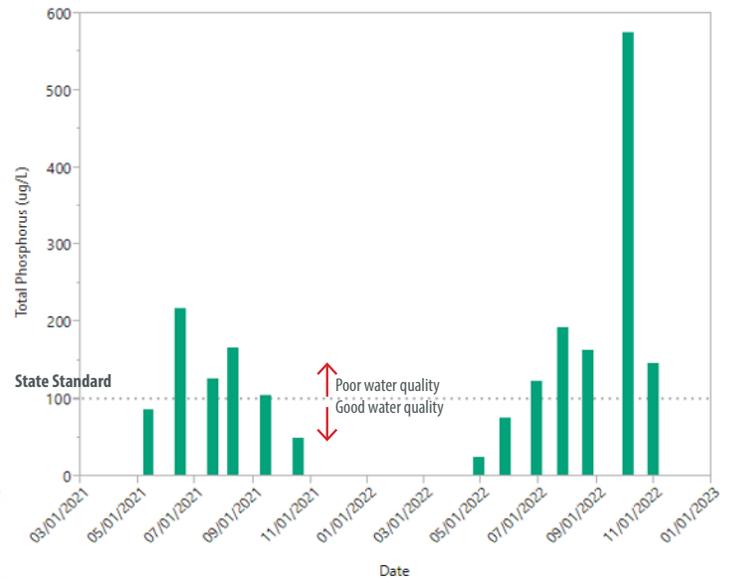
Phosphorus*

Phosphorus is a nutrient required for plant growth. High phosphorus levels can lead to algae blooms, turning water green. Low phosphorus levels indicate good water quality. State standard is ≤ 100 ug/L (dashed line).

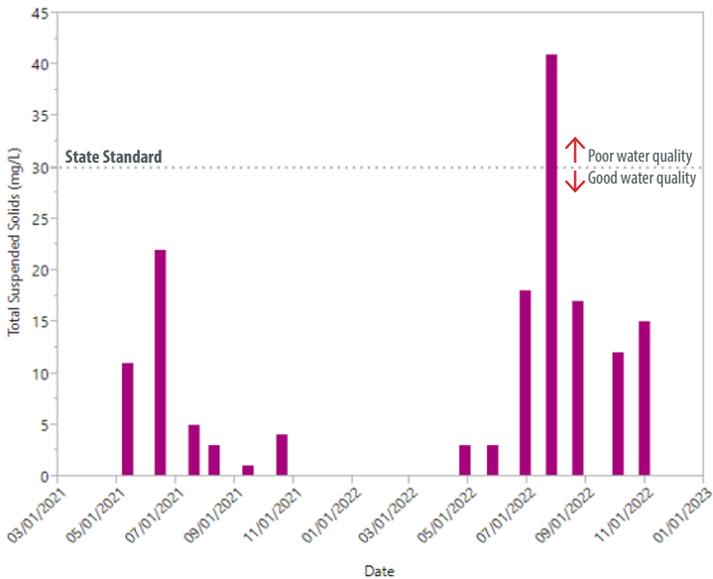
Total Suspended Solids

A measurement of all suspended particles in the water. Potential sources include field and streambank erosion and stormwater runoff. Excessive levels can impair water quality and usability. State standard is ≤ 30 ug/L (dashed line).

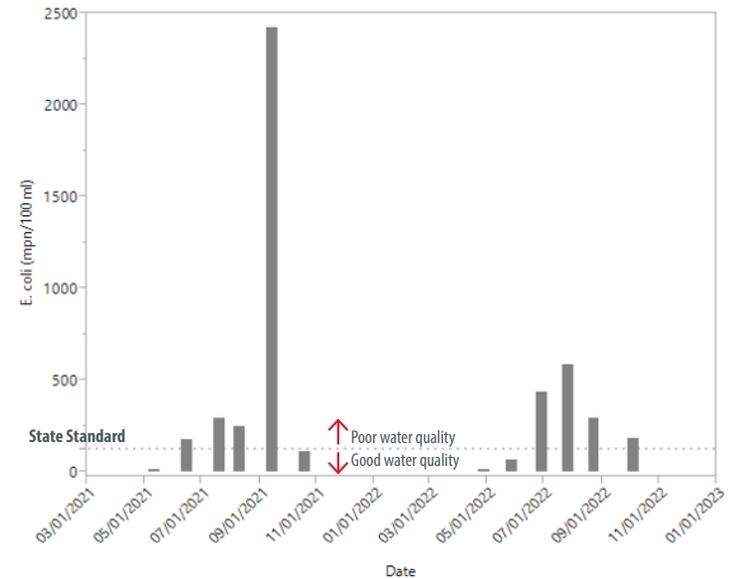
E. coli

Escherichia coli (E. coli) bacteria is a good indicator that disease-causing pathogens may be present in water. A standard of ≤ 126 MPN/100mL has been established (MPN stands for most probable number of organisms).

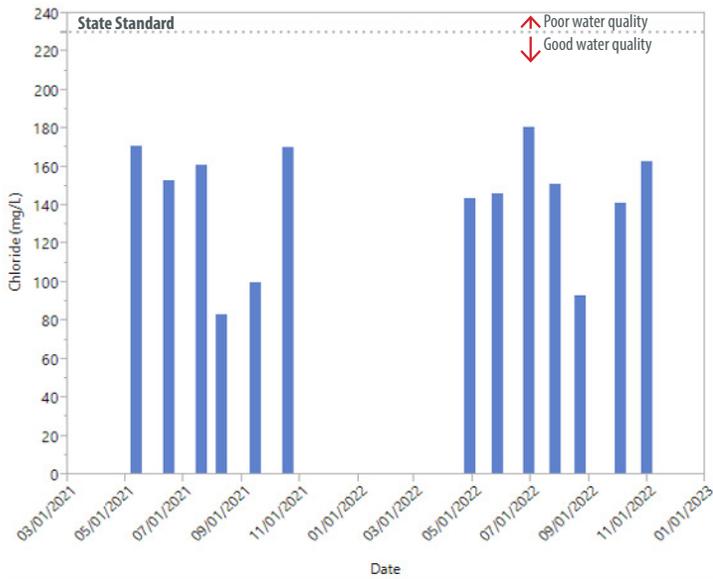
Chloride*

Elevated chloride concentrations can be toxic to some aquatic life – altering community composition, as well as affecting mortality and reproduction capabilities. State standard for acute toxicity is ≤ 230 ug/L (dashed line).

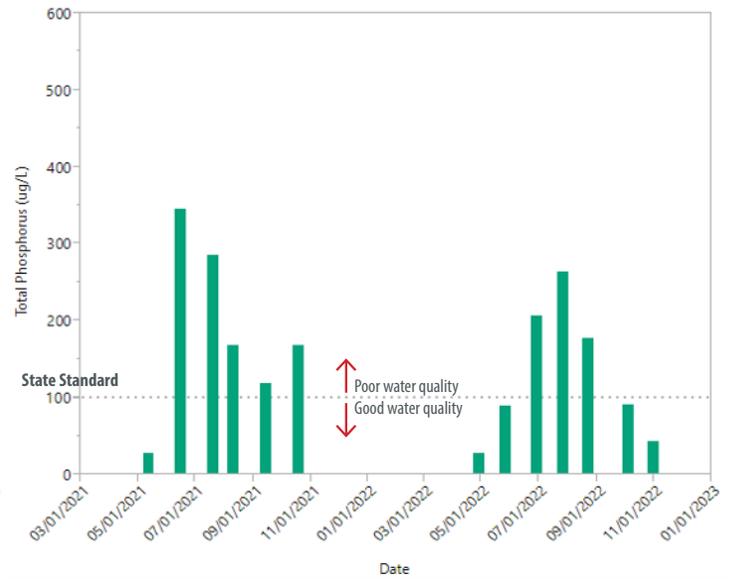
Phosphorus*

Phosphorus is a nutrient required for plant growth. High phosphorus levels can lead to algae blooms, turning water green. Low phosphorus levels indicate good water quality. State standard is ≤ 100 ug/L (dashed line).

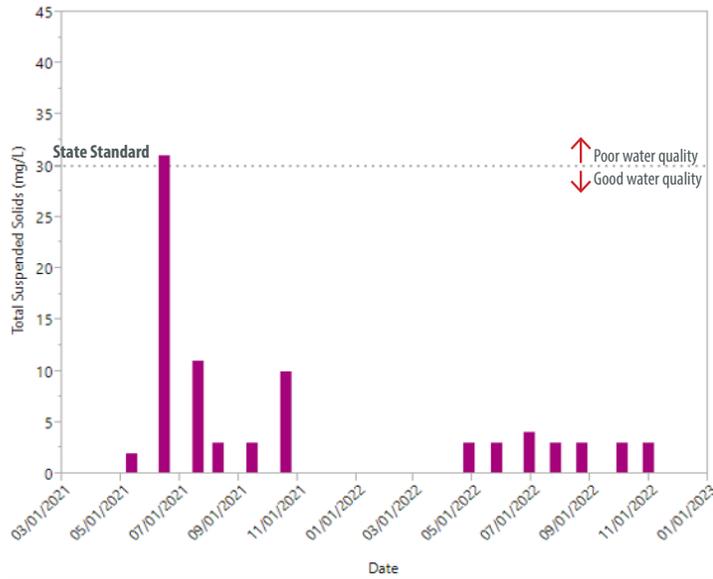
Total Suspended Solids

A measurement of all suspended particles in the water. Potential sources include field and streambank erosion and stormwater runoff. Excessive levels can impair water quality and usability. State standard is ≤ 30 ug/L (dashed line).

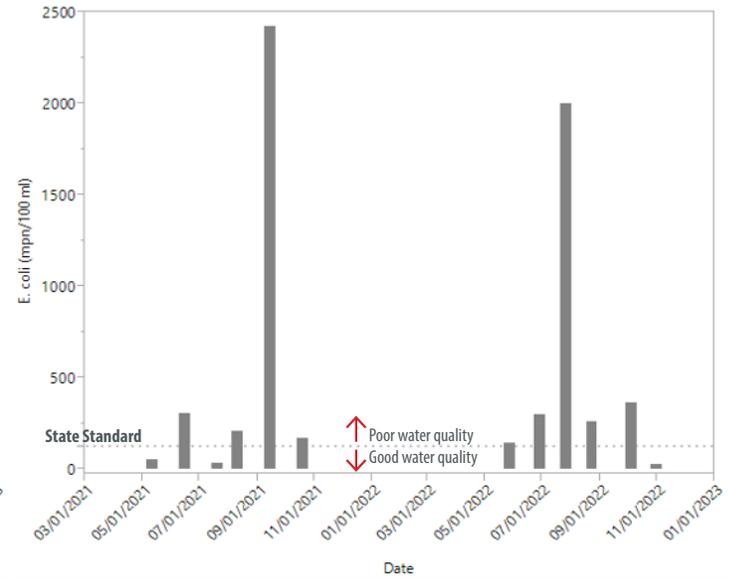
E. coli

Escherichia coli (E. coli) bacteria is a good indicator that disease-causing pathogens may be present in water. A standard of ≤ 126 MPN/100mL has been established (MPN stands for most probable number of organisms).
