Lake Augusta Water Quality Improvement and Outlet Feasibility Study

Prepared for
Lower Mississippi River Watershed Management Organization and
City of Mendota Heights

November 2023

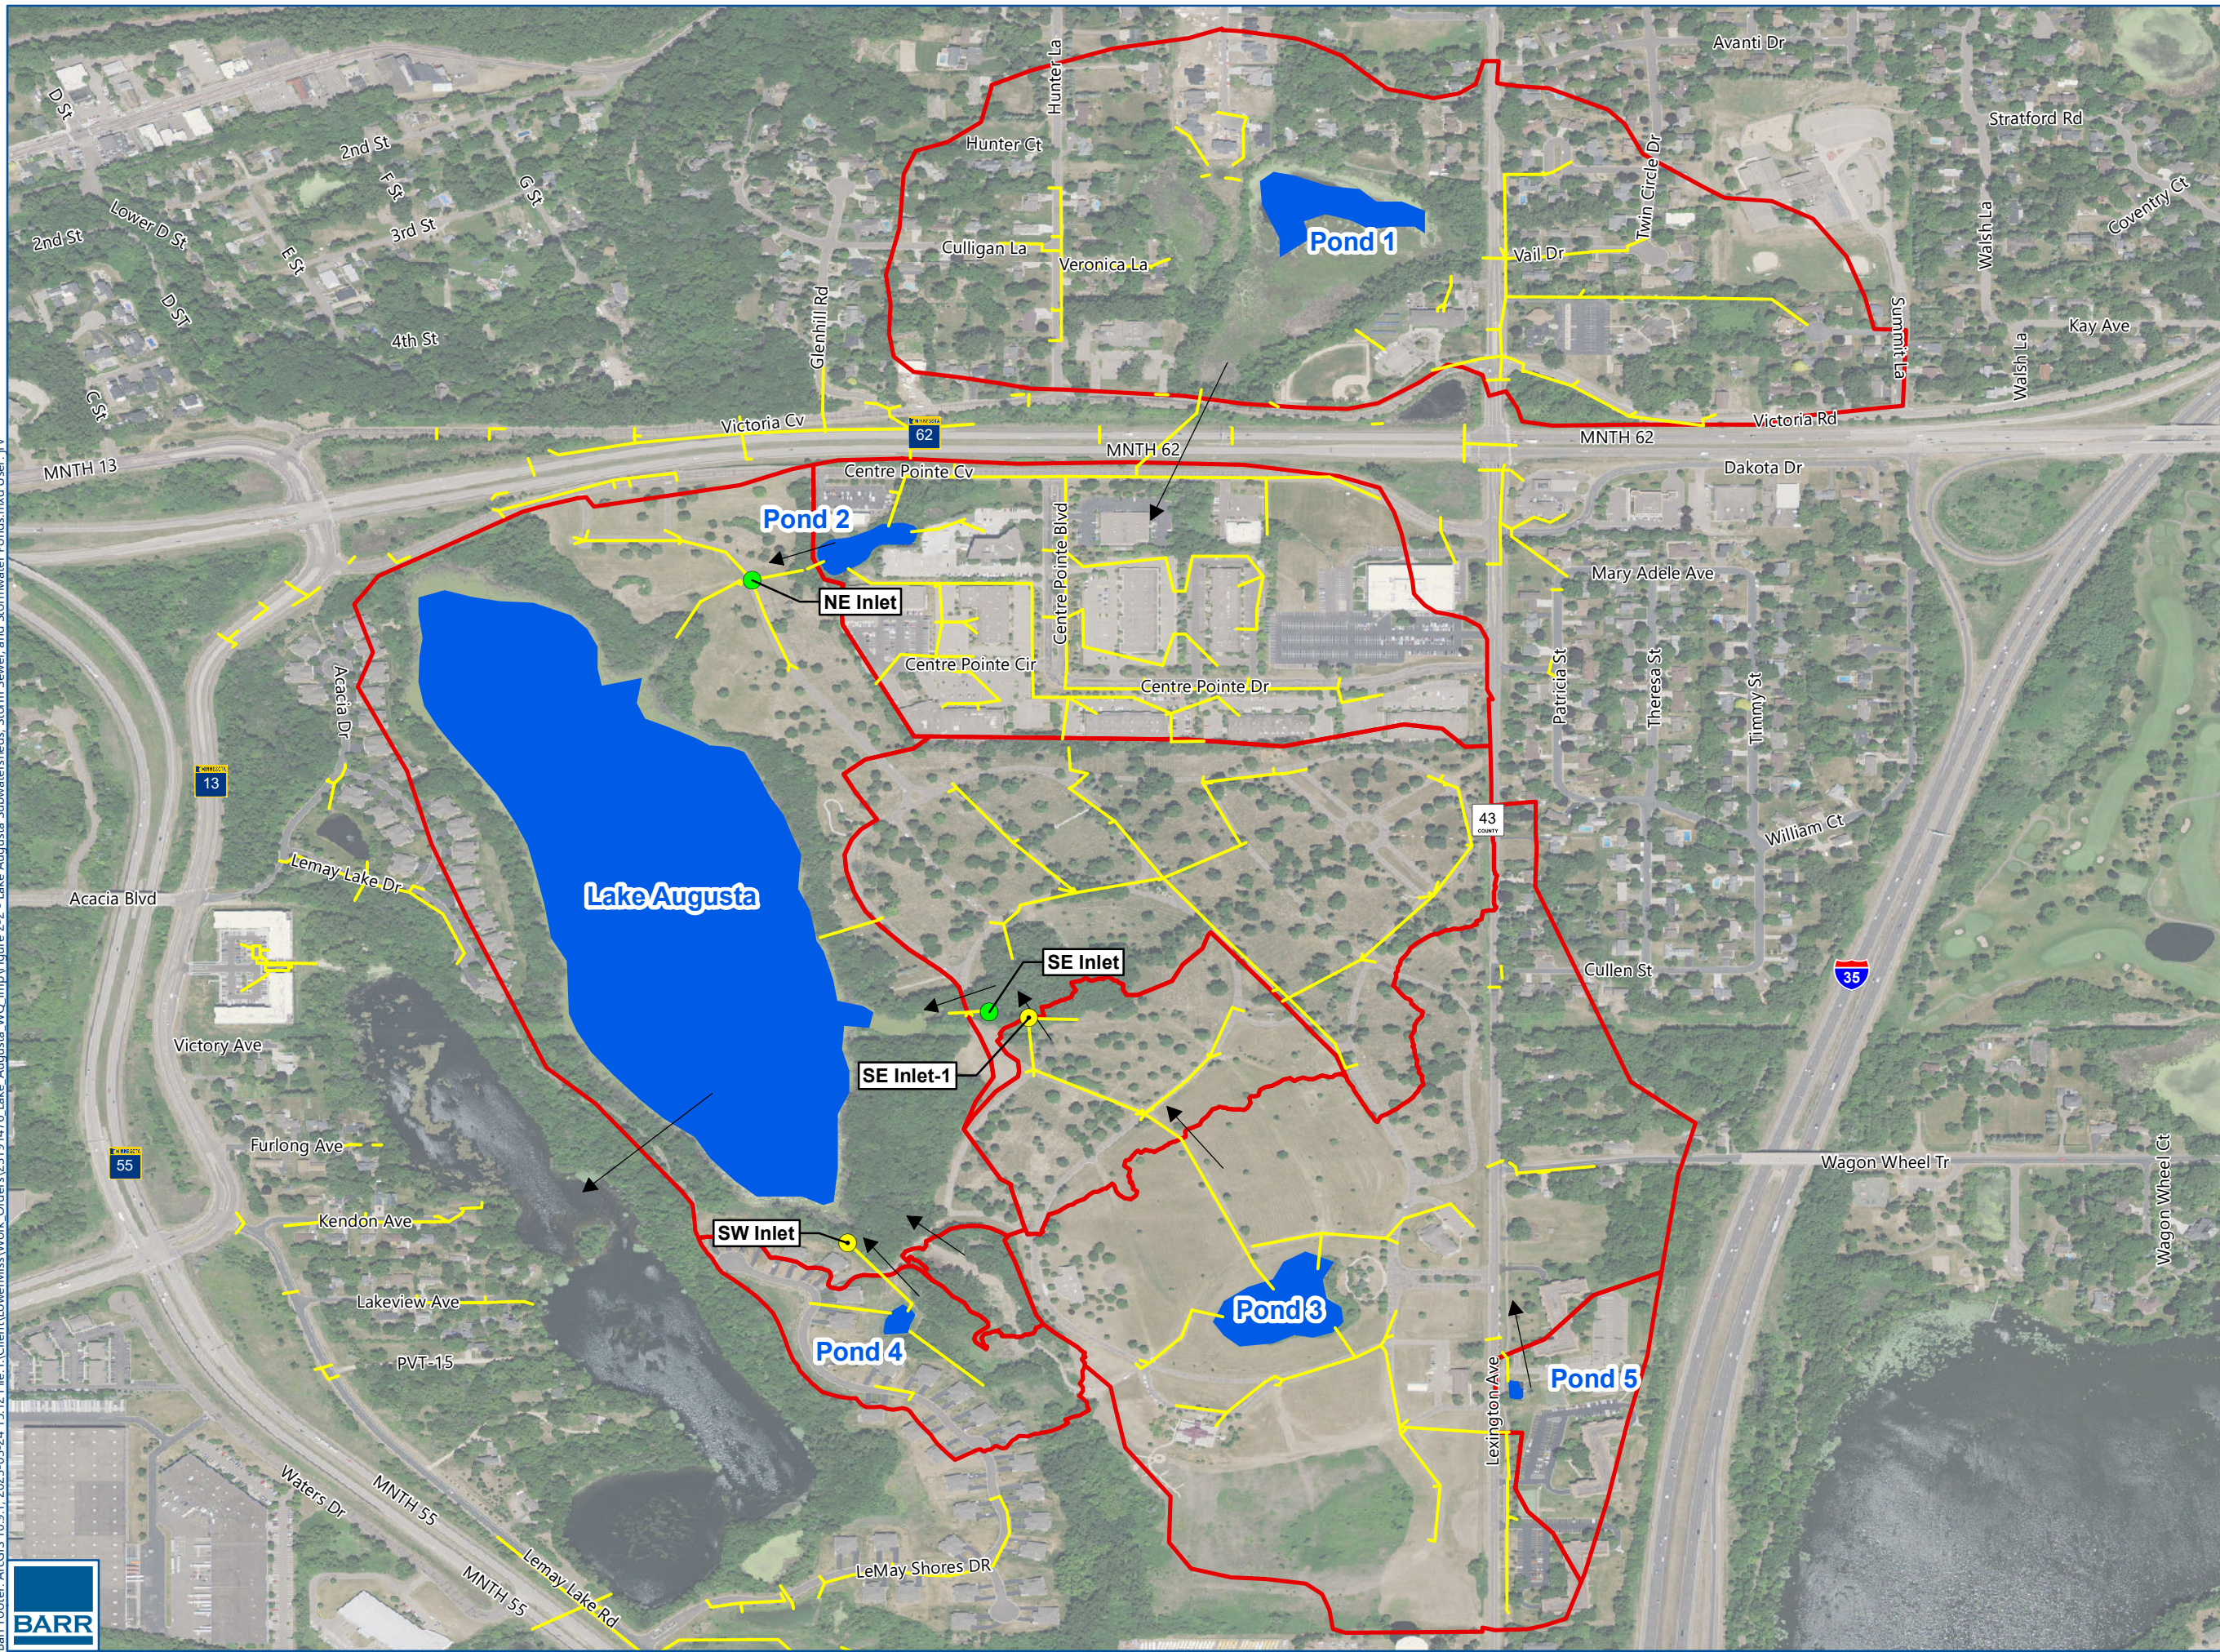
Figure 2-2 Lake Augusta Subwatersheds, Storm Sewer and Stormwater Ponds

LAKE AUGUSTA SUBWATERSHEDS, STORM SEWER AND STORMWATER PONDS
FIGURE 2-2

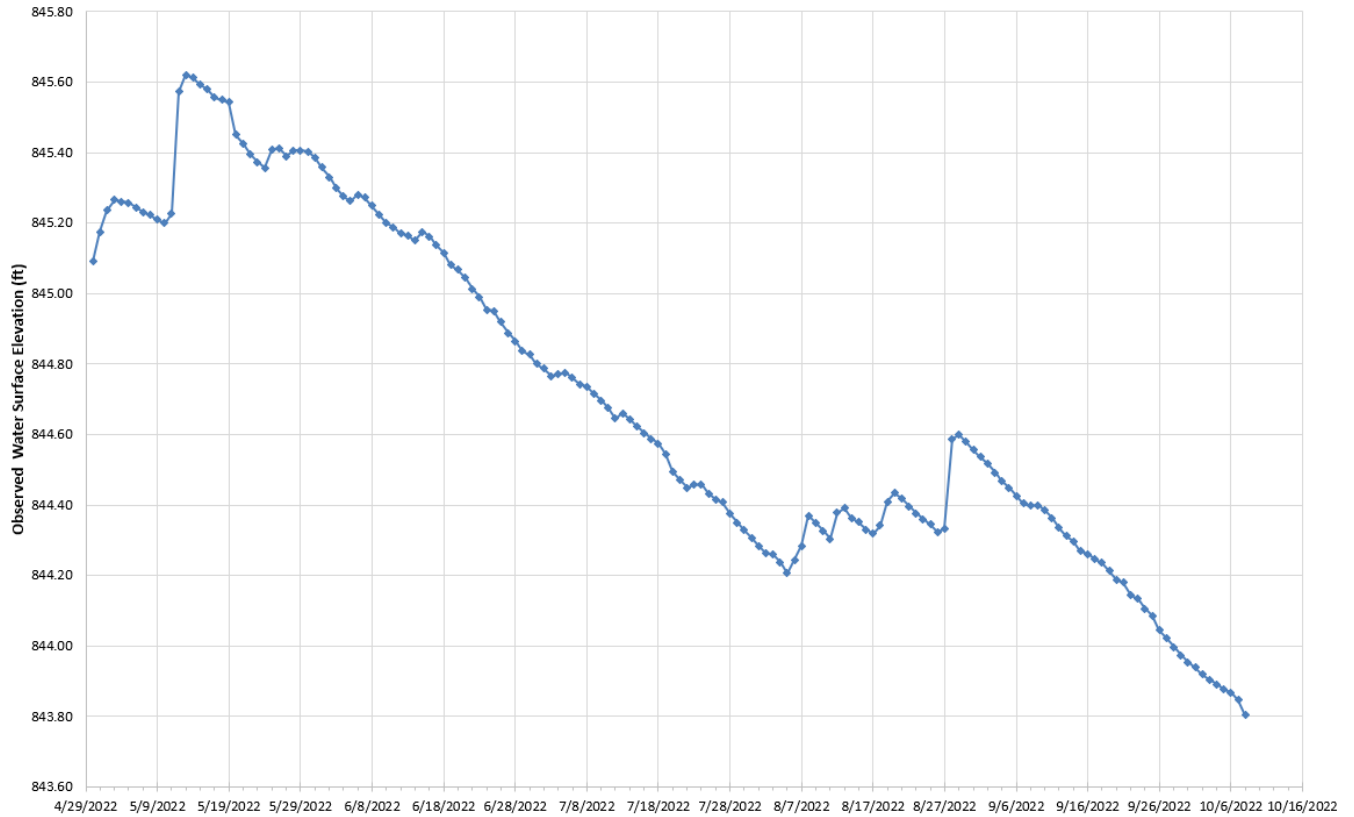
Figure 3-2 2022 Lake Water Levels

Figure 3-2 shows the monitored water levels for Lake Augusta during the 2022 monitoring season. The largest storm events during the monitoring period resulted in water level increases between 0.2 and 0.4 feet in Lake Augusta in the spring and later in the fall. Extremely dry conditions during June and July resulted in a lake level drop of approximately 1.2 feet.

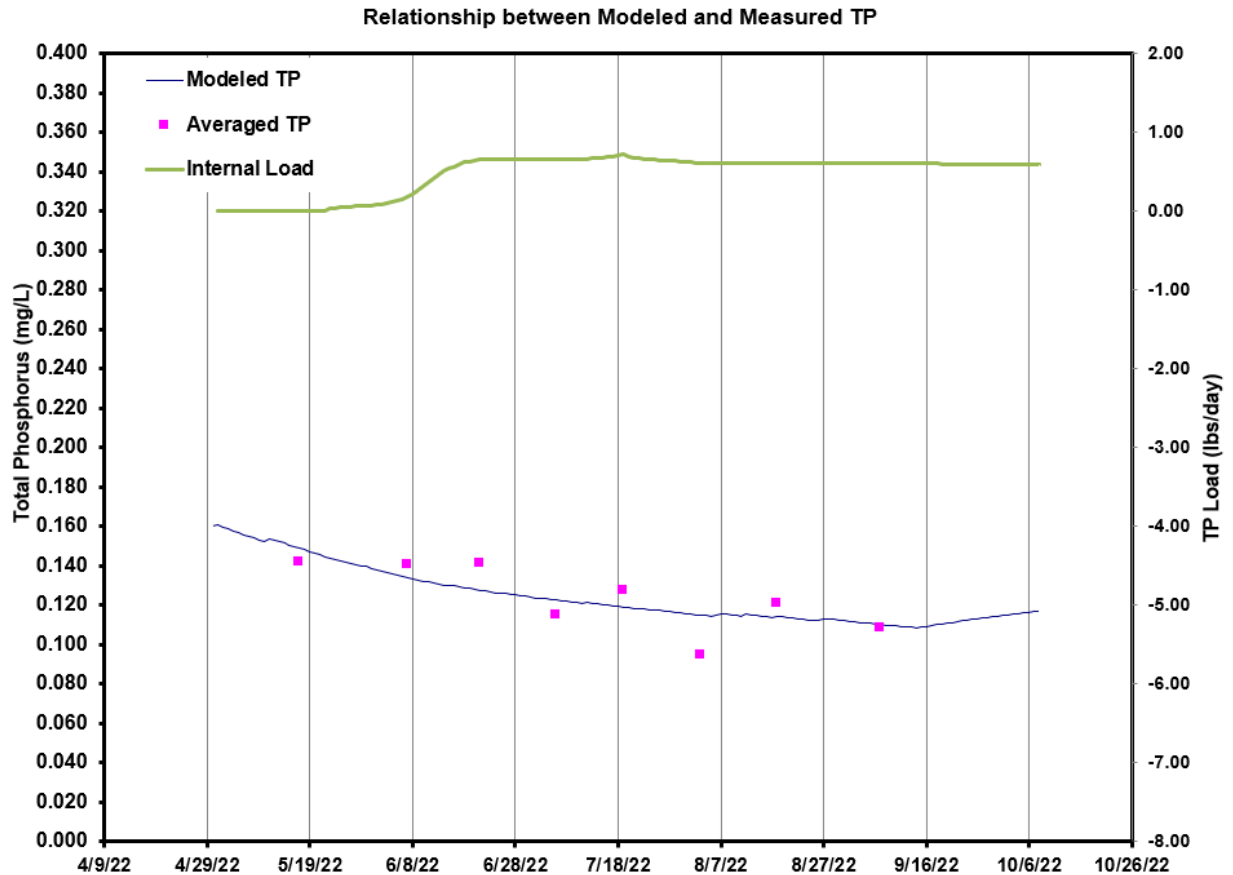
Figure 4-3 Calibrated Water Quality Monitoring and Modeling Results

Figure 4-3 shows how the calibrated daily phosphorus mass balance simulation from the in-lake modeling agreed with the monitored lake phosphorus concentrations (expressed as a volume-averaged TP concentration), based on the calibrated P8 modeling inputs, along with the estimated internal phosphorus loading rate and TP load from bird droppings during the summer of 2022.
