Lake Augusta Feasibility Study

December 13, 2023

Greg Wilson, Barr Engineering

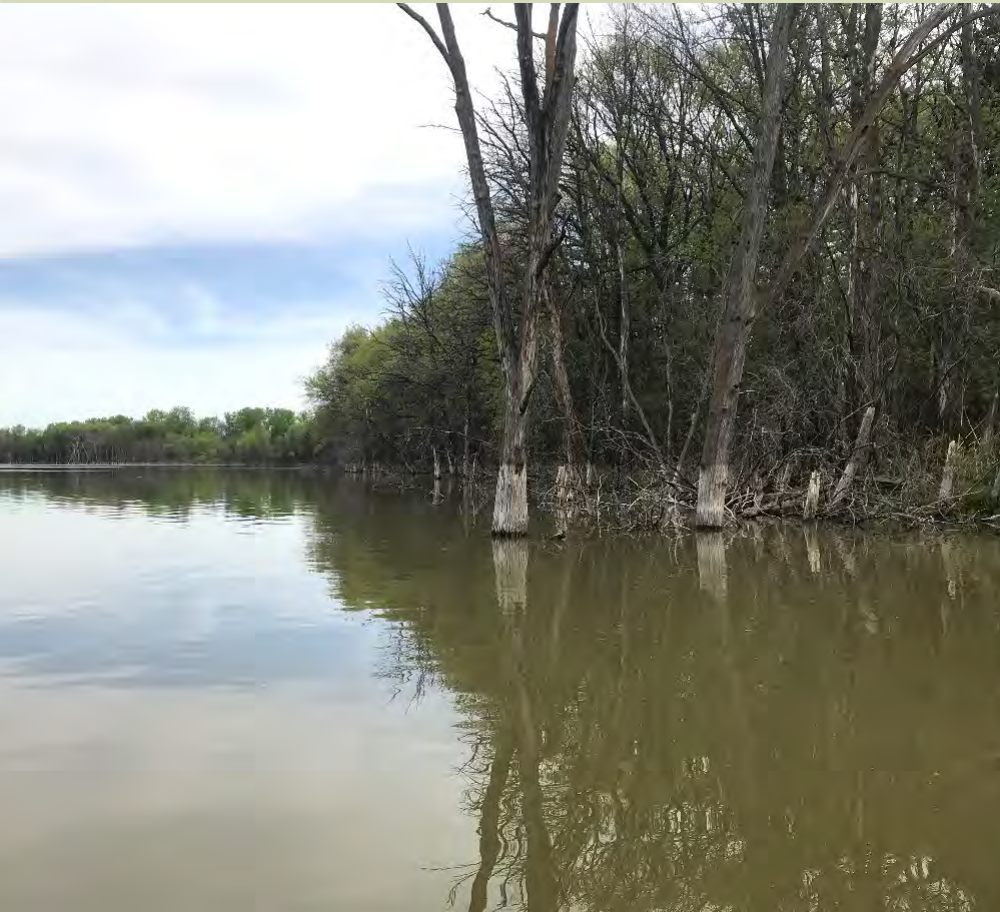
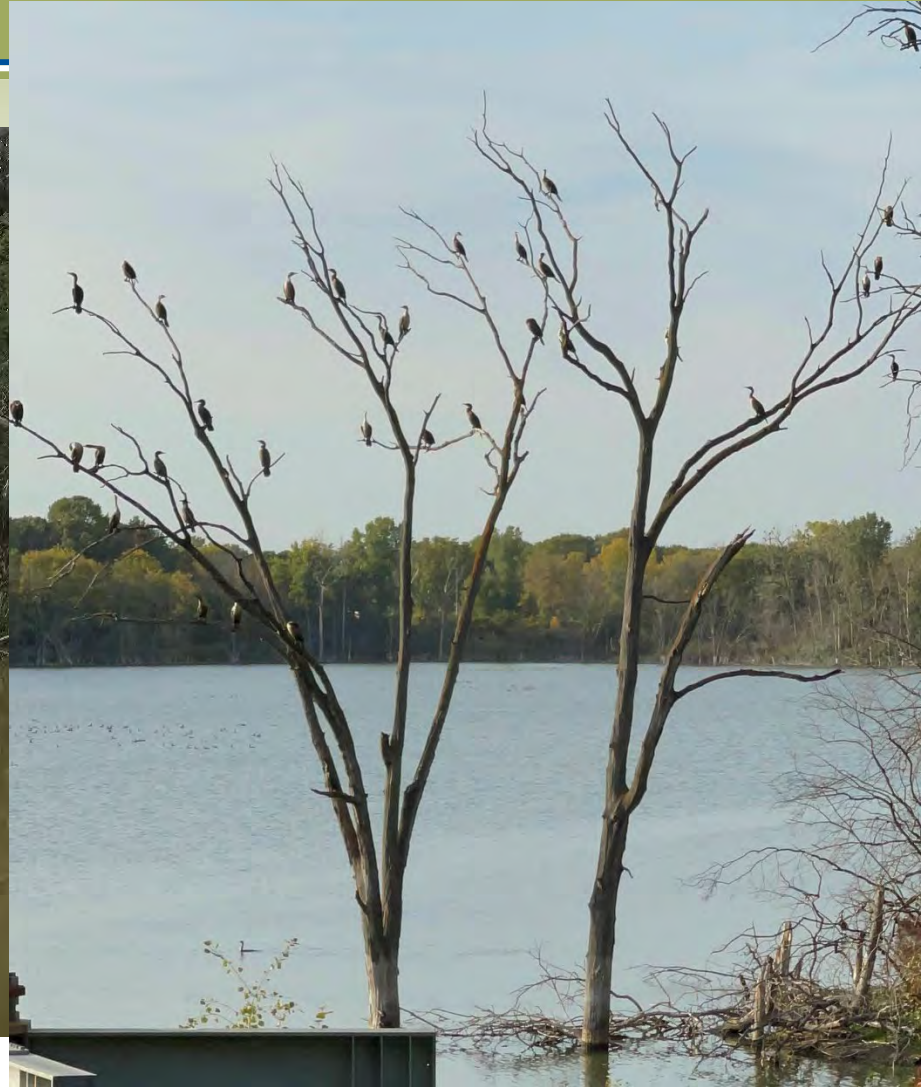
Water Quality Impacts from High Water

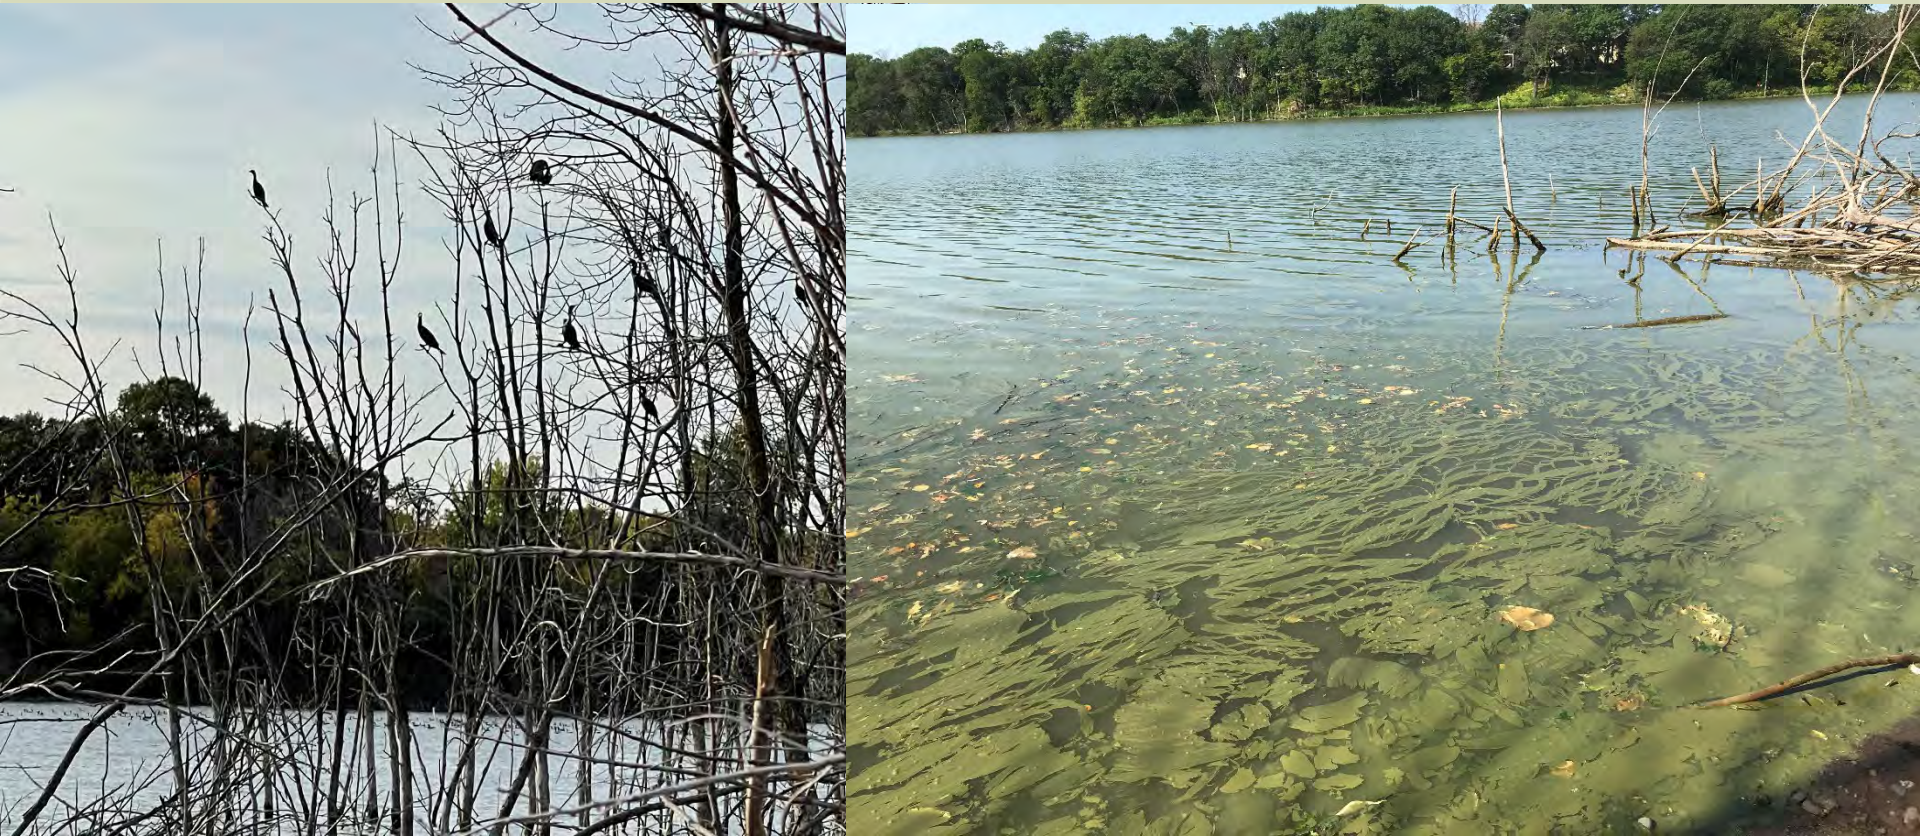
Water Quality Impacts from High Water
