Lake Augusta

Citizen Assisted Monitoring Program (CAMP)

2020 Water Monitoring Report

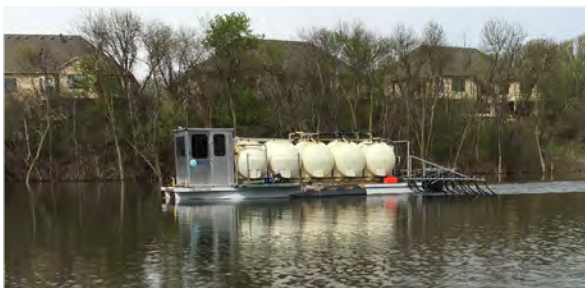
In 2017, the LMRWMO implemented an in-lake aluminum sulfate (alum) treatment to improve water quality. Upon application, the alum binds with phosphorus as aluminum phosphate and settles to the lake bottom. It is believed that long term high water levels impacted the effectiveness of the alum treatment.

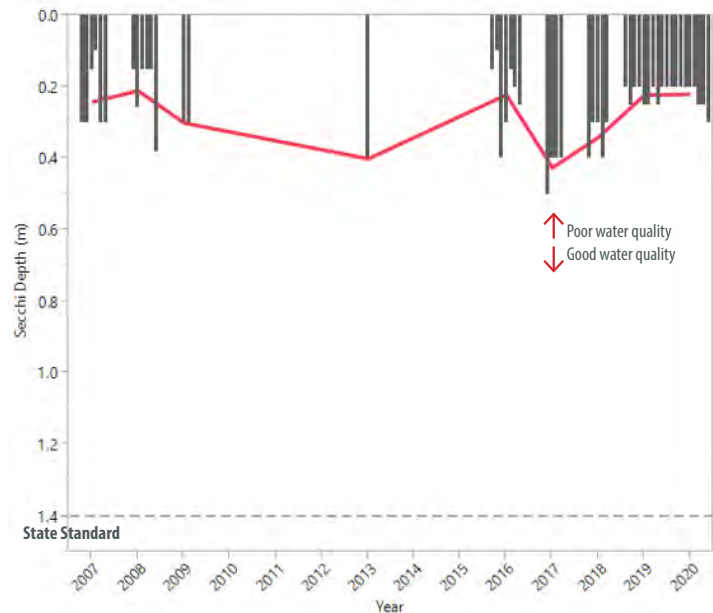
Secchi Depth

A black and white secchi disc is lowered into the water until no longer visible and measures water clarity. High secchi disc depths indicate good water quality. State standard is 1.4 m (dashed line).

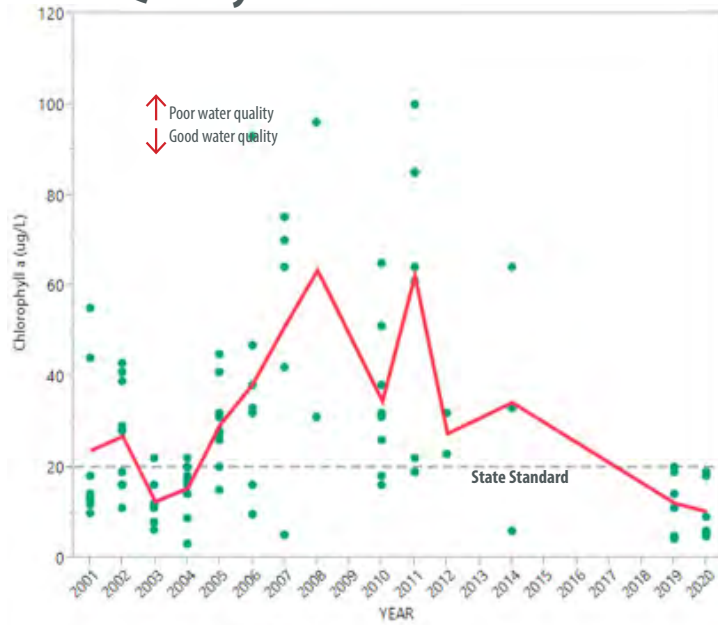
Chlorophyll-a*

Chlorophyll-a is the pigment that gives plants their green color. High levels indicate excessive algae from high nutrient levels in the lake. Low chlorophyll-a levels indicate good water quality. State standard is 20 ug/L (dashed line).

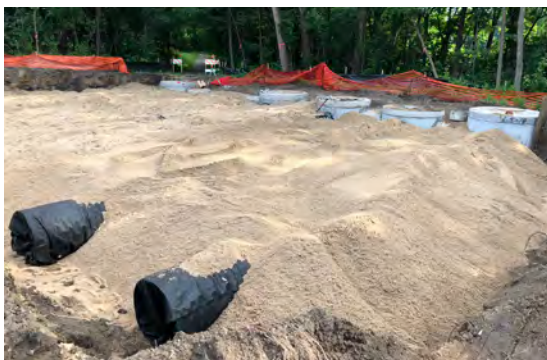
The LMRWMO partnered with the City of South St. Paul to install large underground pipe chambers to infiltrate stormwater before it enters Seidls Lake. The project was implemented with a street reconstruction project.

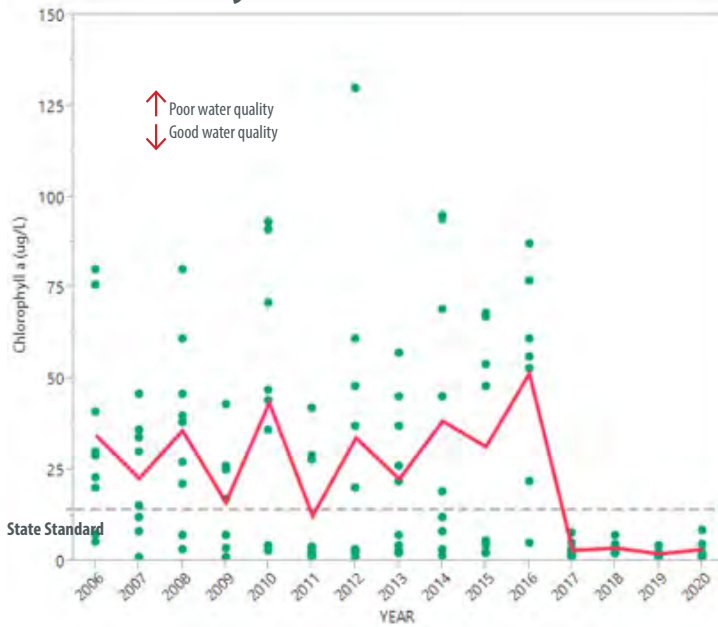
Chlorophyll-a*

Chlorophyll-a is the pigment that gives plants their green color. High levels indicate excessive algae from high nutrient levels in the lake. Low chlorophyll-a levels indicate good water quality. State standard is 14 ug/L (dashed line).

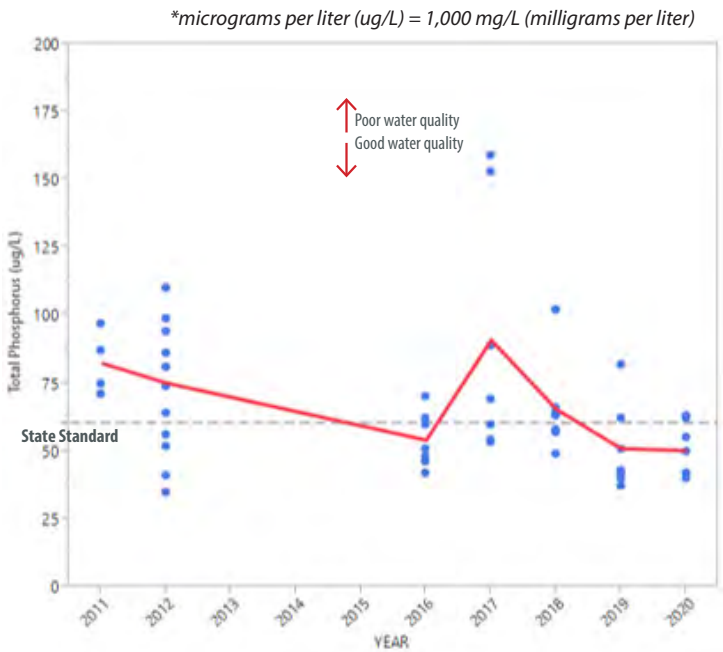
Phosphorus*

Phosphorus is a nutrient required for plant growth. High phosphorus levels can lead to algae blooms, turning water green. Low phosphorus levels indicate good water quality. State standard is 60 ug/L (dashed line).

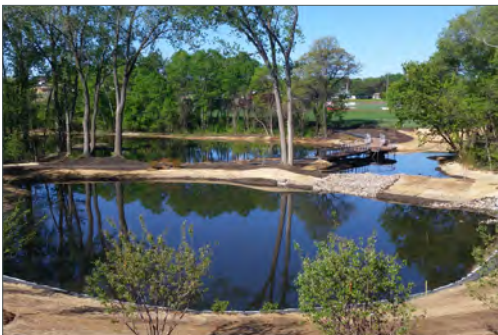
The LMRWMO partnered with Dakota County and the City of West St. Paul on the 2018-2019 installation of stormwater projects at Thompson Lake (shown below). These projects are expected to provide long term, incremental water quality improvements which will be tracked with continued water monitoring.

In 2018 and 2019, the LMRWMO led the installation of a comprehensive “treatment train” stormwater improvement project. This included installation of two underground sediment capture chambers, a stormwater settling treatment pond, a stormwater treatment wetland, and raingarden. Post project installation, slight improvements in chlorophyll and phosphorous levels have been observed in 2019 and 2020 with a degradation in the secchi depth reading in 2020. The below table shows the 2020 data.

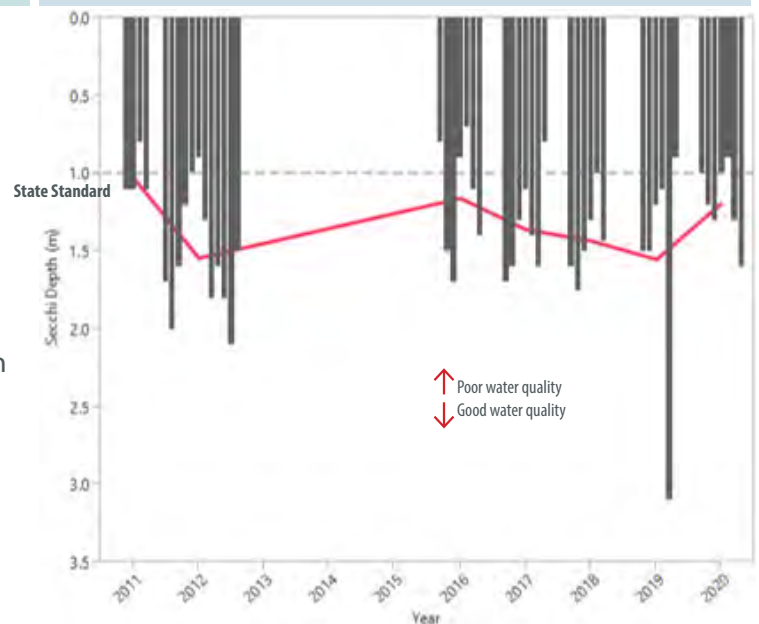
Secchi Depth

A black and white secchi disc is lowered into the water until no longer visible and measures water clarity. High secchi disc depths indicate good water quality. State standard is 1 m (dashed line).
