Lake Augusta

2021 Water Monitoring Report

Lake Summary

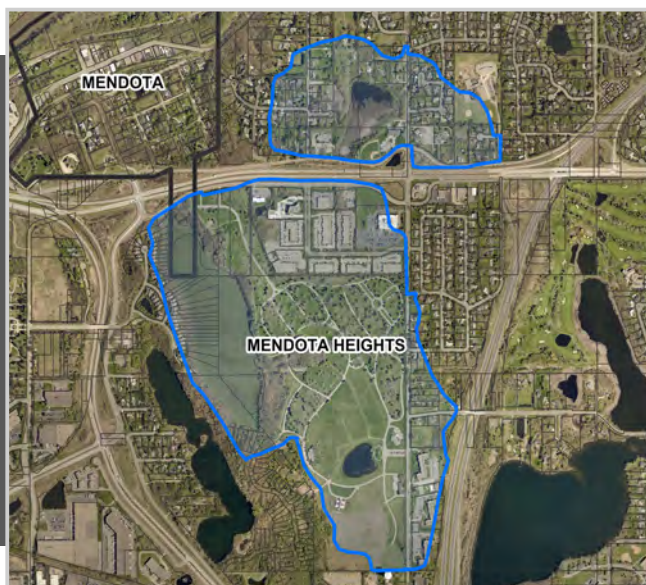
- Max Depth:** 33 feet
- Watershed Size (shown):** 420 acres
- Major Watershed:** Minnesota River
- MPCA Lake Classification:** Deep
- Met Council 2021 Lake Grade:** **F** (2020)

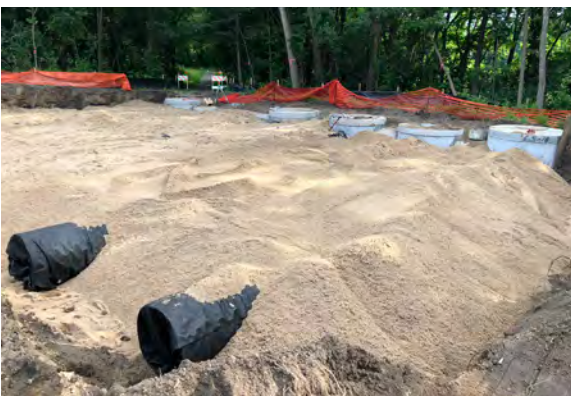
The LMRWMO partnered with the City of South St. Paul to install large underground pipe chambers (shown below) in 2018 to clean and infiltrate stormwater before it enters Seidls Lake.

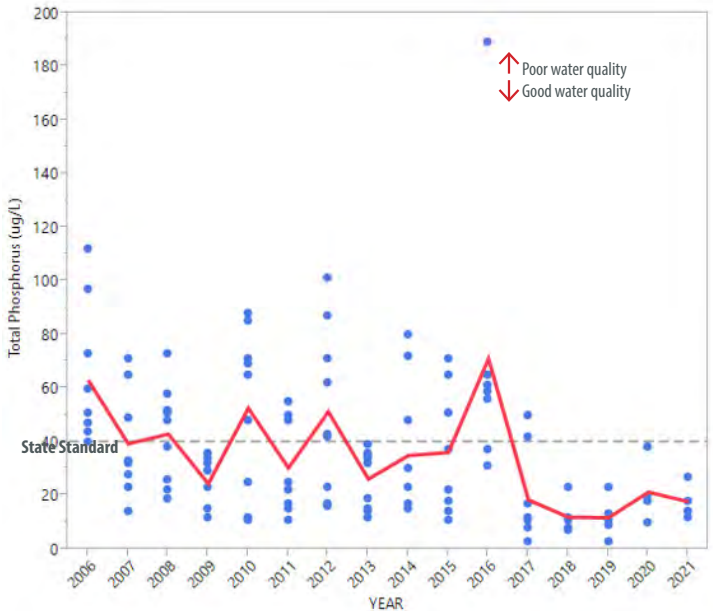
Phosphorus*

Phosphorus is a nutrient required for plant growth. High phosphorus levels can lead to algae blooms, turning water green. Low phosphorus levels indicate good water quality. State standard is 40 ug/L (dashed line).

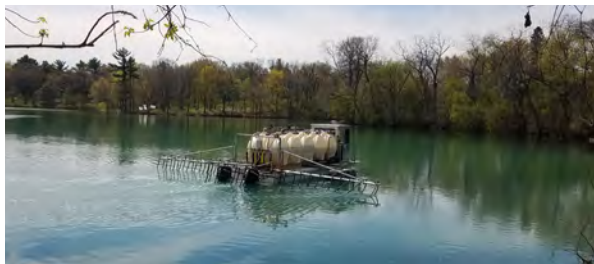
In 2017, the LMRWMO implemented an in-lake aluminum sulfate (alum) treatment to improve water quality. Upon application, the alum binds with phosphorus as aluminum phosphate and settles to the lake bottom. A significant improvement in water quality has been realized from this treatment, with the lake to be removed from the impaired waters list in 2023.

A 2012 study conducted by the LMRWMO identified internal phosphorus from the lake bottom as the primary source of phosphorus in Sunfish Lake.

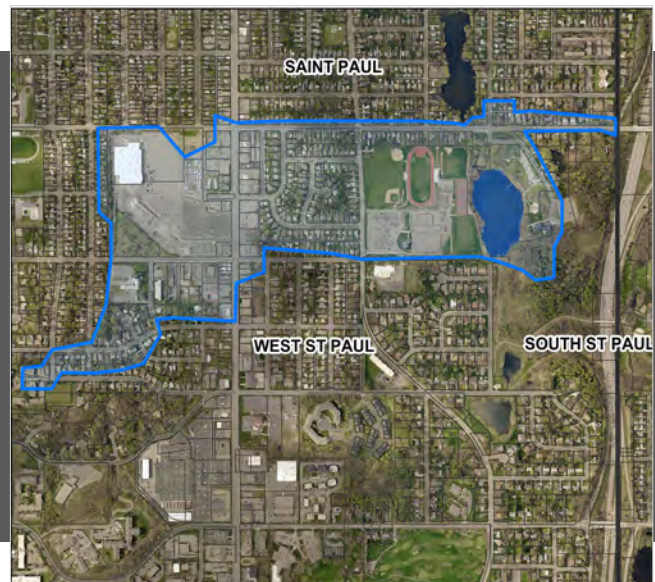
- Max Depth:** 8 feet
- Watershed Size (shown):** 180 acres
- Major Watershed:** Mississippi River
- MPCA Lake Classification:** Shallow
- Met Council 2021 Lake Grade:** **C**₍₂₀₂₀₎
