Sunfish Lake

2022 Water Monitoring Report

LOWER MISSISSIPPI RIVER
WATERSHED MANAGEMENT ORGANIZATION

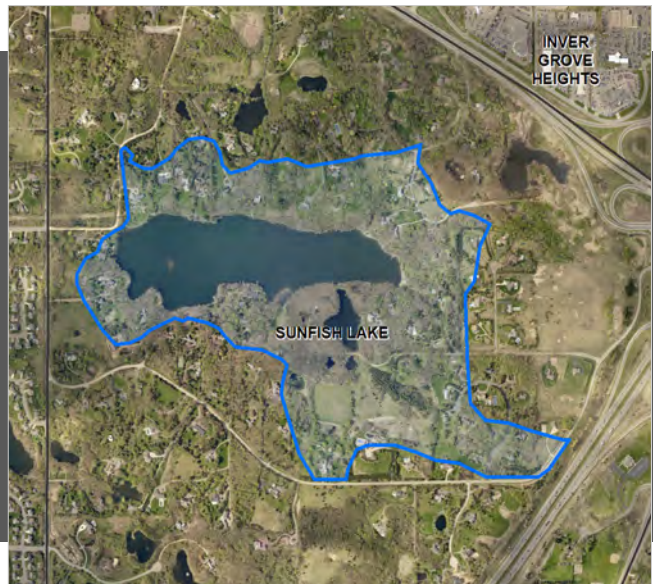
- Max Depth:** 32 feet
- Watershed Size (shown):** 235 acres
- Major Watershed:** Mississippi River
- MPCA Lake Classification:** Deep
- Met Council 2022 Lake Grade:** **A** (2021)

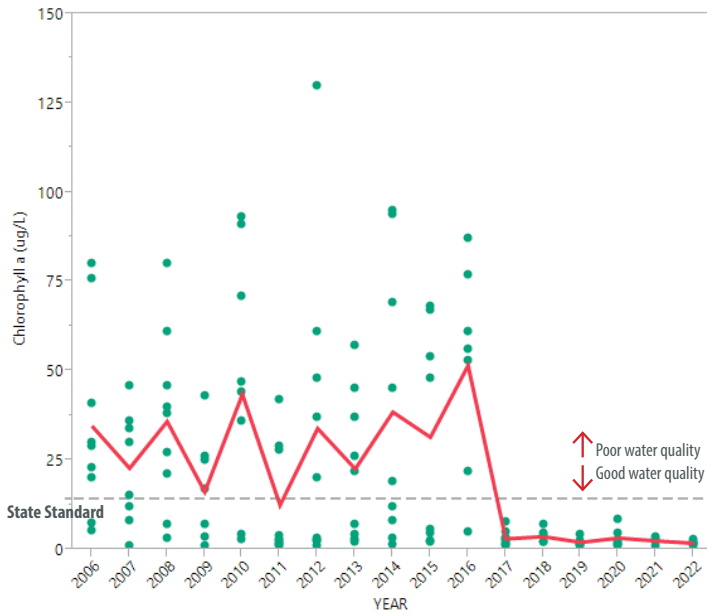
Chlorophyll-a*

Chlorophyll-a is the pigment that gives plants their green color. High levels indicate excessive algae from high nutrient levels in the lake. Low chlorophyll-a levels indicate good water quality. State standard is 14 ug/L (dashed line).

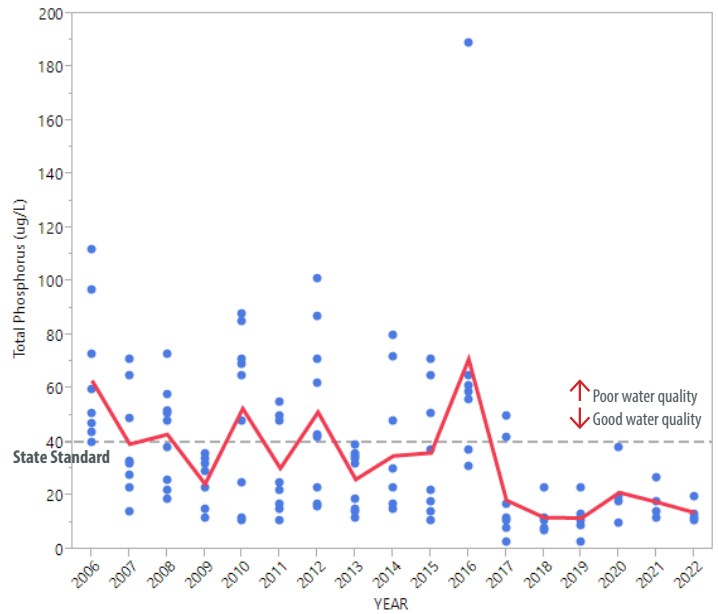
Phosphorus*

Phosphorus is a nutrient required for plant growth. High phosphorus levels can lead to algae blooms, turning water green. Low phosphorus levels indicate good water quality. State standard is 40 ug/L (dashed line).

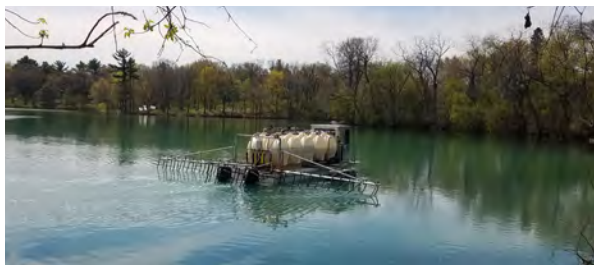
In 2017, the LMRWMO implemented an in-lake aluminum sulfate (alum) treatment to improve water quality. Upon application, the alum binds with phosphorus as aluminum phosphate and settles to the lake bottom. A significant improvement in water quality has been shown from this treatment, with the lake removed from the impaired waters list in 2022.

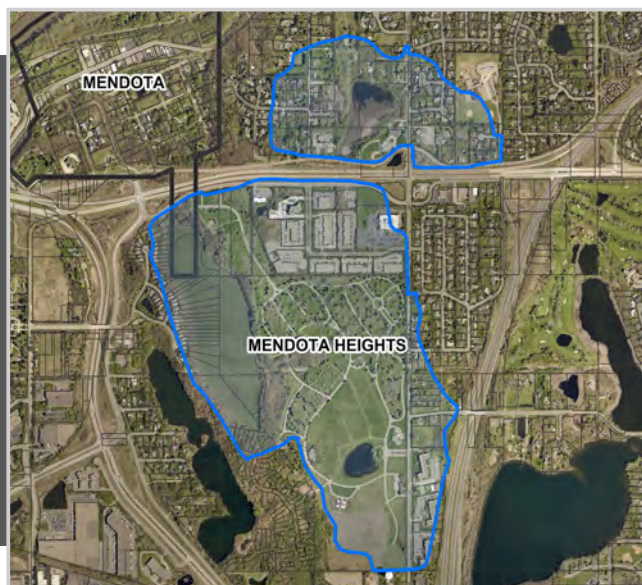
Max Depth: 33 feet

Watershed Size (shown): 420 acres

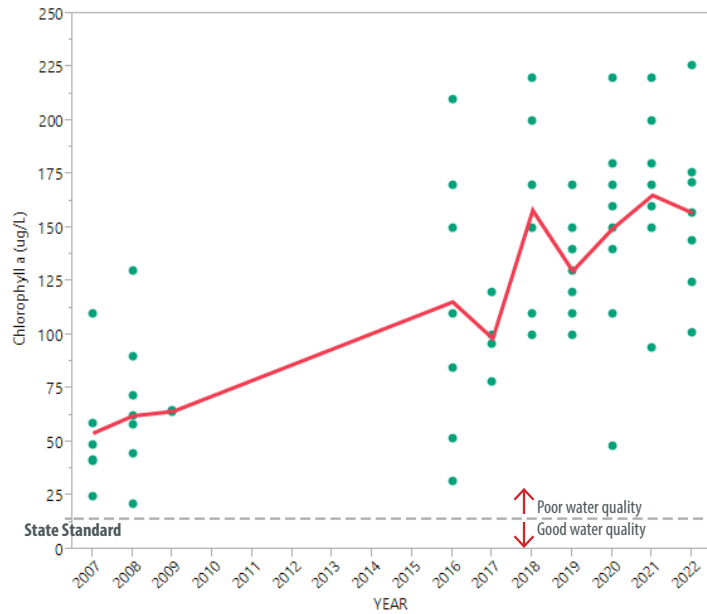
Chlorophyll-a*

Chlorophyll-a is the pigment that gives plants their green color. High levels indicate excessive algae from high nutrient levels in the lake. Low chlorophyll-a levels indicate good water quality. State standard is 14 ug/L (dashed line).

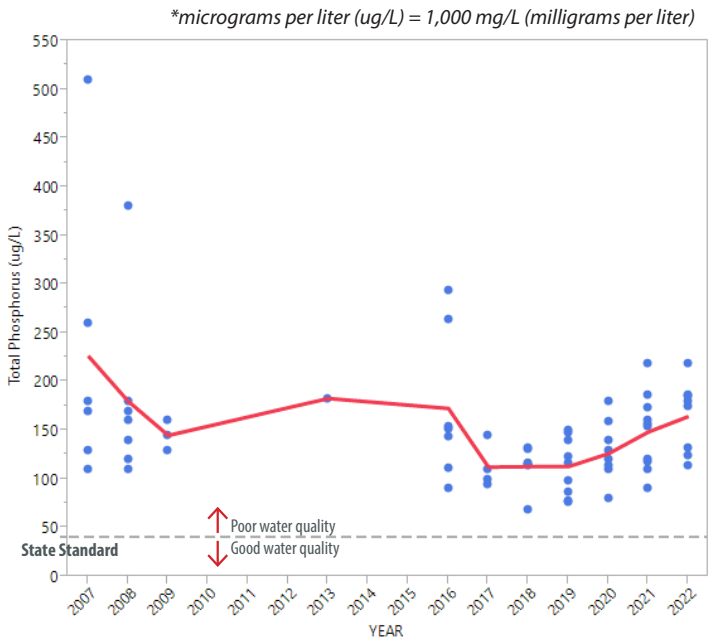
Phosphorus*

Phosphorus is a nutrient required for plant growth. High phosphorus levels can lead to algae blooms, turning water green. Low phosphorus levels indicate good water quality. State standard is 40 ug/L (dashed line).

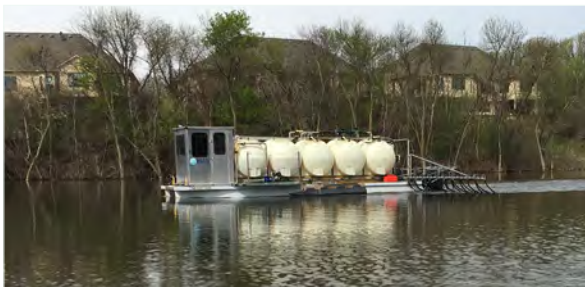
In 2017, the LMRWMO implemented an aluminum sulfate treatment (shown below) to improve water quality which provided slight phosphorus reductions.

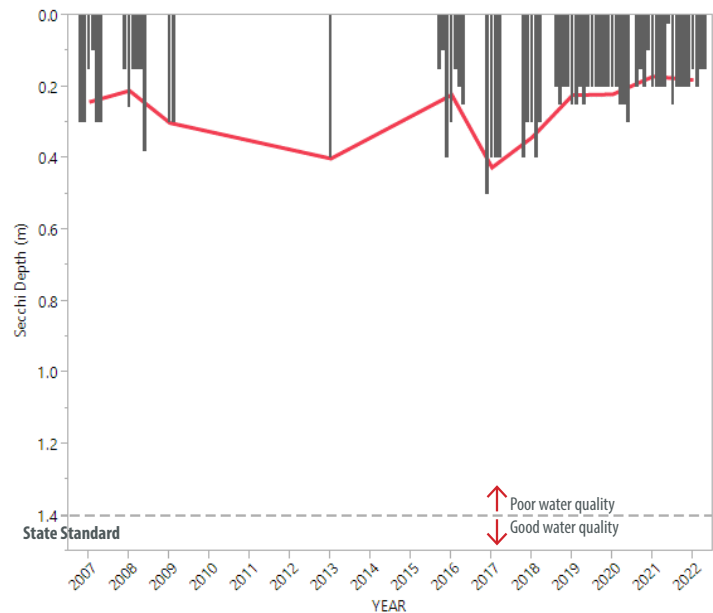
Secchi Depth

A black and white secchi disc is lowered into the water until no longer visible and measures water clarity. High secchi disc depths indicate good water quality. State standard is 1.4 m (dashed line).

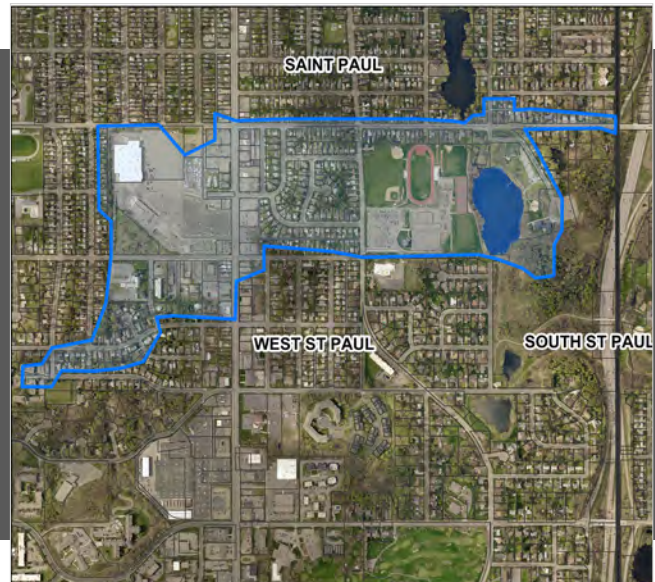
- Max Depth:** 8 feet
- Watershed Size (shown):** 180 acres
- Major Watershed:** Mississippi River
- MPCA Lake Classification:** Shallow
- Met Council 2022 Lake Grade:** **C** (2021)

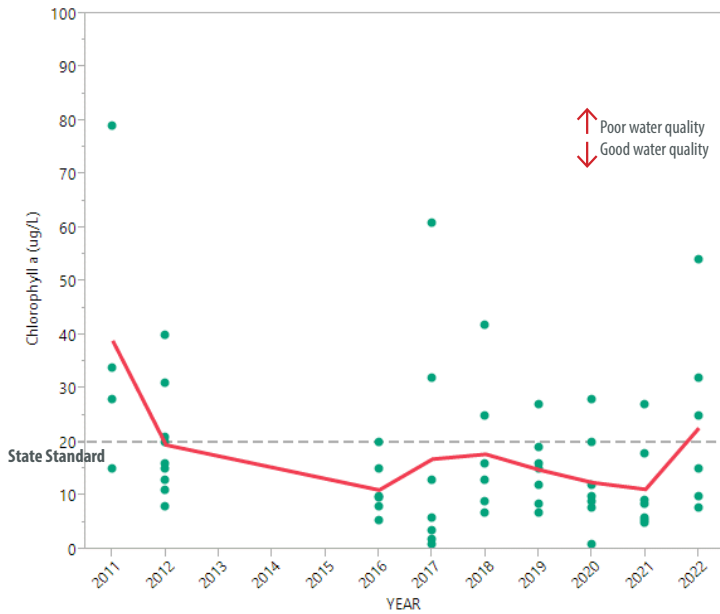
Chlorophyll-a*

Chlorophyll-a is the pigment that gives plants their green color. High levels indicate excessive algae from high nutrient levels in the lake. Low chlorophyll-a levels indicate good water quality. State standard is 20 ug/L (dashed line).

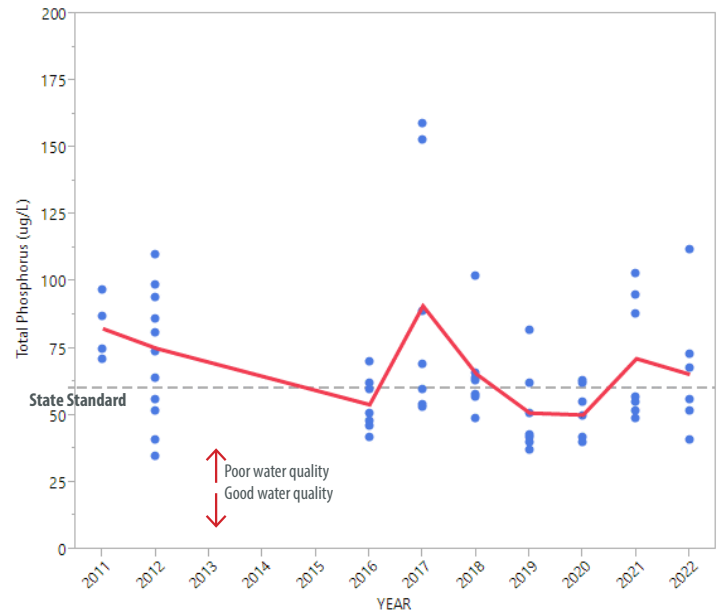
Phosphorus*

Phosphorus is a nutrient required for plant growth. High phosphorus levels can lead to algae blooms, turning water green. Low phosphorus levels indicate good water quality. State standard is 60 ug/L (dashed line).

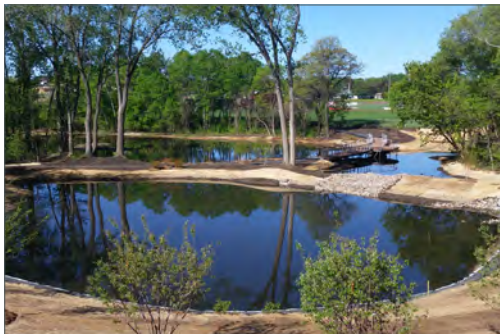
The LMRWMO partnered with Dakota County and the City of West St. Paul on the 2018-2019 installation of stormwater projects at Thompson Lake. These projects are expected to provide long term, incremental water quality improvements which will be tracked with continued water monitoring.

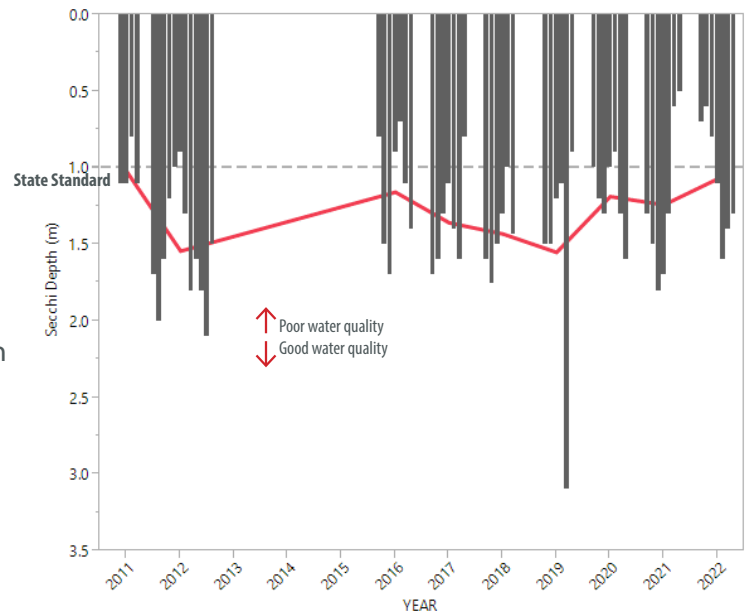
Secchi Depth

A black and white secchi disc is lowered into the water until no longer visible and measures water clarity. High secchi disc depths indicate good water quality. State standard is 1 m (dashed line).

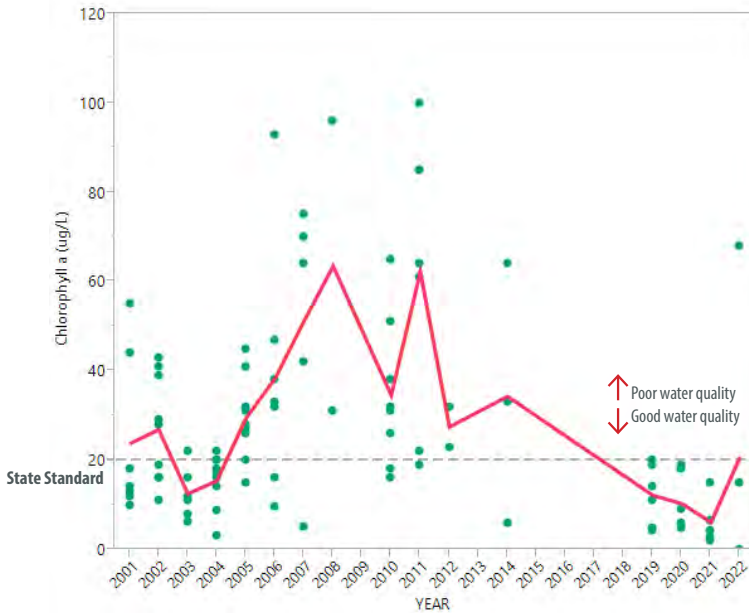
Chlorophyll-a*

Chlorophyll-a is the pigment that gives plants their green color. High levels indicate excessive algae from high nutrient levels in the lake. Low chlorophyll-a levels indicate good water quality. State standard is 20 ug/L (dashed line).

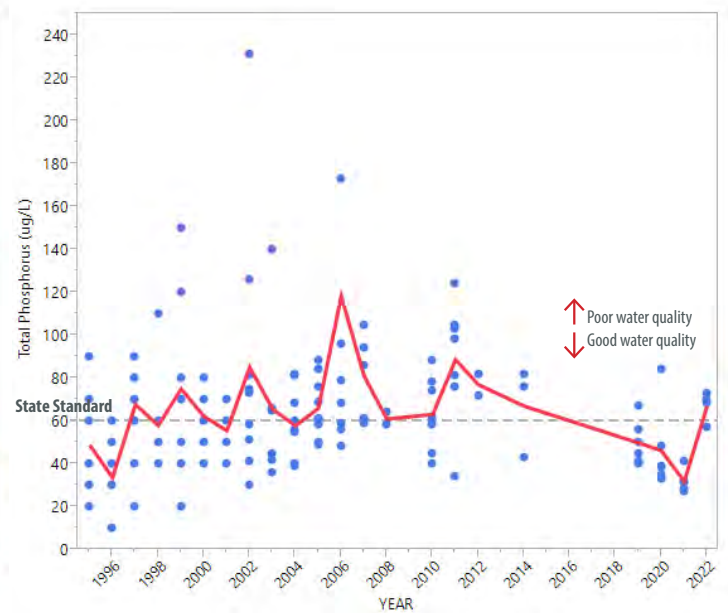
Phosphorus*

Phosphorus is a nutrient required for plant growth. High phosphorus levels can lead to algae blooms, turning water green. Low phosphorus levels indicate good water quality. State standard is 60 ug/L (dashed line).

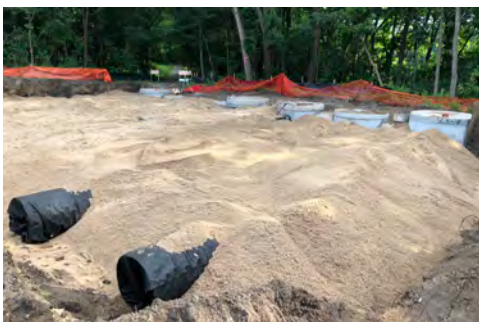
The LMRWMO partnered with the City of South St. Paul to install large buried pipes (shown below) in 2018 to clean and infiltrate stormwater before entering the Lake.

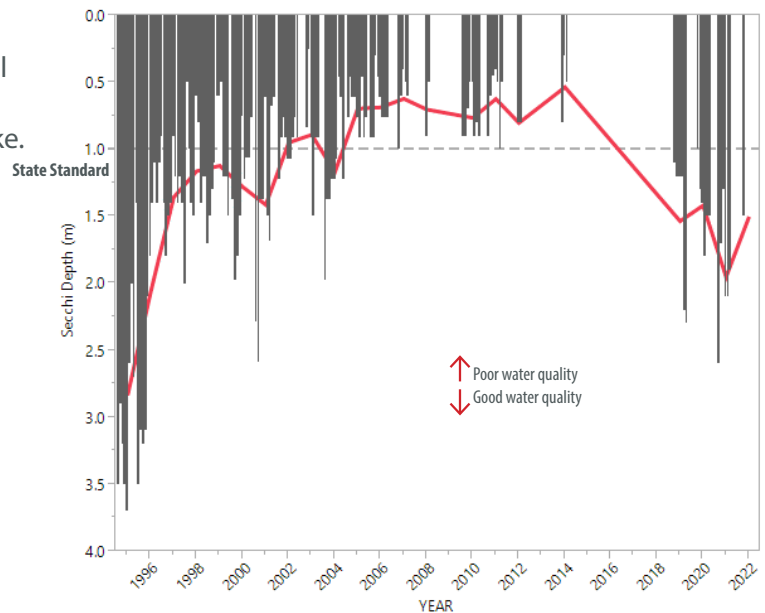
Secchi Depth

A black and white secchi disc is lowered into the water until no longer visible and measures water clarity. High secchi disc depths indicate good water quality. State standard is 1 m (dashed line).

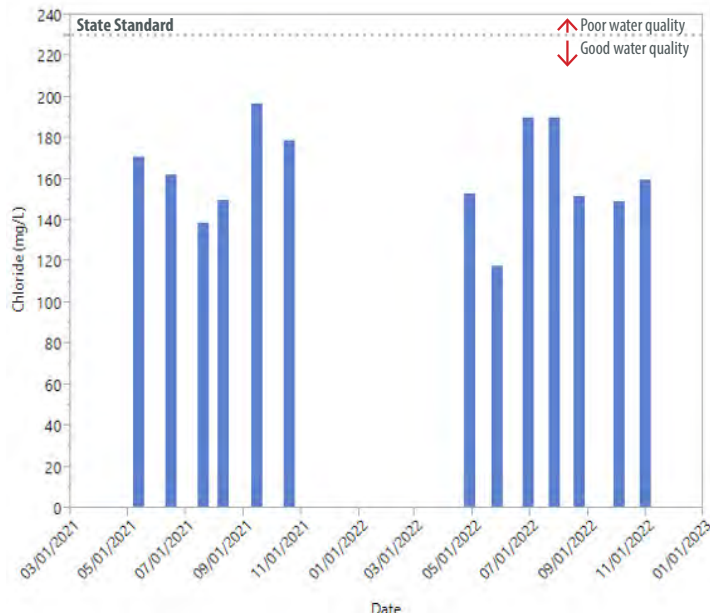
Chloride

Elevated chloride concentrations can be toxic to some aquatic life – altering community composition, as well as affecting mortality and reproduction capabilities. State standard for acute toxicity is ≤ 230 ug/L (dashed line).

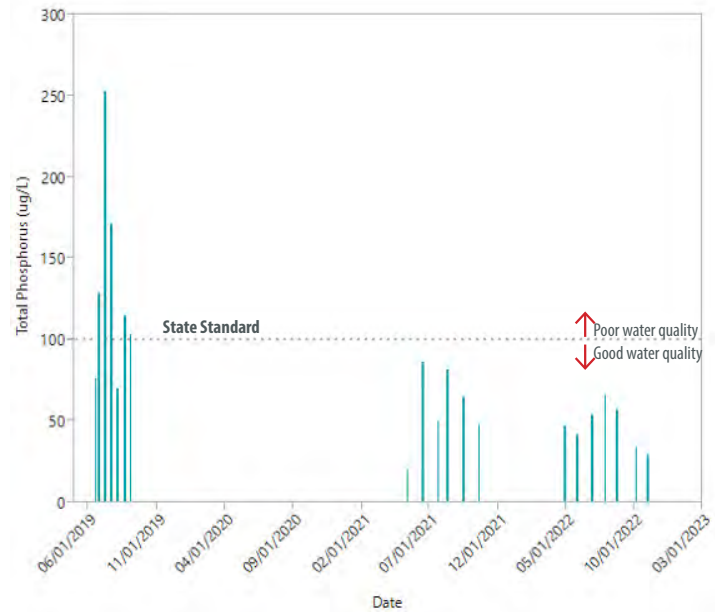
Phosphorus*

Phosphorus is a nutrient required for plant growth. High phosphorus levels can lead to algae blooms, turning water green. Low phosphorus levels indicate good water quality. State standard is ≤ 100 ug/L (dashed line).

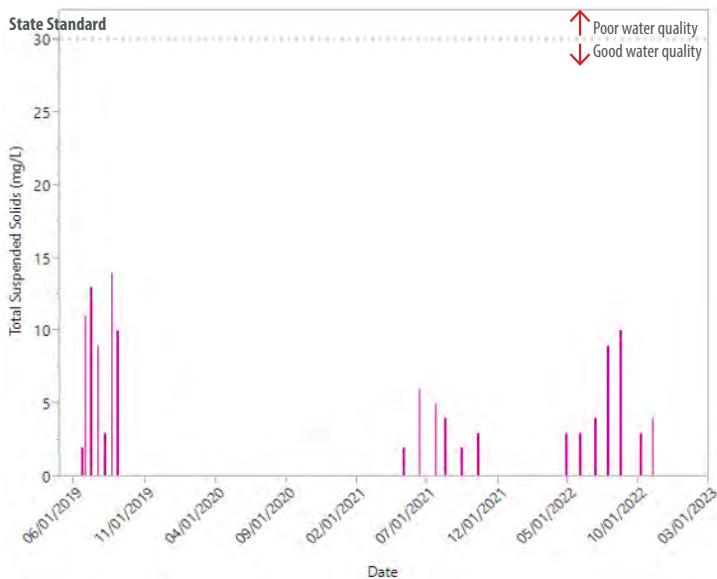
Total Suspended Solids

A measurement of all suspended particles in the water. Potential sources include field and streambank erosion and stormwater runoff. Excessive levels can impair water quality and usability. State standard is ≤ 30 ug/L (dashed line).

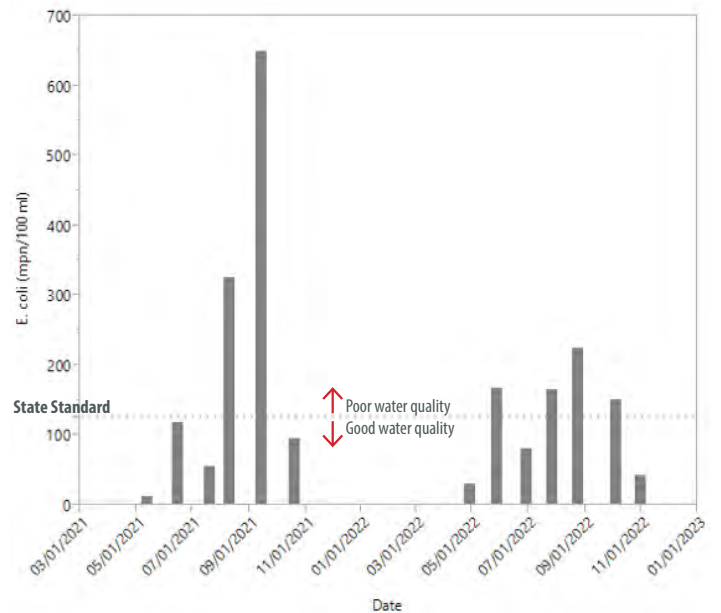
E. coli

Escherichia coli (E. coli) bacteria is a good indicator that disease-causing pathogens may be present in water. A standard of ≤ 126 MPN/100mL (dashed line) has been established (MPN = most probable number of organisms).

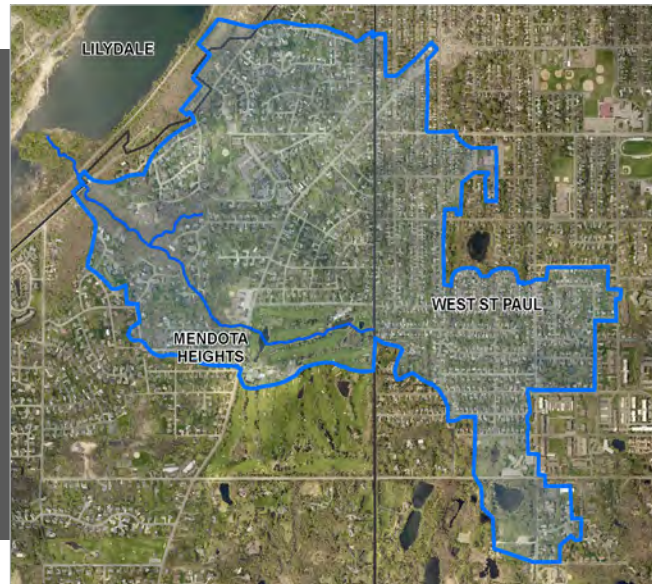
Impairment: None

Years monitored: 2

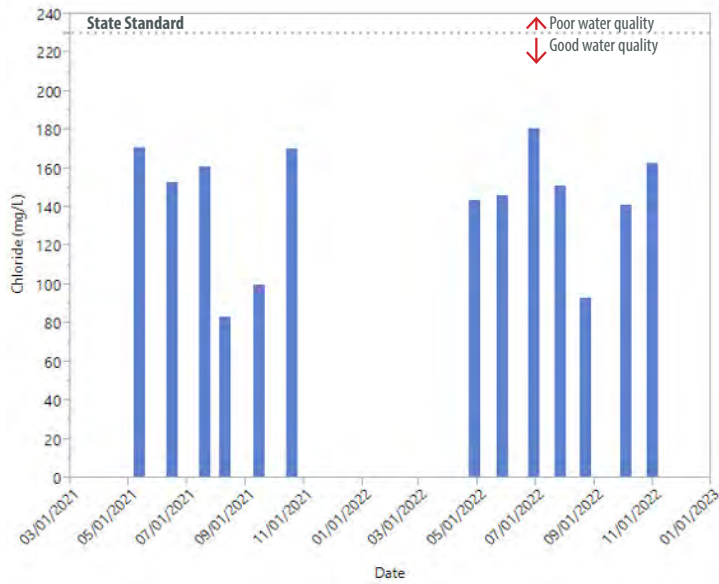
Chloride*

Elevated chloride concentrations can be toxic to some aquatic life – altering community composition, as well as affecting mortality and reproduction capabilities. State standard for acute toxicity is ≤ 230 ug/L (dashed line).

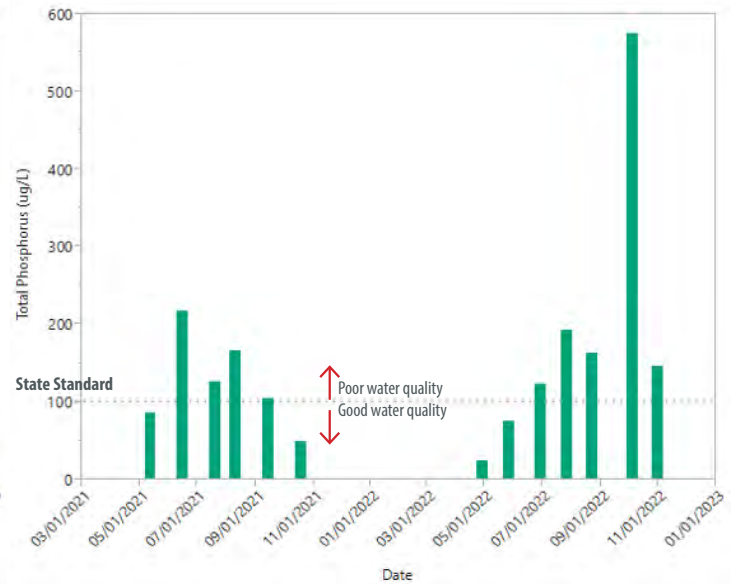
Phosphorus*

Phosphorus is a nutrient required for plant growth. High phosphorus levels can lead to algae blooms, turning water green. Low phosphorus levels indicate good water quality. State standard is ≤ 100 ug/L (dashed line).

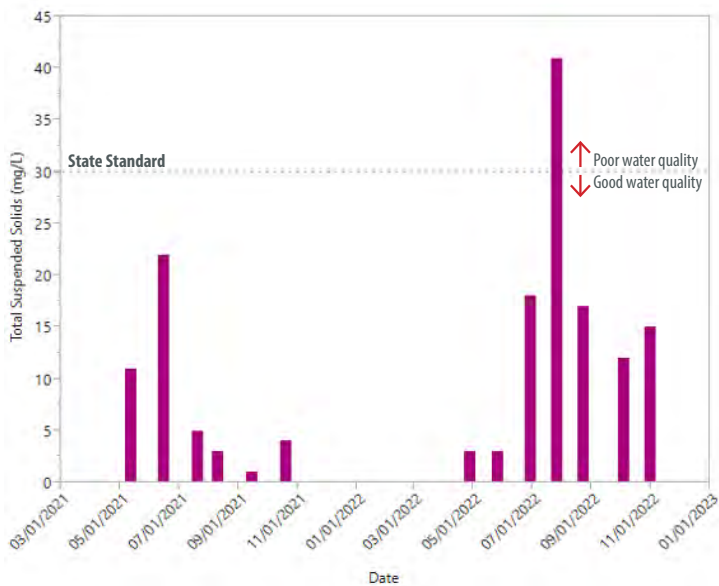
Total Suspended Solids

A measurement of all suspended particles in the water. Potential sources include field and streambank erosion and stormwater runoff. Excessive levels can impair water quality and usability. State standard is ≤ 30 ug/L (dashed line).

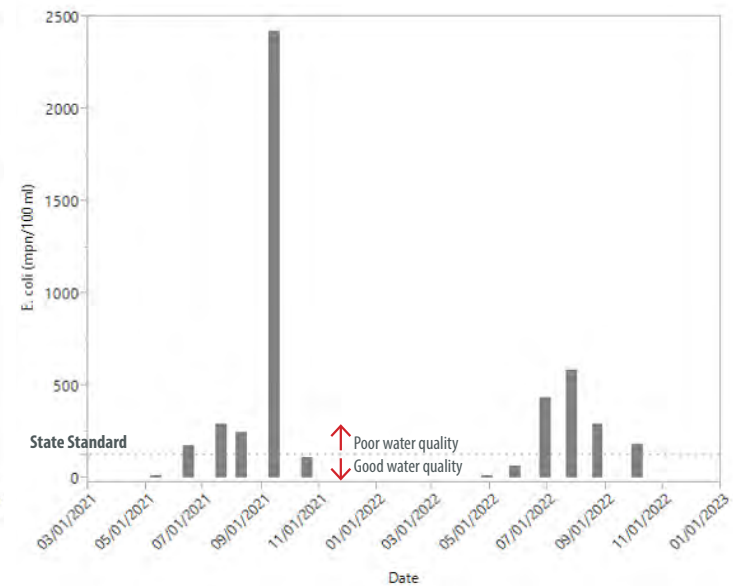
E. coli

Escherichia coli (E. coli) bacteria is a good indicator that disease-causing pathogens may be present in water. A standard of ≤ 126 MPN/100mL has been established (MPN stands for most probable number of organisms).

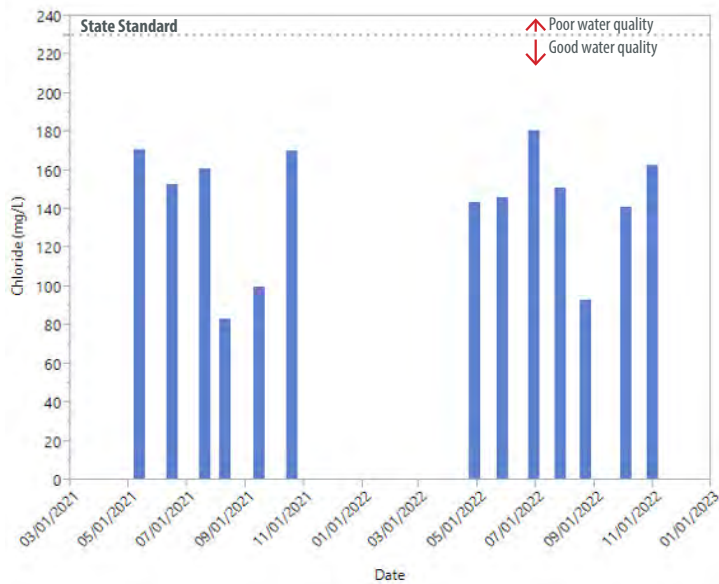
Chloride*

Elevated chloride concentrations can be toxic to some aquatic life – altering community composition, as well as affecting mortality and reproduction capabilities. State standard for acute toxicity is ≤ 230 ug/L (dashed line).

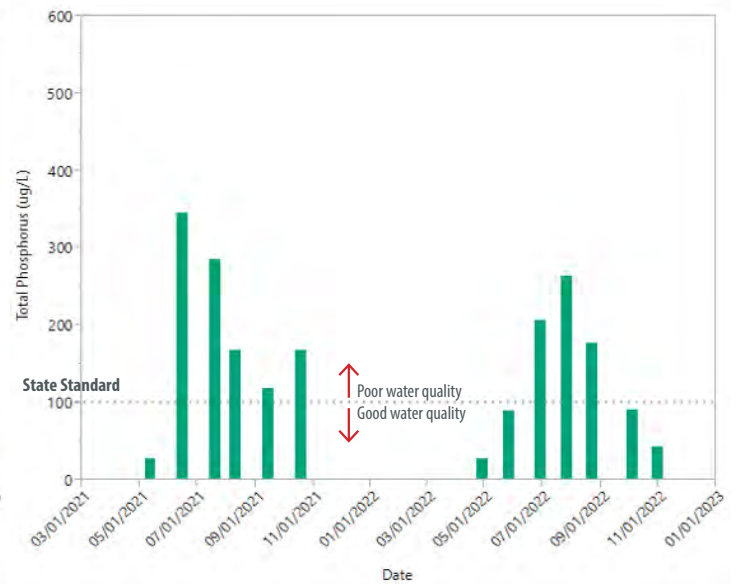
Phosphorus*

Phosphorus is a nutrient required for plant growth. High phosphorus levels can lead to algae blooms, turning water green. Low phosphorus levels indicate good water quality. State standard is ≤ 100 ug/L (dashed line).

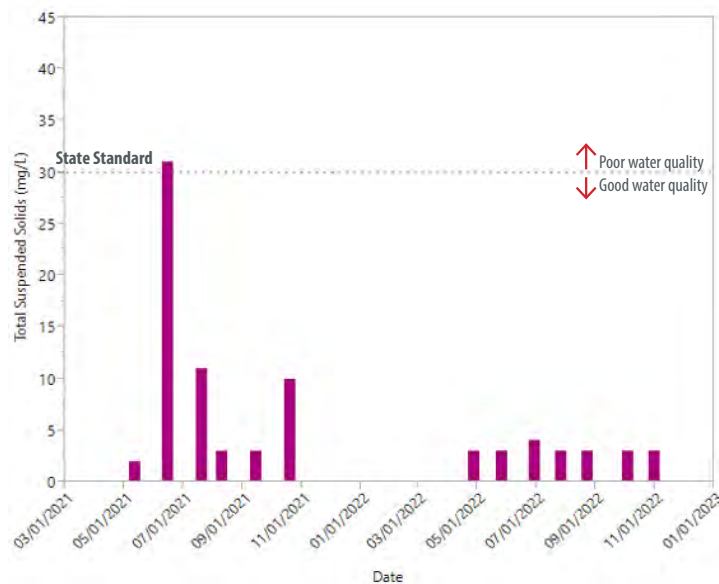
Total Suspended Solids

A measurement of all suspended particles in the water. Potential sources include field and streambank erosion and stormwater runoff. Excessive levels can impair water quality and usability. State standard is ≤ 30 ug/L (dashed line).

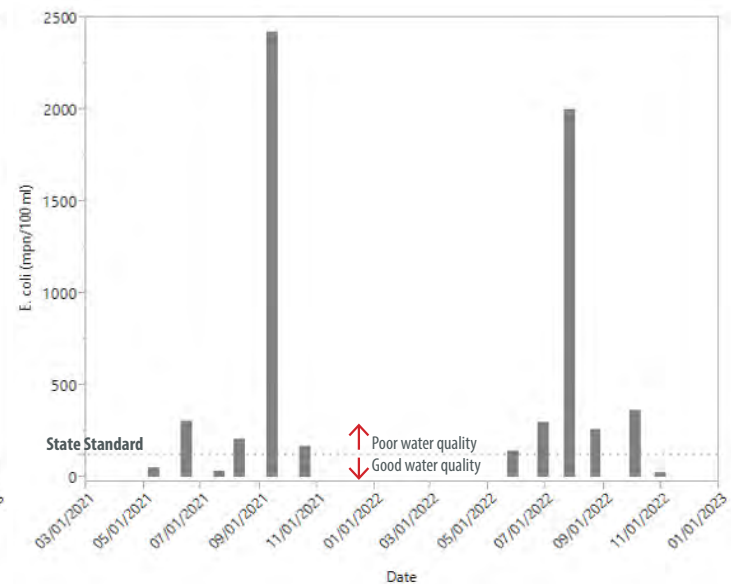
E. coli

Escherichia coli (E. coli) bacteria is a good indicator that disease-causing pathogens may be present in water. A standard of ≤ 126 MPN/100mL has been established (MPN stands for most probable number of organisms).
