Lake Augusta Water Quality Improvement and Outlet Feasibility Study

Prepared for
Lower Mississippi River Watershed Management Organization and
City of Mendota Heights

December 2023

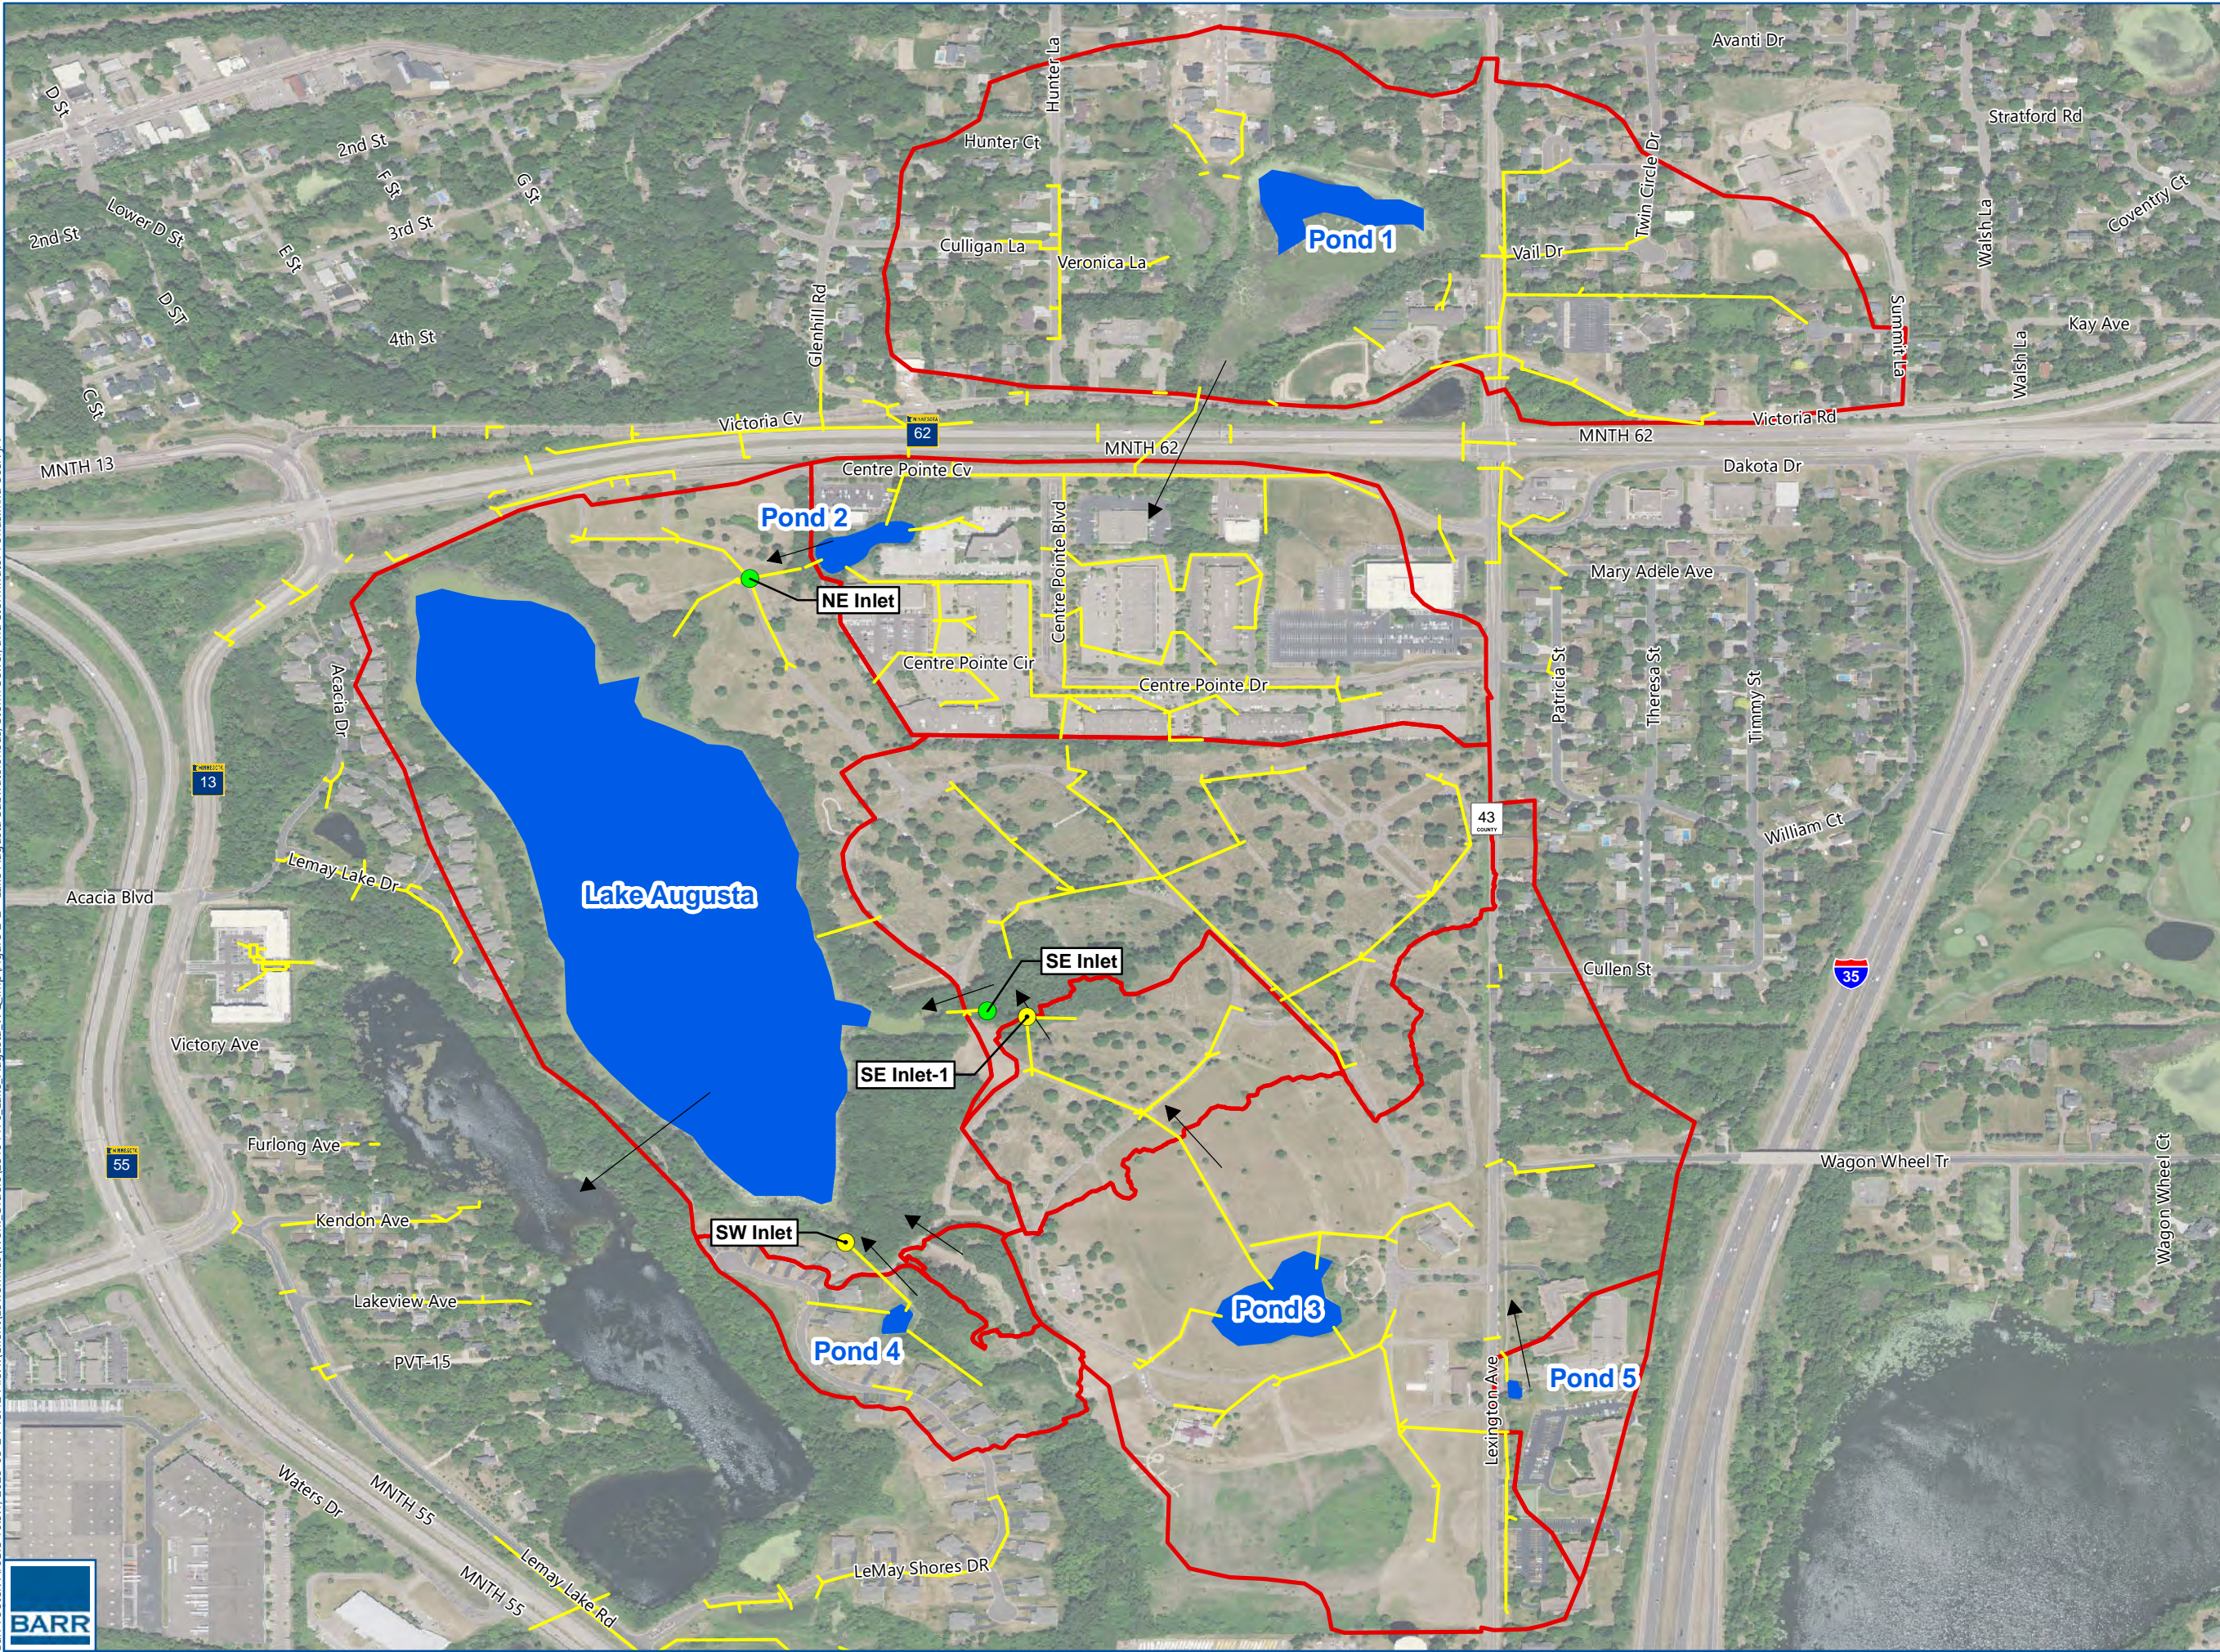
FIGURE 2-2

**LAKE AUGUSTA
SUBWATERSHEDS, STORM
SEWER AND
STORMWATER PONDS**

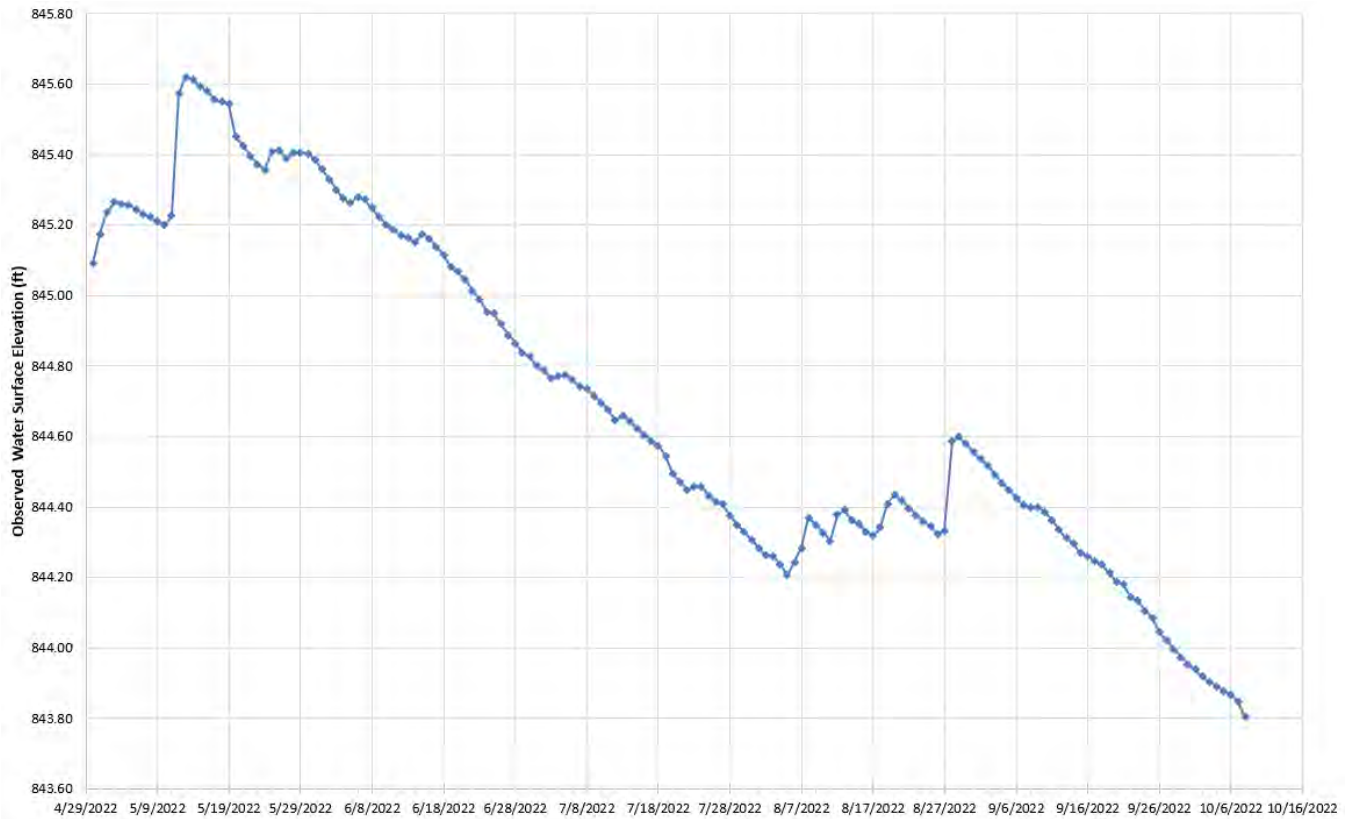
Figure 3-2 2022 Lake Water Levels

Figure 3-2 shows the monitored water levels for Lake Augusta during the 2022 monitoring season. The largest storm events during the monitoring period resulted in water level increases between 0.2 and 0.4 feet in Lake Augusta in the spring and later in the fall. Extremely dry conditions during June and July resulted in a lake level drop of approximately 1.2 feet.

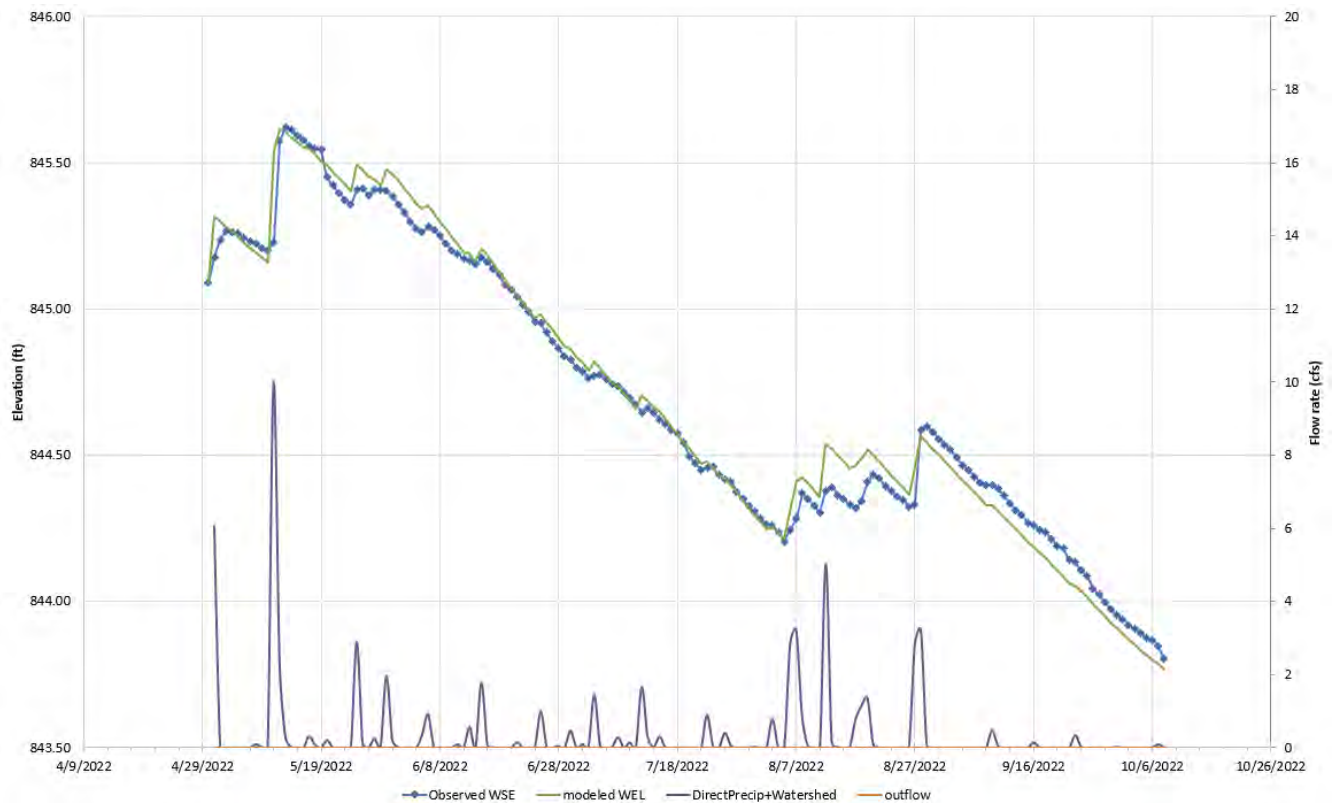
Figure 4-1 Calibrated Water Balance Modeling Results

Figure 4-1 shows how the calibrated daily water balance simulation from the in-lake modeling agreed with the monitored lake levels, based on the P8 modeling inputs, local precipitation records and estimated evaporation and net groundwater exchange during the summer of 2022.

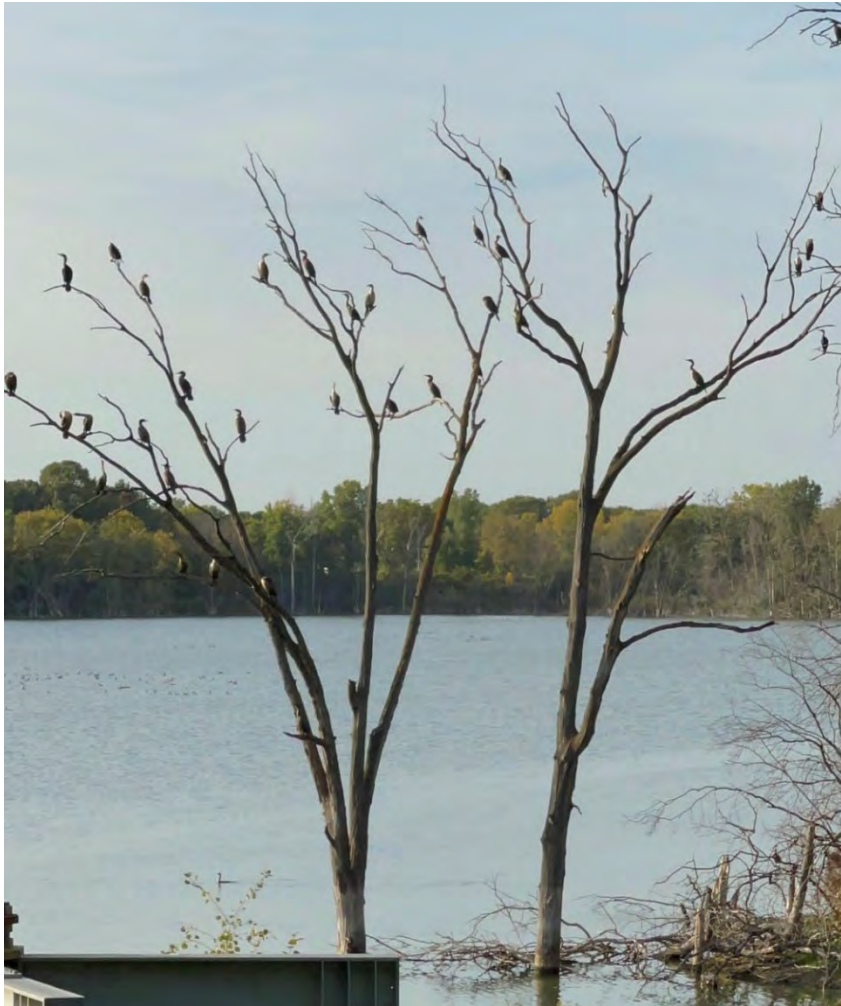
Figure 4-2 Cormorants Congregating on Dead Shoreline Trees

As previously noted, the landlocked condition of Lake Augusta has led to high lake levels that, in turn, have killed hundreds of the older growth trees that surround the lake shoreline as well as the forested understory. As shown in Figure 4-2, the dead trees are typically surrounded by lake water and are preferred habitat for large numbers of cormorants. Based on discussions with lake area residents, it was determined that fecal droppings from cormorants could represent another potentially significant source of TP load to Lake Augusta. Residents had compiled longer-term records about the number of birds and their daily patterns during the open water season. It was believed that many of the birds are fishing elsewhere during the day and returning to Lake Augusta during the evening and early morning hours. As a result, it is assumed that fecal matter from the birds represents a direct source of TP load to the lake that is derived from outside of the Lake Augusta watershed.

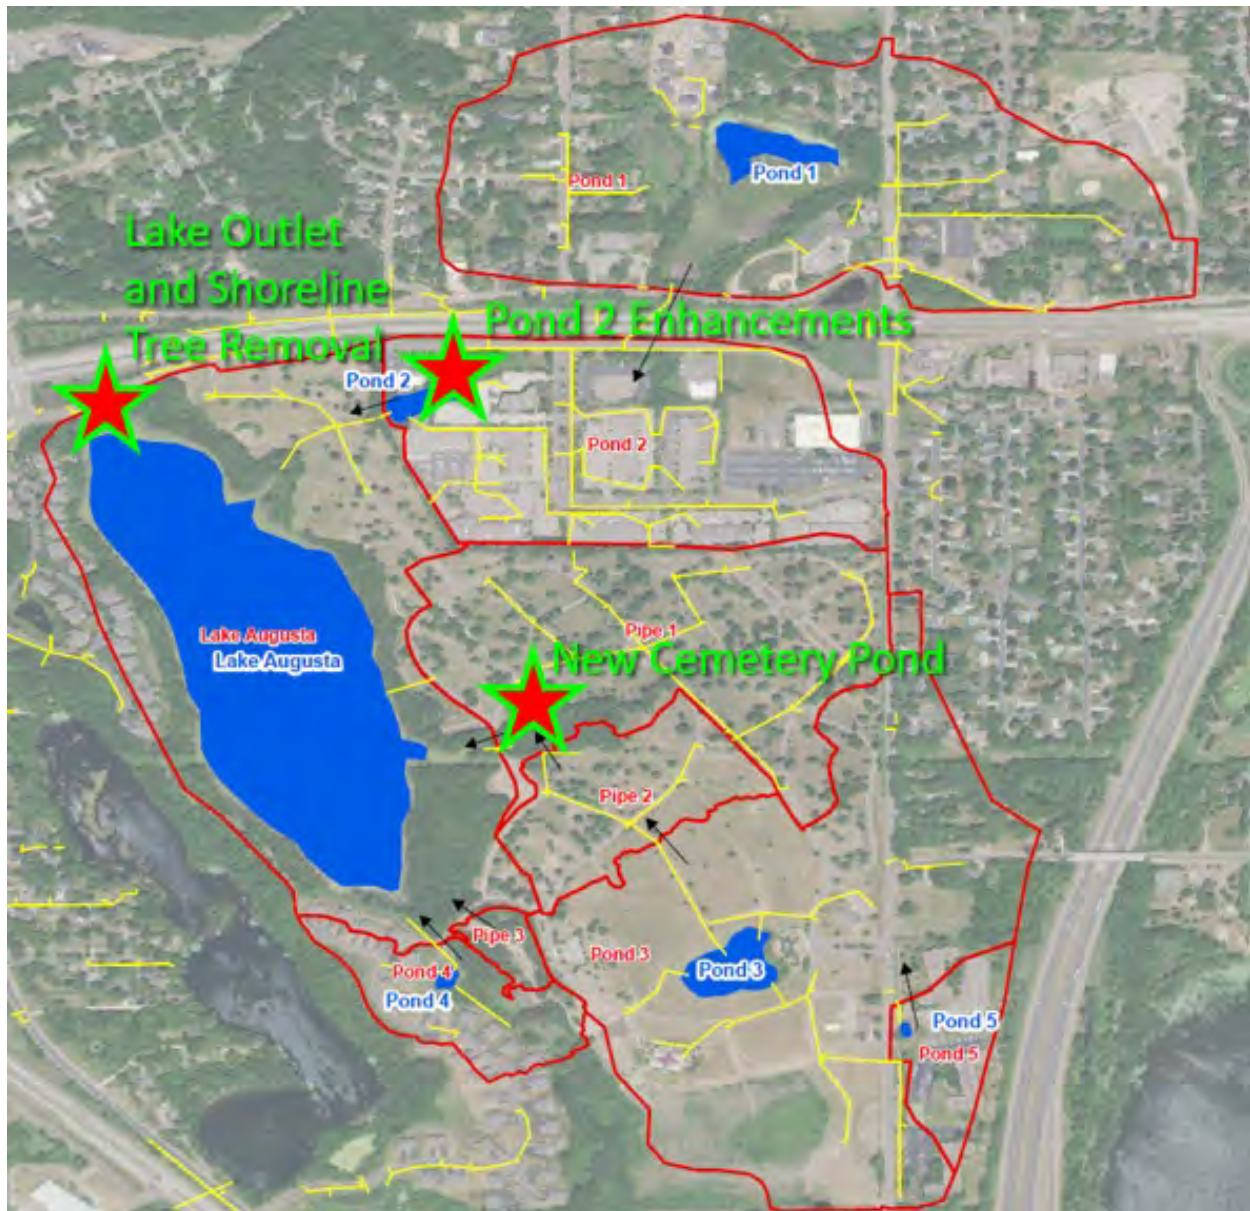
Figure 5-1 Recommended Lake Augusta Subwatershed Locations for Structural BMPs

Figure 5-1 shows the location of the potential lake improvement options in the watershed. The proposed BMP located in the Pond 2 subwatershed involves stormwater pond expansion and an iron-enhanced sand filter retrofit to improve TP treatment. The proposed BMP located in the Pipe 1 subwatershed involves installation of a new wet detention pond for untreated runoff, while the improvement options in

the direct watershed involve implementation of a lake outlet and removal of dead trees at the location shown in Figure 5-1.

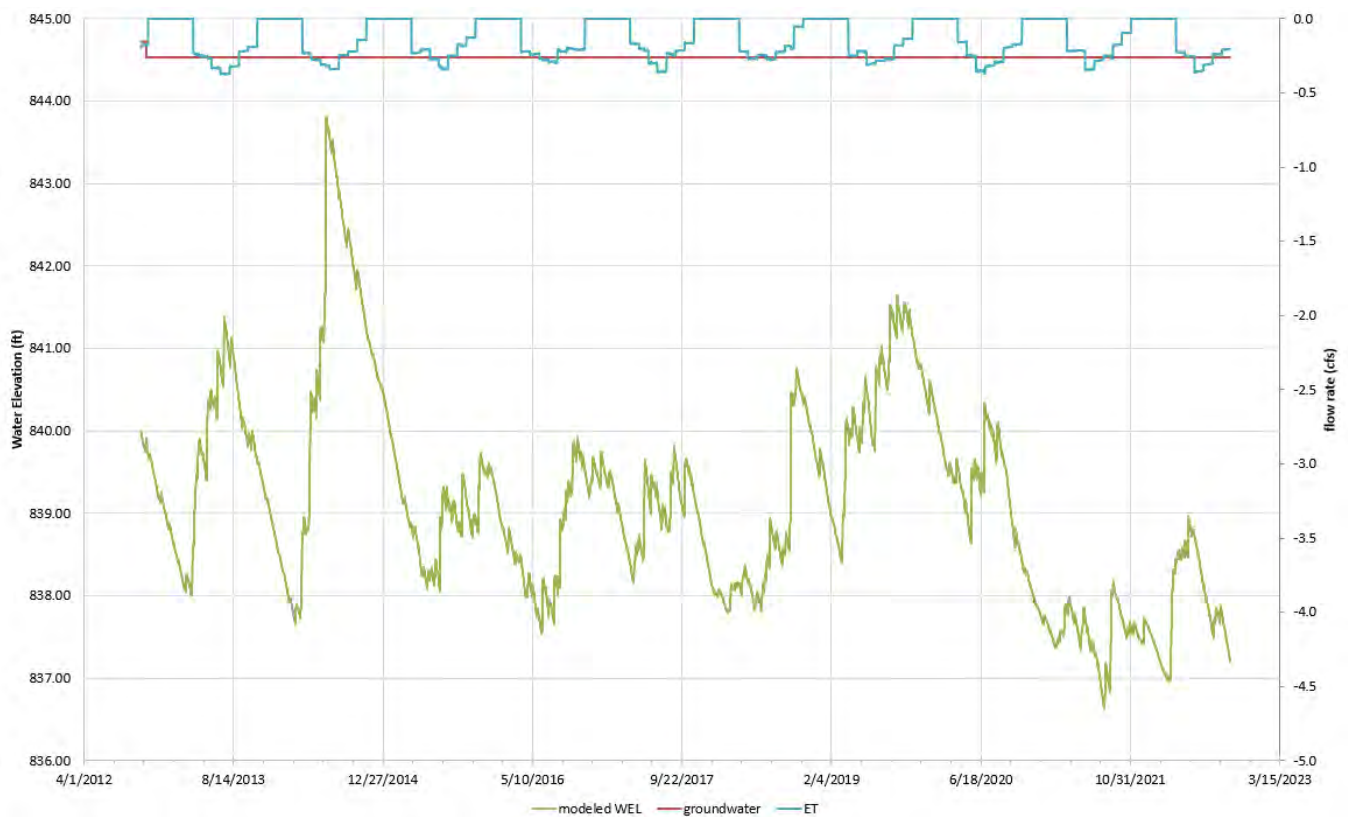
Figure 5-2 Long-Term Simulated Lake Augusta Lake Levels with Proposed Lake Outlet

The lake modeling was used to evaluate the potential water balance impact of various pumped outlet capacities and to optimize its operation to maintain relatively stable lake levels during the long-term simulation, which had an assumed starting water level of 840.0 feet (that may or may not be indicative of future management). Based on the preliminary model simulations, the lake outlet pumping can likely be optimized such that the maximum pumping rate would not exceed 1 cfs, and in most cases, a pumping rate of 0.33 cfs (150 gpm) or less, from one pump, would generally maintain lake level bounce below 2 feet (as shown in Figure 5-2, which shows the modeled water surface elevation [WEL], along with estimated/calibrated outflow rates for evapotranspiration [ET] and groundwater). Figure 5-2 shows that a 150 gpm pumping capacity during the extreme events of the spring of 2014 would result in approximately a six-foot increase in lake level, but the potential use of pumping redundancy (in the form of a backup pump) could mitigate the bounce and inundation time during these extreme events. The backup pump would be installed as a part of this improvement option in case the primary pump requires service.

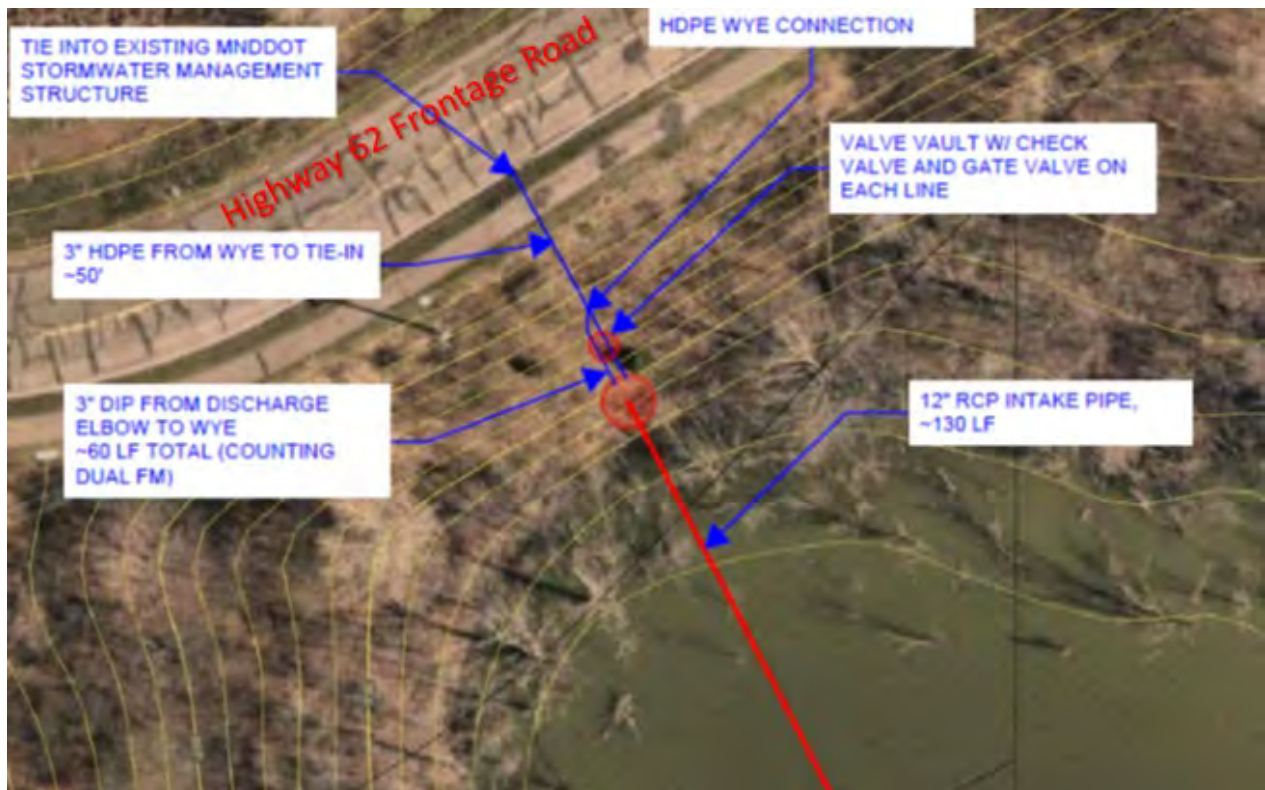
Figure 5-3 Lake Outlet Conceptual Design

Figure 5-3 shows the proposed lake outlet conceptual design features, which include two 150 gpm submersible pumps (for redundancy, as noted above) with a wetwell and discharge piping to the closest frontage road catch basin. It is expected that the system would ordinarily be programmed to operate one pump at a maximum discharge rate of 150 gpm, but pump operation could be manually changed during high water conditions. The proposed intake pipe would extend far enough into Lake Augusta to allow for a drawdown that would facilitate the removal of the dead trees that surround the lake shoreline. Removal

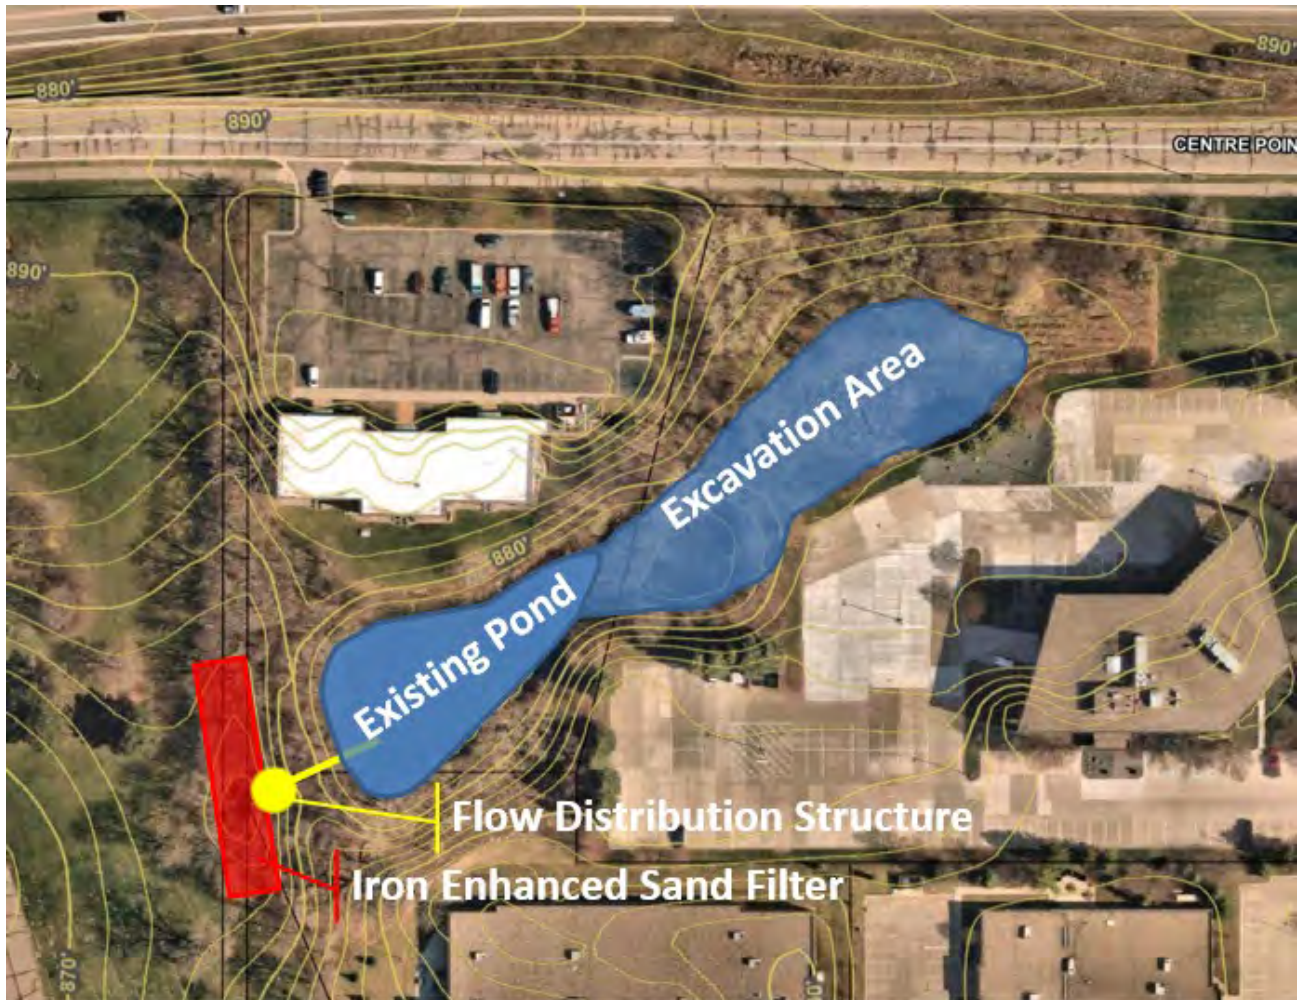
Figure 5-4 Conceptual Design of Stormwater Pond 2 Enhancements

Figure 5-4 shows the conceptual design for enhancements to stormwater treatment at the Pond 2 site. Under current conditions, the calibrated long-term P8 model simulation estimates that Pond 2 is

removing 29% of the incoming TP load before discharge to Lake Augusta. The conceptual design includes significant expansion of the existing pond surface area and depth for improved particulate phosphorus removal, as well as an iron-enhanced sand filter to provide treatment of dissolved phosphorus from the pond effluent. The proposed pond surface area is twice as large as the existing area and the proposed dead storage volume is three times larger than current conditions. A TP load reduction of 17 pounds per year is estimated for the proposed condition, based on the long-term P8 model simulation. This pond is located on private property and would need close coordination with the property owners to implement improvements. Similar to the lake outlet, the expansion proposed for this improvement option will involve multiple landowners and future considerations for ongoing operation and maintenance, including drainage and access easements.
