Thompson Lake LMR WMO

2022 Water Monitoring Report

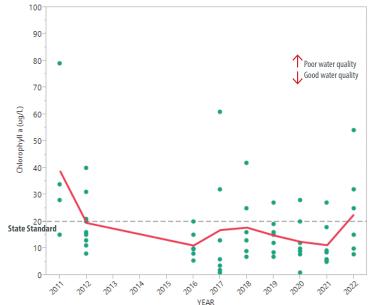
Chlorophyll-a*

Chlorophyll-a is the pigment that gives plants their green color. High levels indicate excessive algae from high nutrient levels in the lake. Low chlorphophyll-a levels indicate good water quality. State standard is 20 ug/L (dashed line).

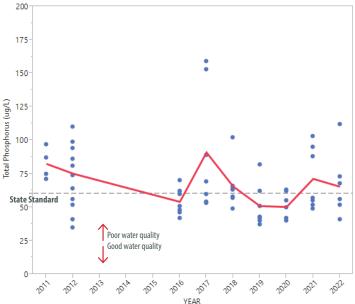
Phosphorus*

Phosphorus is a nutrient required for plant growth. High phosphorus levels can lead to algae blooms, turning water green. Low phosphorus levels indicate good water quality. State standard is 60 ug/L (dashed line).

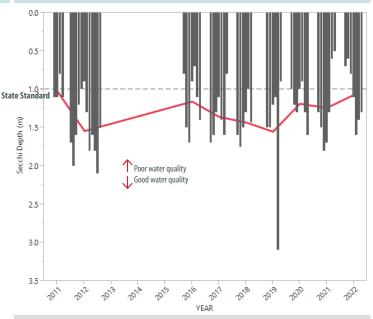
Secchi Depth

A black and white secchi disc is lowered into the water until no longer visible and measures water clarity. High secchi disc depths indicate good water quality. State standard is 1 m (dashed line).
