Lake Augusta Water Quality Improvement and Outlet Feasibility Study

Prepared for
Lower Mississippi River Watershed Management Organization and
City of Mendota Heights

December 2023

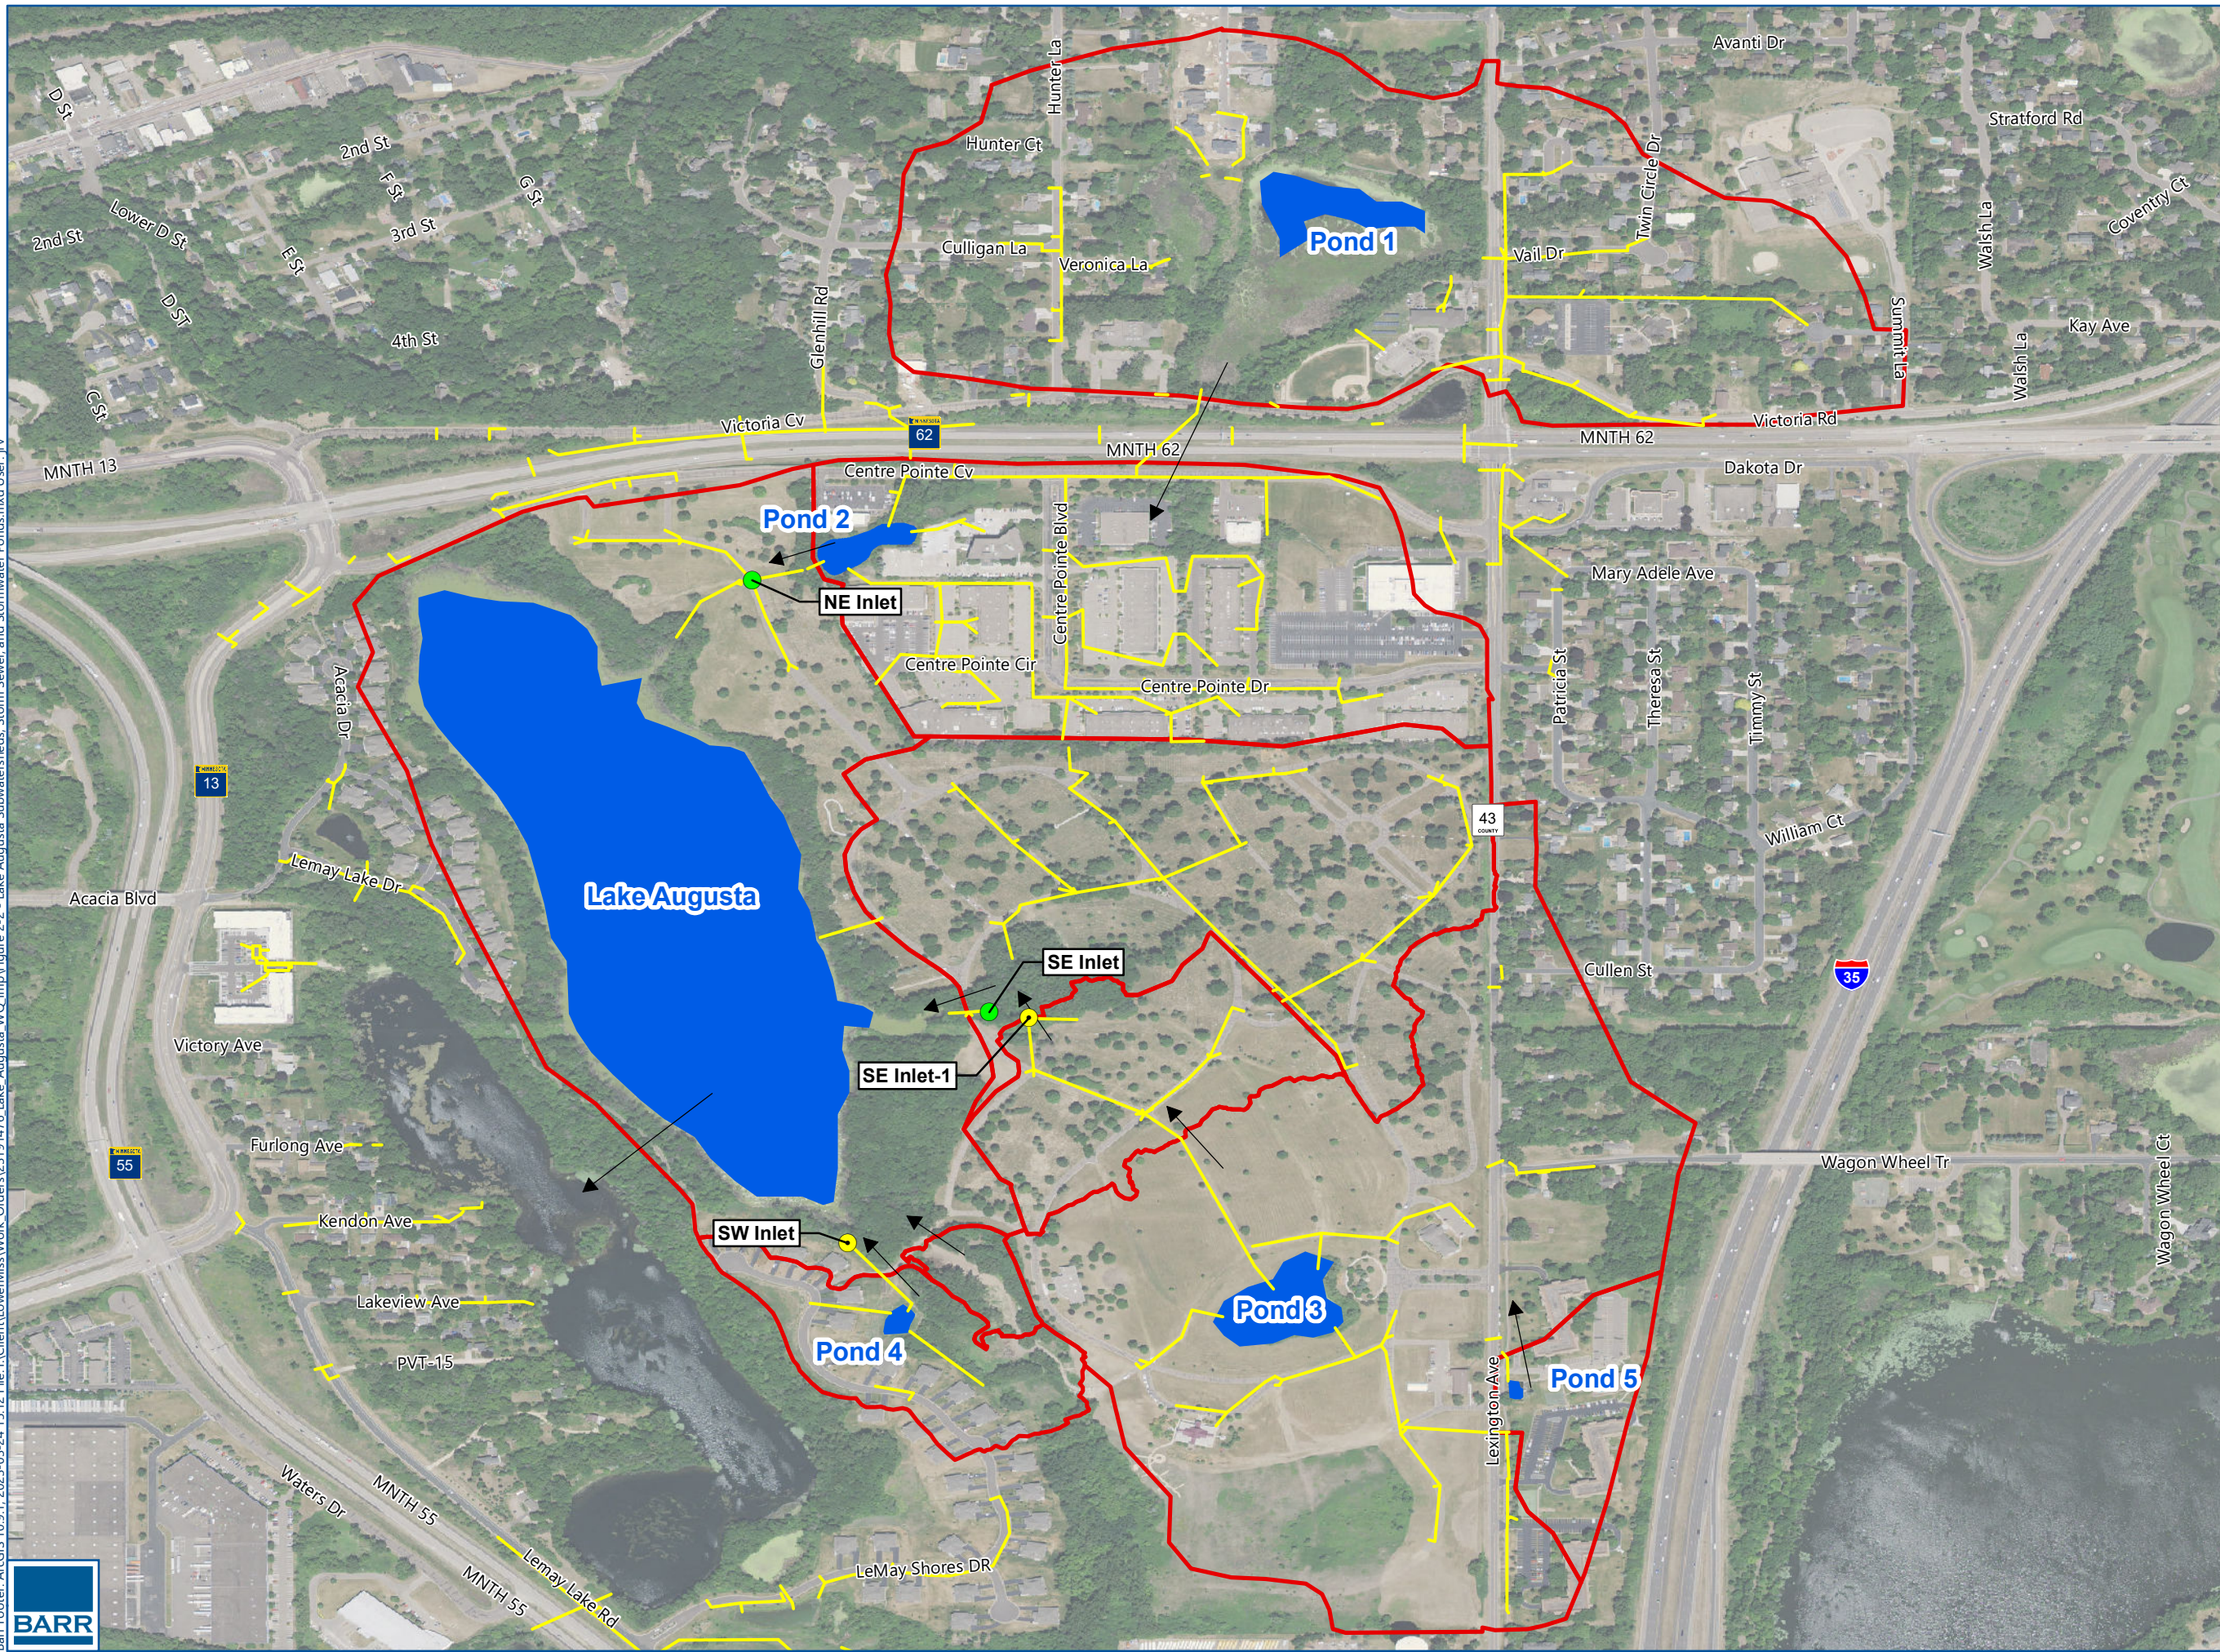
LAKE AUGUSTA SUBWATERSHEDS, STORM SEWER AND STORMWATER PONDS
FIGURE 2-2

- Stormwater Flow and Water Quality Monitoring Site
- Stormwater Grab Sampling Site
- ➔ Flow Direction
- Pipes (Mendota Heights)
- 🔴 Watersheds
- 🟦 Water Bodies

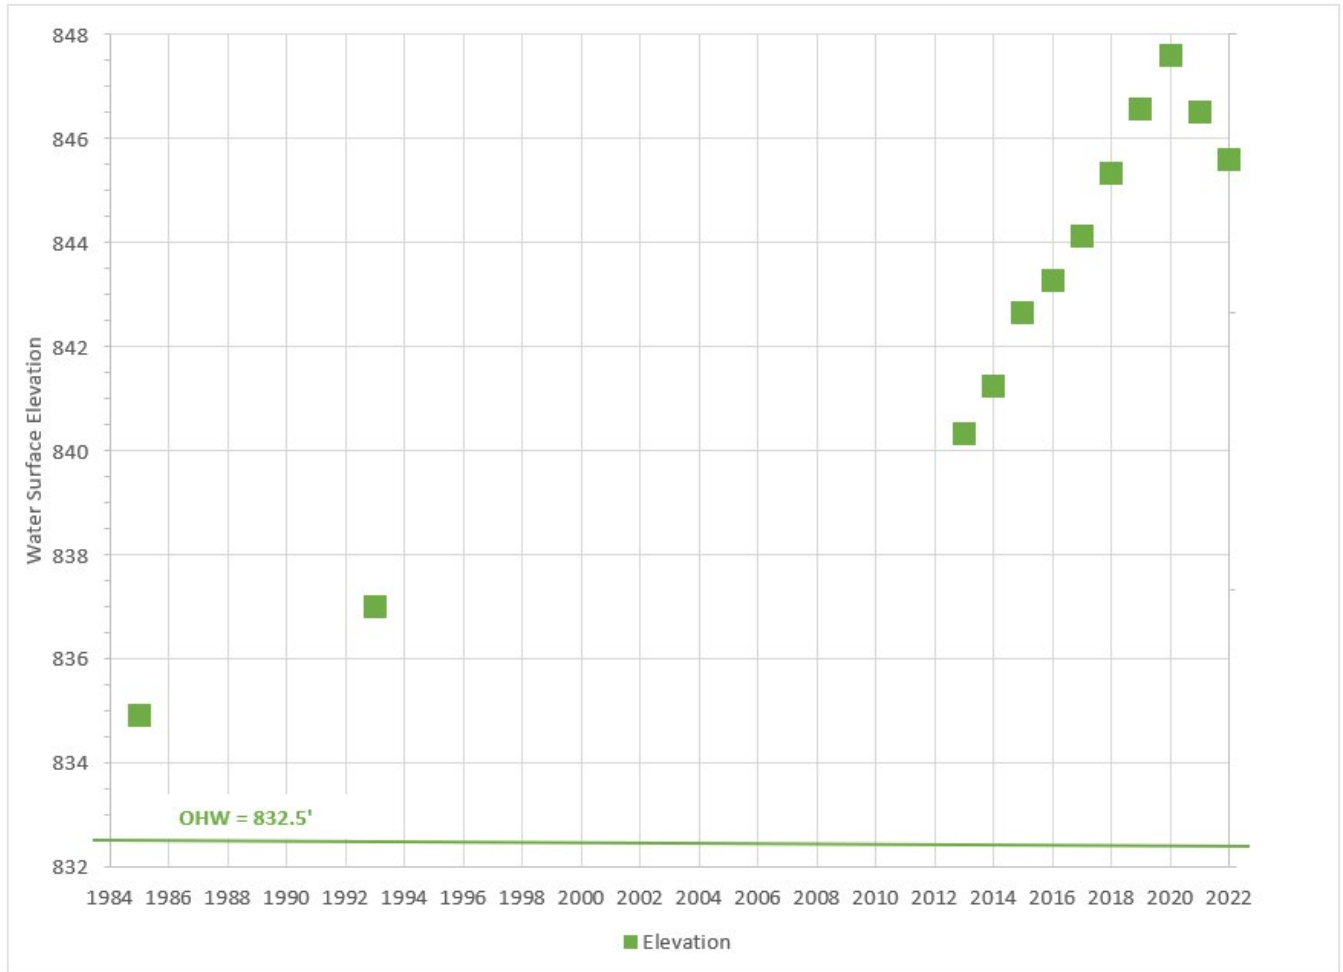
Figure 3-3 Historical Lake Level Estimates

Limited historic lake level observations are available for Lake Augusta. Past survey elevations and aerial photos were used to approximate how water levels in Lake Augusta responded to wetter than average conditions between 2013 and 2020. Figure 3-3 shows the combined record of past lake level measurements and estimates, along with comparison to older lake level measurements and the OHWL. Figure 3-3 shows that the estimated lake level from 2020 was about 8 feet higher than 2013 and about 15 feet higher than the OHWL.

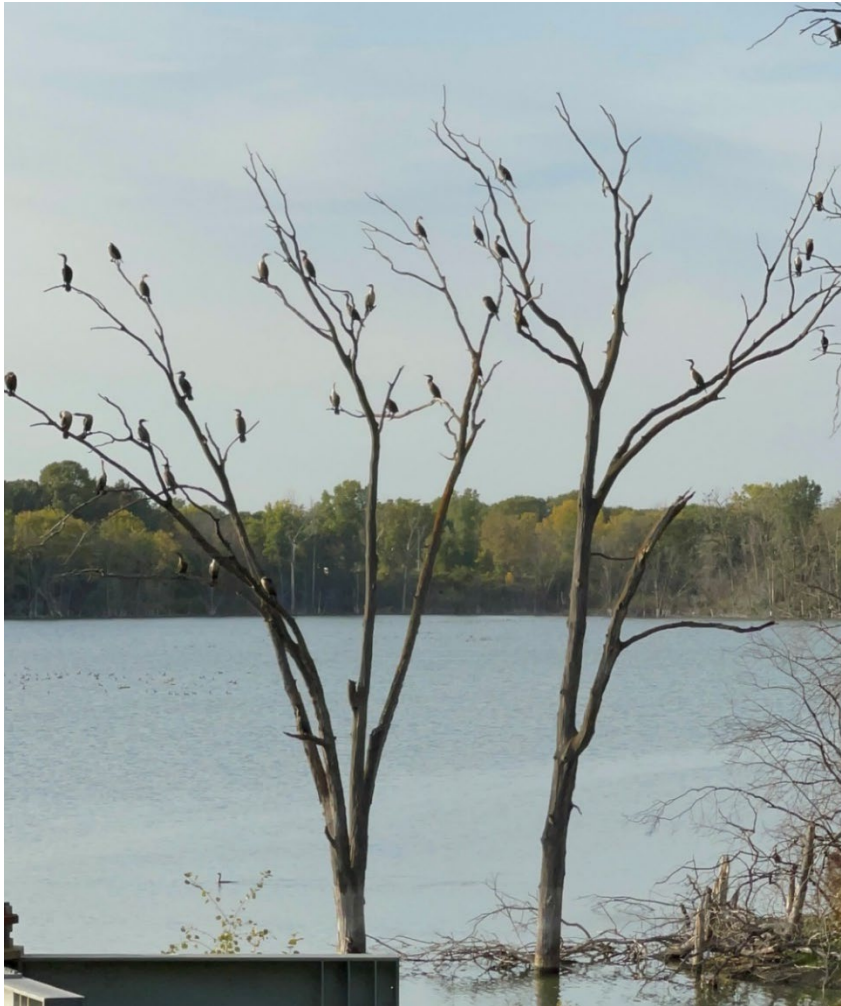
Figure 4-2 Cormorants Congregating on Dead Shoreline Trees

As previously noted, the landlocked condition of Lake Augusta has led to high lake levels that, in turn, have killed hundreds of the older growth trees that surround the lake shoreline as well as the forested understory. As shown in Figure 4-2, the dead trees are typically surrounded by lake water and are preferred habitat for large numbers of cormorants. Based on discussions with lake area residents, it was determined that fecal droppings from cormorants could represent another potentially significant source of TP load to Lake Augusta. Residents had compiled longer-term records about the number of birds and their daily patterns during the open water season. It was believed that many of the birds are fishing elsewhere during the day and returning to Lake Augusta during the evening and early morning hours. As a result, it is assumed that fecal matter from the birds represents a direct source of TP load to the lake that is derived from outside of the Lake Augusta watershed.

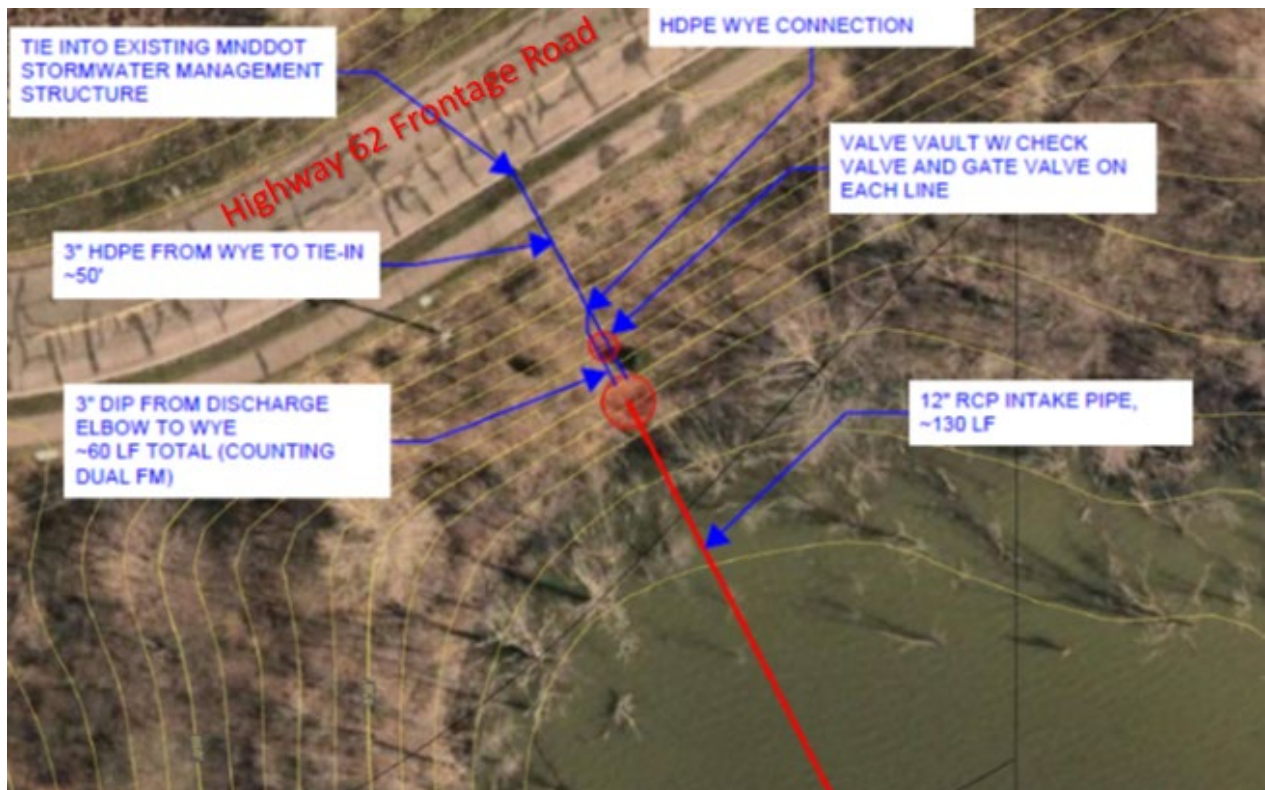
Figure 5-3 Lake Outlet Conceptual Design

Figure 5-3 shows the proposed lake outlet conceptual design features, which include two 150 gpm submersible pumps (for redundancy, as noted above) with a wetwell and discharge piping to the closest frontage road catch basin. It is expected that the system would ordinarily be programmed to operate one pump at a maximum discharge rate of 150 gpm, but pump operation could be manually changed during high water conditions. The proposed intake pipe would extend far enough into Lake Augusta to allow for a drawdown that would facilitate the removal of the dead trees that surround the lake shoreline. Removal

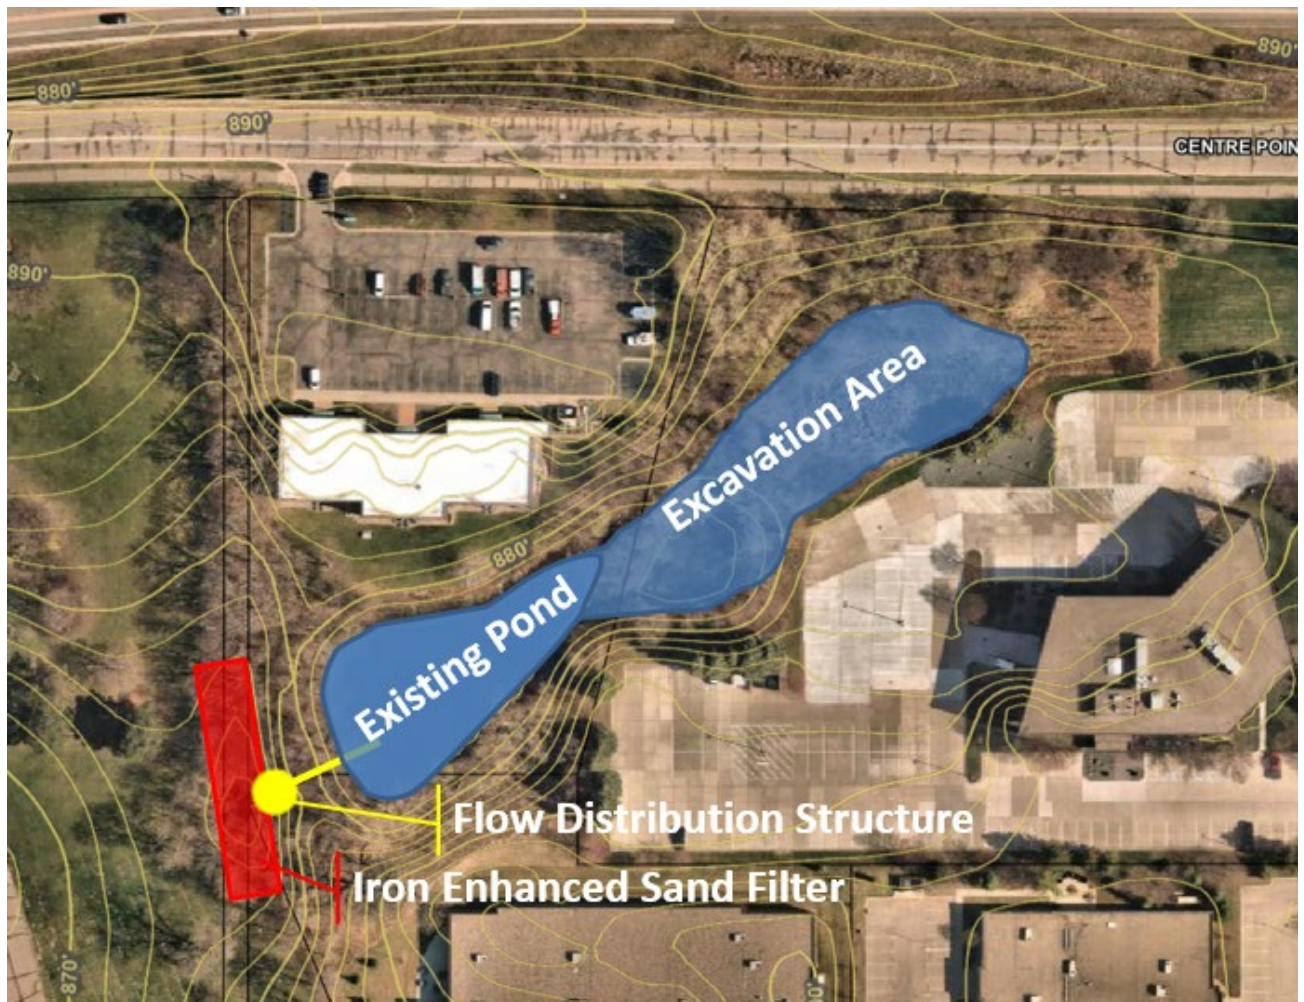
Figure 5-4 Conceptual Design of Stormwater Pond 2 Enhancements

Figure 5-4 shows the conceptual design for enhancements to stormwater treatment at the Pond 2 site. Under current conditions, the calibrated long-term P8 model simulation estimates that Pond 2 is

removing 29% of the incoming TP load before discharge to Lake Augusta. The conceptual design includes significant expansion of the existing pond surface area and depth for improved particulate phosphorus removal, as well as an iron-enhanced sand filter to provide treatment of dissolved phosphorus from the pond effluent. The proposed pond surface area is twice as large as the existing area and the proposed dead storage volume is three times larger than current conditions. A TP load reduction of 17 pounds per year is estimated for the proposed condition, based on the long-term P8 model simulation. This pond is located on private property and would need close coordination with the property owners to implement improvements. Similar to the lake outlet, the expansion proposed for this improvement option will involve multiple landowners and future considerations for ongoing operation and maintenance, including drainage and access easements.
