Lake Augusta

2024 Water Monitoring Report

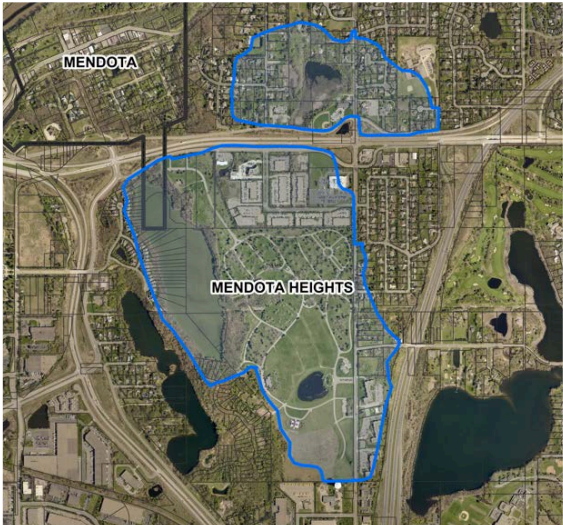
Lake Augusta is located in the City of Mendota Heights, within the Lower Mississippi River Watershed Management Organization (LMRWMO). Land use within the watershed is primarily institutional (cemetery), commercial, and residential (low and high density). Lake Augusta was placed on Minnesota’s 303(d) List of Impaired Waters in 2010 for aquatic recreation due to excess nutrients (phosphorus).

- Max Depth: 33 feet
- Watershed Size (shown): 420 acres
- Major Watershed: Mississippi River
- MPCA Lake Classification: Deep
- Met Council Lake Grade (2024): **F**

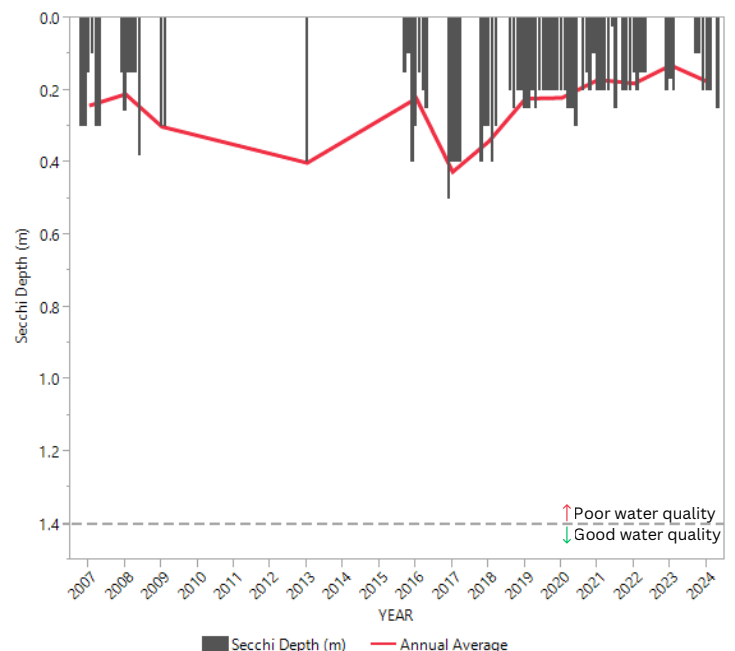
Secchi Depth

A black and white secchi disc is lowered into the water until no longer visible and measures water clarity. High secchi disc depths indicate good water quality. MPCA standard is 1.4 m (dashed line).
