# Lake Augusta

## 2024 Water Monitoring Report

# Water Quality Data 2007 - 2024

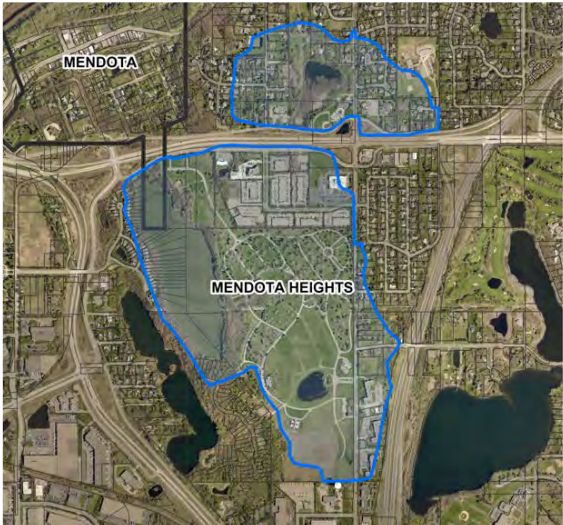
- Max Depth: 33 feet
- Watershed Size (shown): 420 acres
- Major Watershed: Mississippi River
- MPCA Lake Classification: Deep
- Met Council Lake Grade (2024): **F**

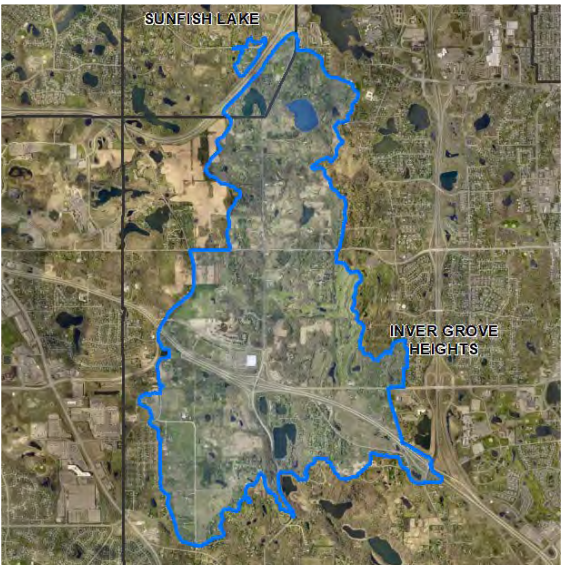
Max Depth: 23 feet

Lake Size (shown): 24 acres

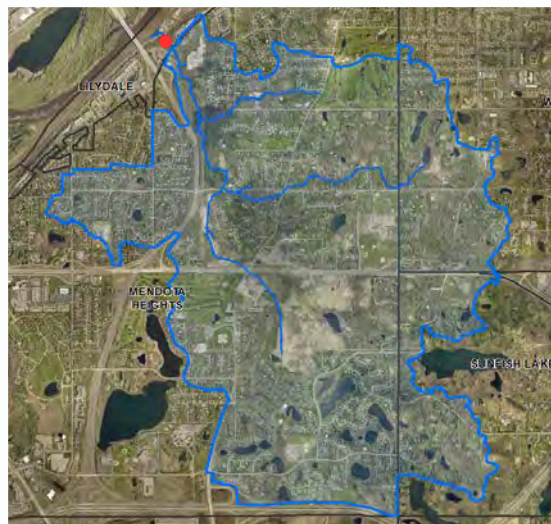
A volunteer monitor takes water samples from one location (red dot above) from Interstate Valley Creek for lab analysis. The purpose is to identify stream reaches that contribute pollutants and establish baseline stream water quality conditions. Monitoring also helps track the impact of future watershed projects that stabilize banks or treat stormwater in the watershed to reduce the in-stream pollutant load (sediment and phosphorus).

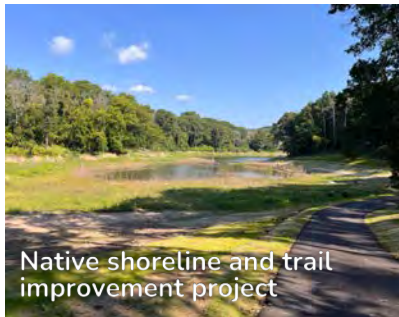
A lake outlet project to maintain consistent water levels was completed in 2022 and a natural shoreline restoration project was installed in 2024 along with trail improvements.

Native shoreline and trail improvement project

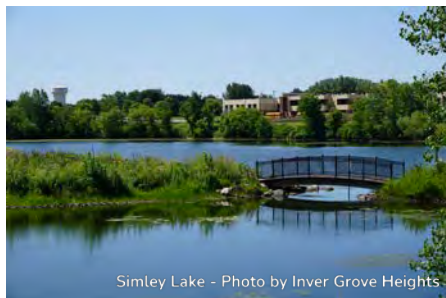
The City of Inver Grove Heights installed a shoreline restoration project in partnership with

the Dakota County SWCD in 2011 with a variety of native plant species to naturally stabilize the shoreline.

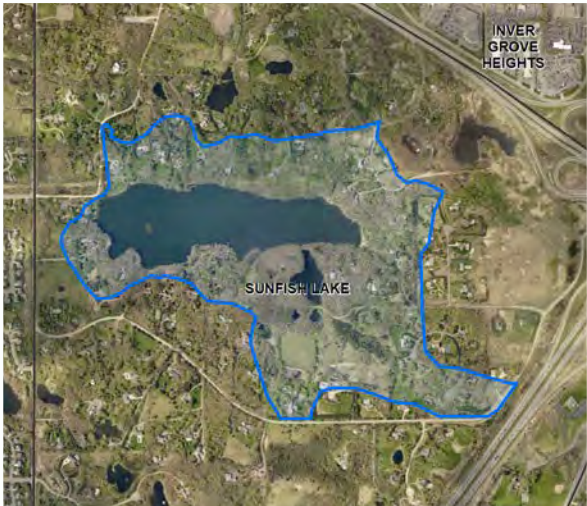
- Max Depth: 32 feet
- Watershed Size (shown): 235 acres
- Major Watershed: Mississippi River
- MPCA Lake Classification: Deep
- Met Council Lake Grade (2024): **A**
