# Seidls Lake

## 2024 Water Monitoring Report

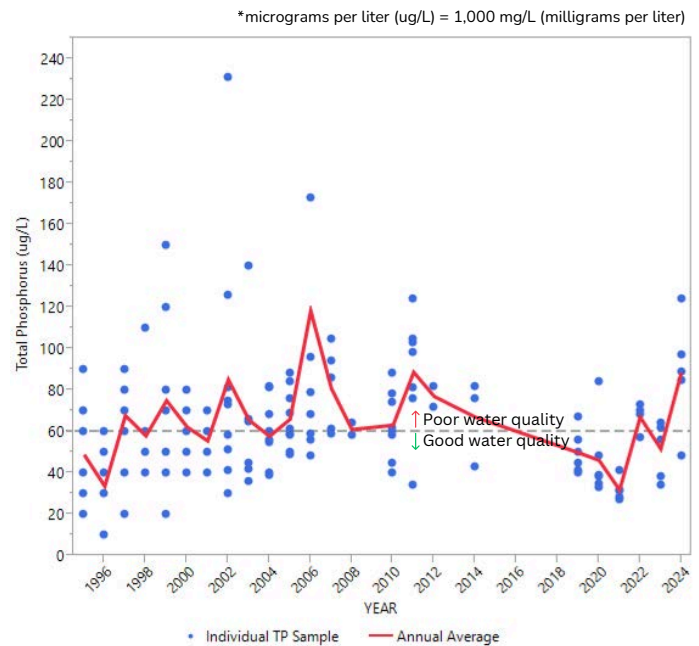
## Phosphorus\*

Phosphorus is a nutrient required for plant growth. High phosphorus levels can lead to algae blooms, turning water green. Low phosphorus levels indicate good water quality. MPCA standard is 60 ug/L (dashed line).

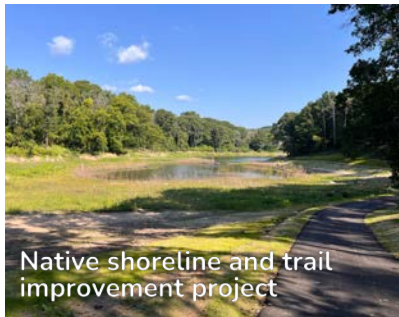
Native shoreline and trail improvement project

A lake outlet project to maintain consistent water levels was completed in 2022 and a natural shoreline restoration project was installed in 2024 along with trail improvements.
