LMR WMO
LOWER MISSISSIPPI RIVER
WATERSHED MANAGEMENT ORGANIZATION

FEASIBILITY STUDY

MISSISSIPPI RIVER DIRECT DRAINAGE

September 30, 2024 DRAFT

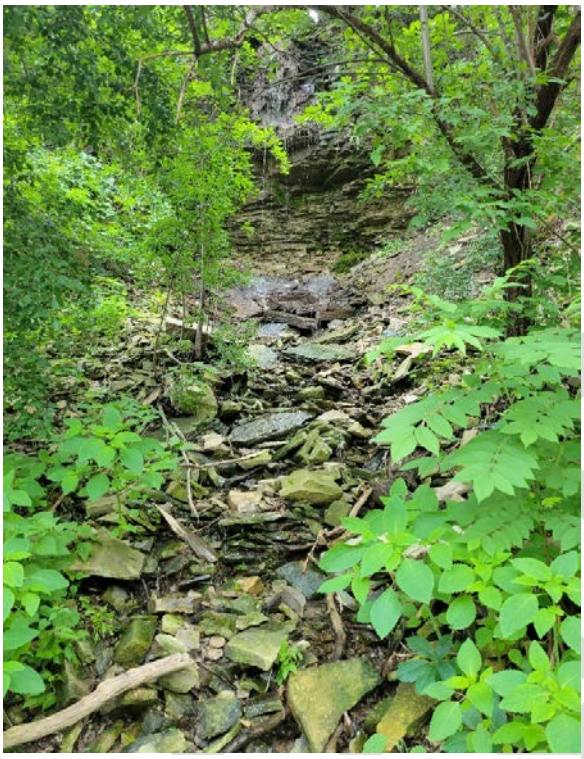
Photo 10 - Piped outfall along Big Rivers Regional Trail

During the inspection WSB observed two different classes of drainage which may cause future erosion issues for the bluffs along the Mississippi River. First was non-piped outlets or overland flow, which are visible from the trail and generally look like waterfalls. Some of these may be groundwater seeps rather than overland flow or stormwater flow, which could be verified with further investigation. These areas generally had large (>8 inch diameter) rockfalls at the bottom and all had substantial vegetation within the area, indicating that the flow is not moving fine material which would contribute sediment loading to the Mississippi River.

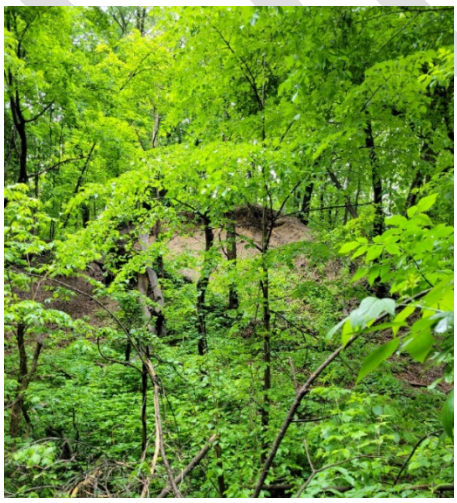
Photo 11 - Hillside erosion in Simon's Ravine

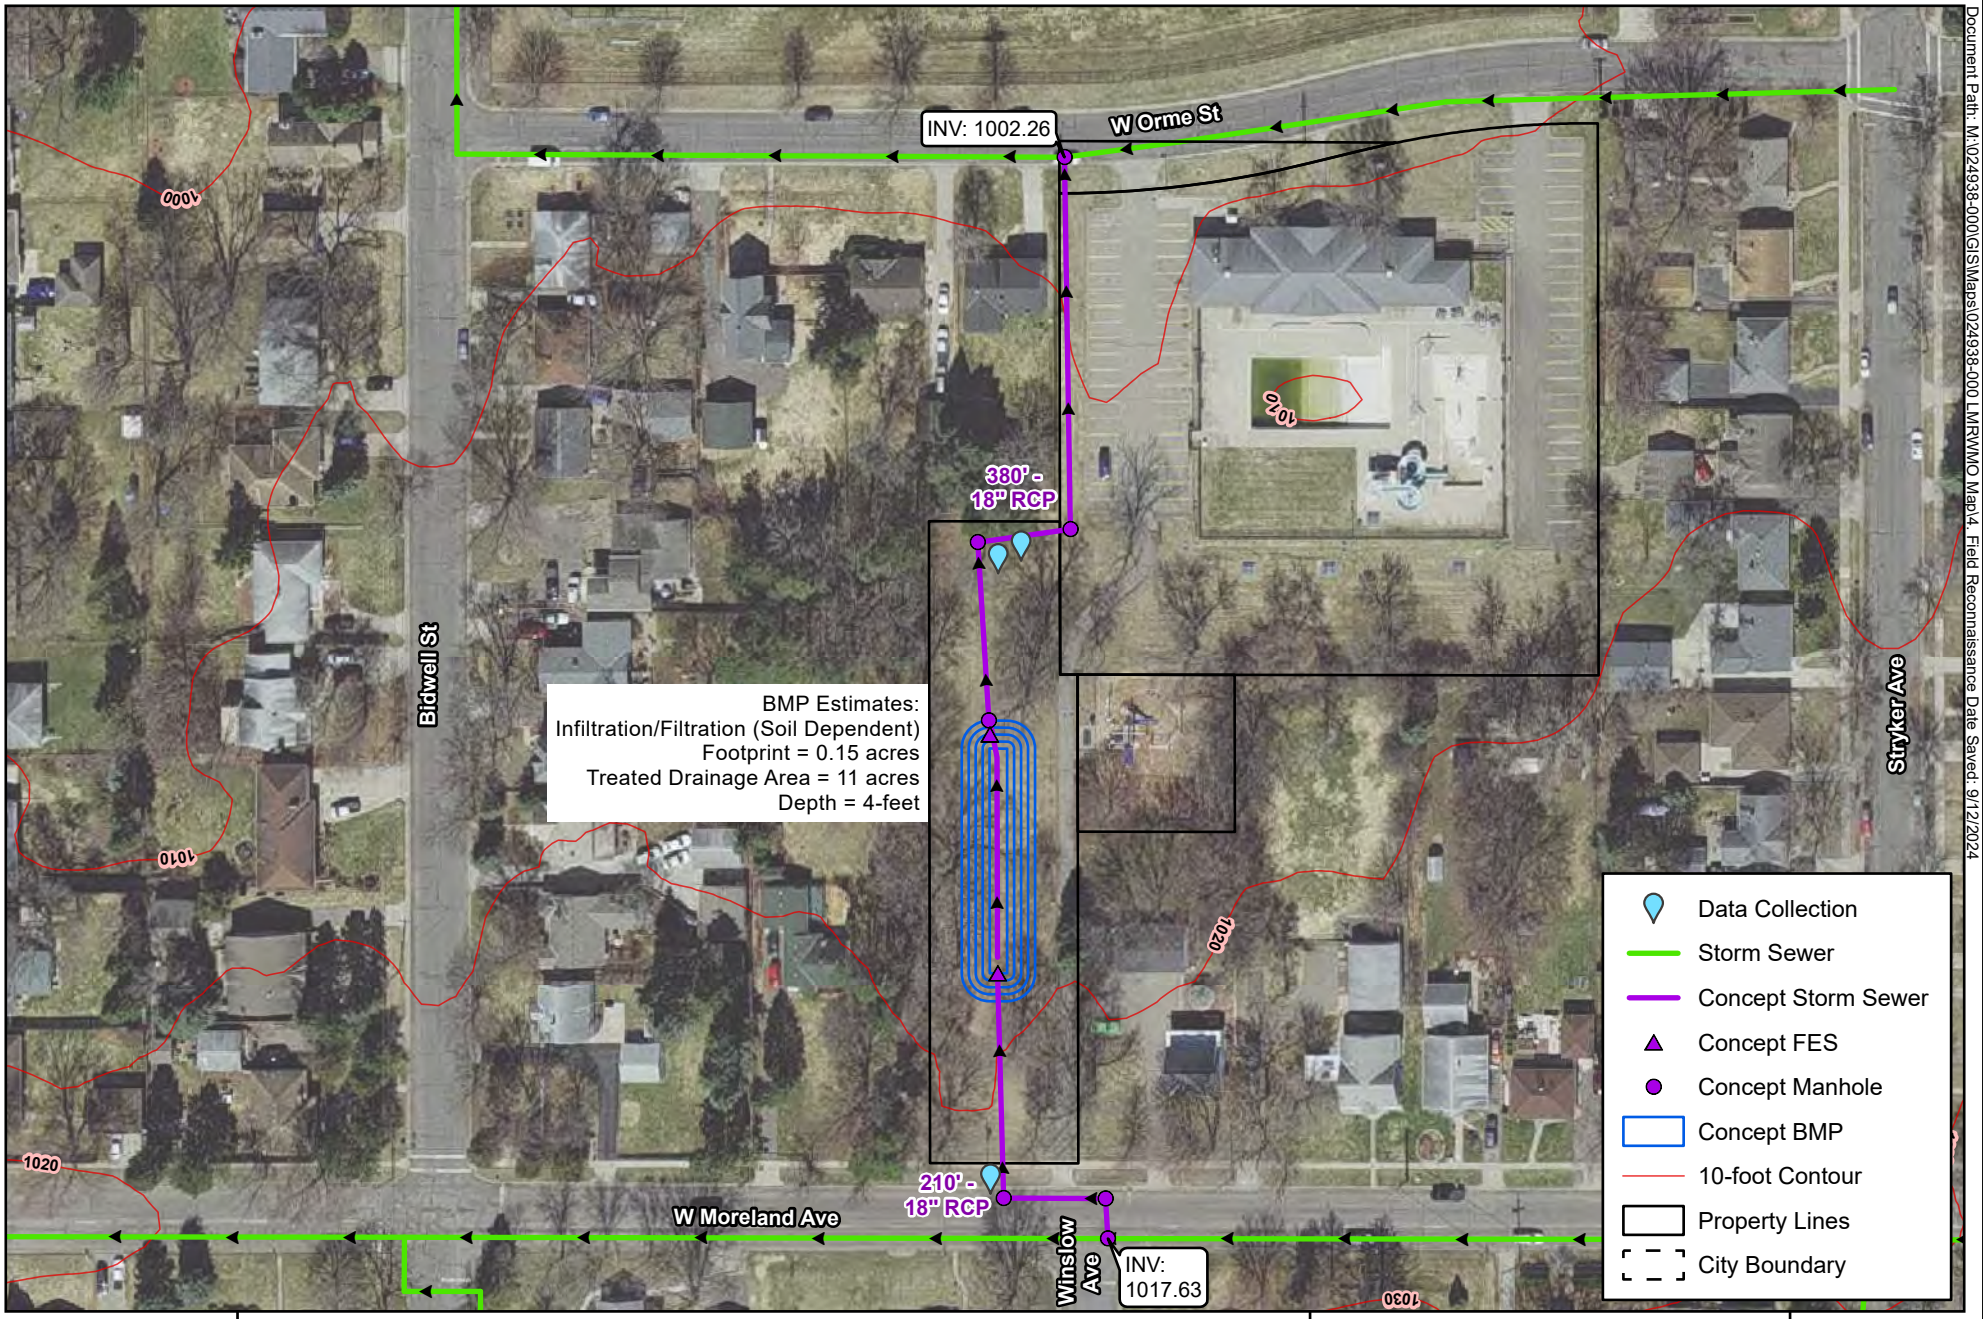
Figure 4.1.2 - City Pool Park

Figure 4.1.2 shows the site visit map for City Pool Park. WSB staff visited City Pool Park in June 2024. WSB selected City Pool Park for a site visit because it was a city-owned parcel outside the karst buffer area, meaning infiltration would be possible on the site, and because there are two existing storm sewer lines running under West Moreland Avenue to the south and West Orme Street to the north. The presence of these two lines allowed for the possibility of running a stormwater structure between the two existing lines.

City Pool Park has an elongated open space to the west of an existing playground and paved trail. WSB determined that a potential infiltration/filtration basin could be installed in this area which was the top priority stormwater management type for the City of West St. Paul, and the project could be installed with minimal tree loss. City Pool Park was therefore selected for a concept design. The preliminary concept design for City Pool Park is discussed in detail in section 5.3.1.

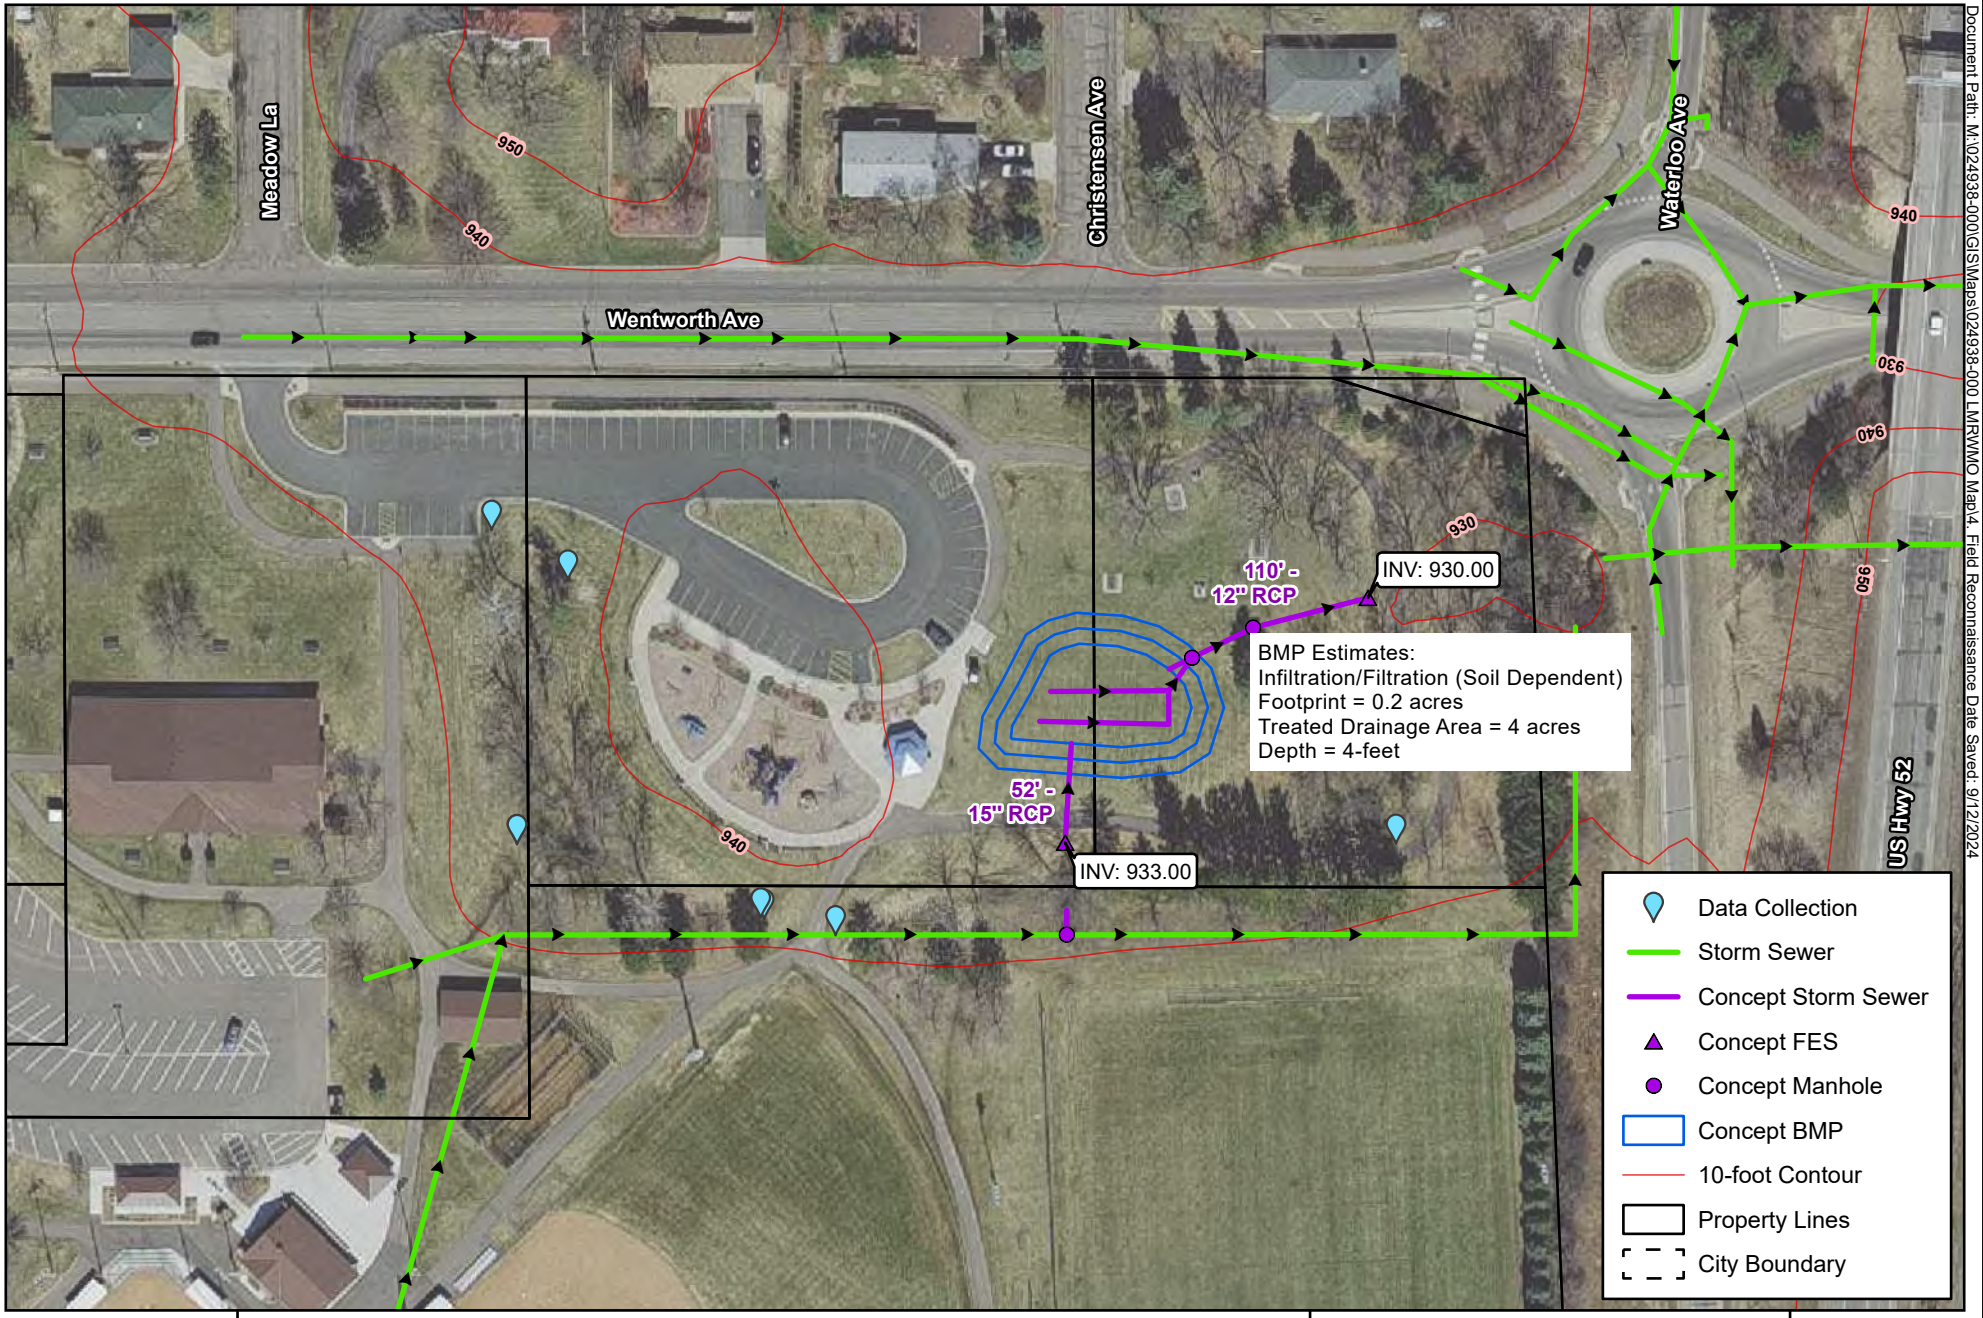
Figure 4.1.4 - West St. Paul Sports Complex

Figure 4.1.4 shows the site visit map for West St. Paul Sports Complex. WSB staff visited West St. Paul Sports Complex in July 2024. City of West St. Paul staff suggested a stormwater installation in the West St. Paul Sports Complex that could work alongside existing stormwater installations. The Sports Complex is outside the karst buffer area, meaning infiltration is possible, and there are existing storm sewer lines that run through the park itself as well as under Wentworth Avenue to the north.

During the site visit, WSB determined that there would be room for an additional infiltration basin between the parking lot and the existing trail. There would be no tree loss and no realignment of the existing trail would be needed. Infiltration was also the top priority stormwater management type for the City of West St. Paul. The preliminary concept design for West St. Paul Sports Complex will be discussed in detail in section 5.3.3.

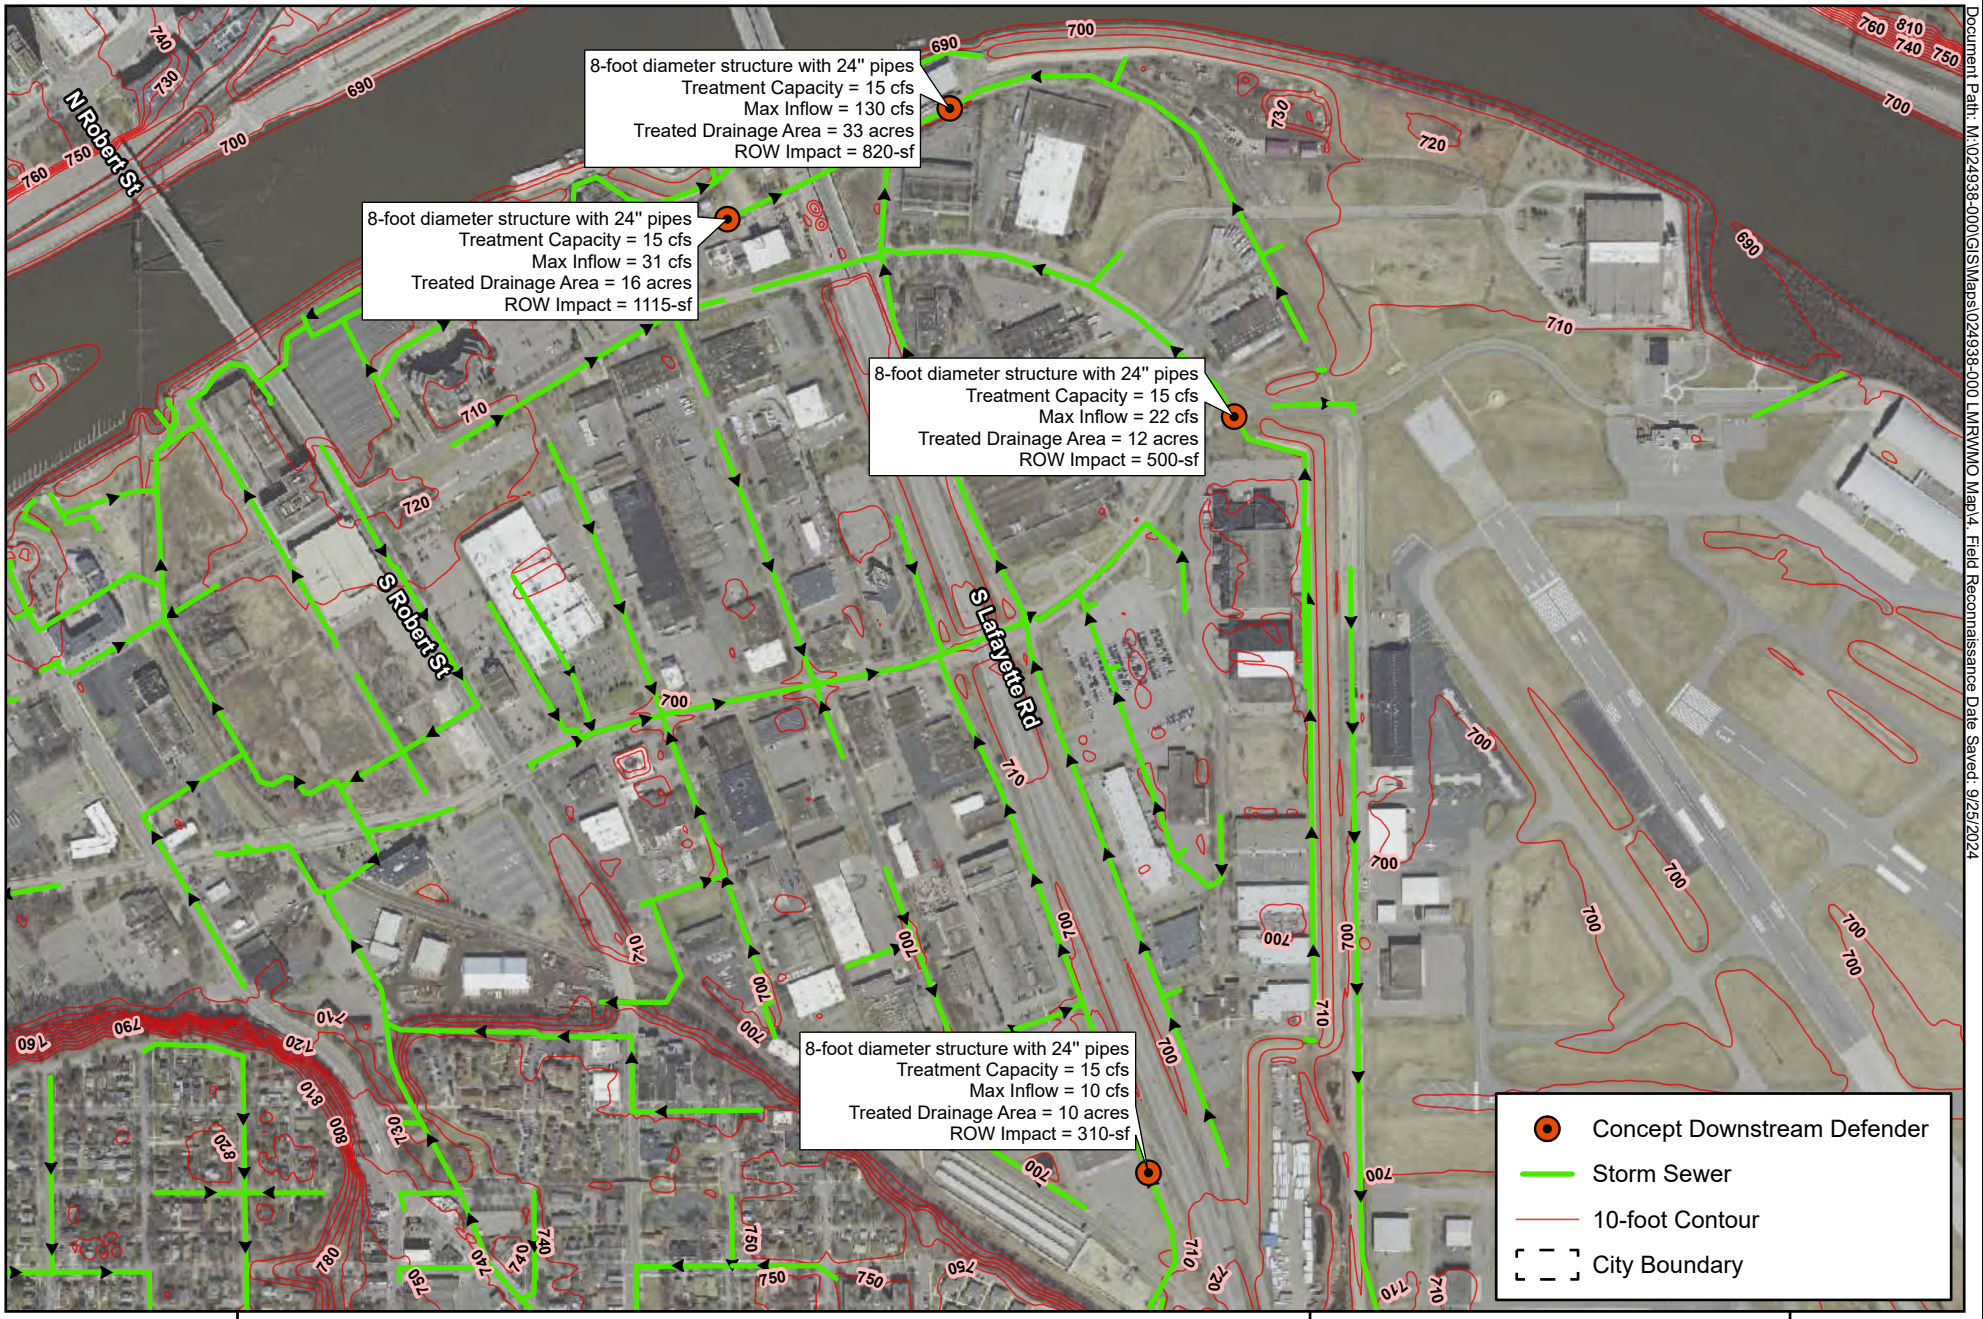
Figure 4.3.2 - Highway 13 Slope Failure

MnDOT closed Highway 13 between Sylvandale Road and Wachtler Avenue in Mendota Heights in June 2024 due to a slope failure. The slope failure occurred on the shoulder of the southbound lane which is part of the bluffs above Pickerel Lake in Mendota Heights. WSB staff completed a site visit to the slope failure accompanied by MnDOT staff in July 2024. Figure 4.3.2 shows the location of the site visit and the slope failure.

During the site visit, MnDOT indicated that there had been past slope failures on this section of Highway 13 and repair projects had focused on installing slope containment systems such as soil nail walls that were more resilient to a variety of conditions and less prone to failure. MnDOT staff on site indicated that because Highway 13 was a state highway that was completely closed to traffic, it was a high priority for repair and would likely be completed and reopened in late 2024. Because of this accelerated timeline and MnDOT's ongoing design for repairs, the Highway 13 slope failure is not recommended as an erosion reduction or bluff stabilization project for LMRWMO to consider as part of this study.

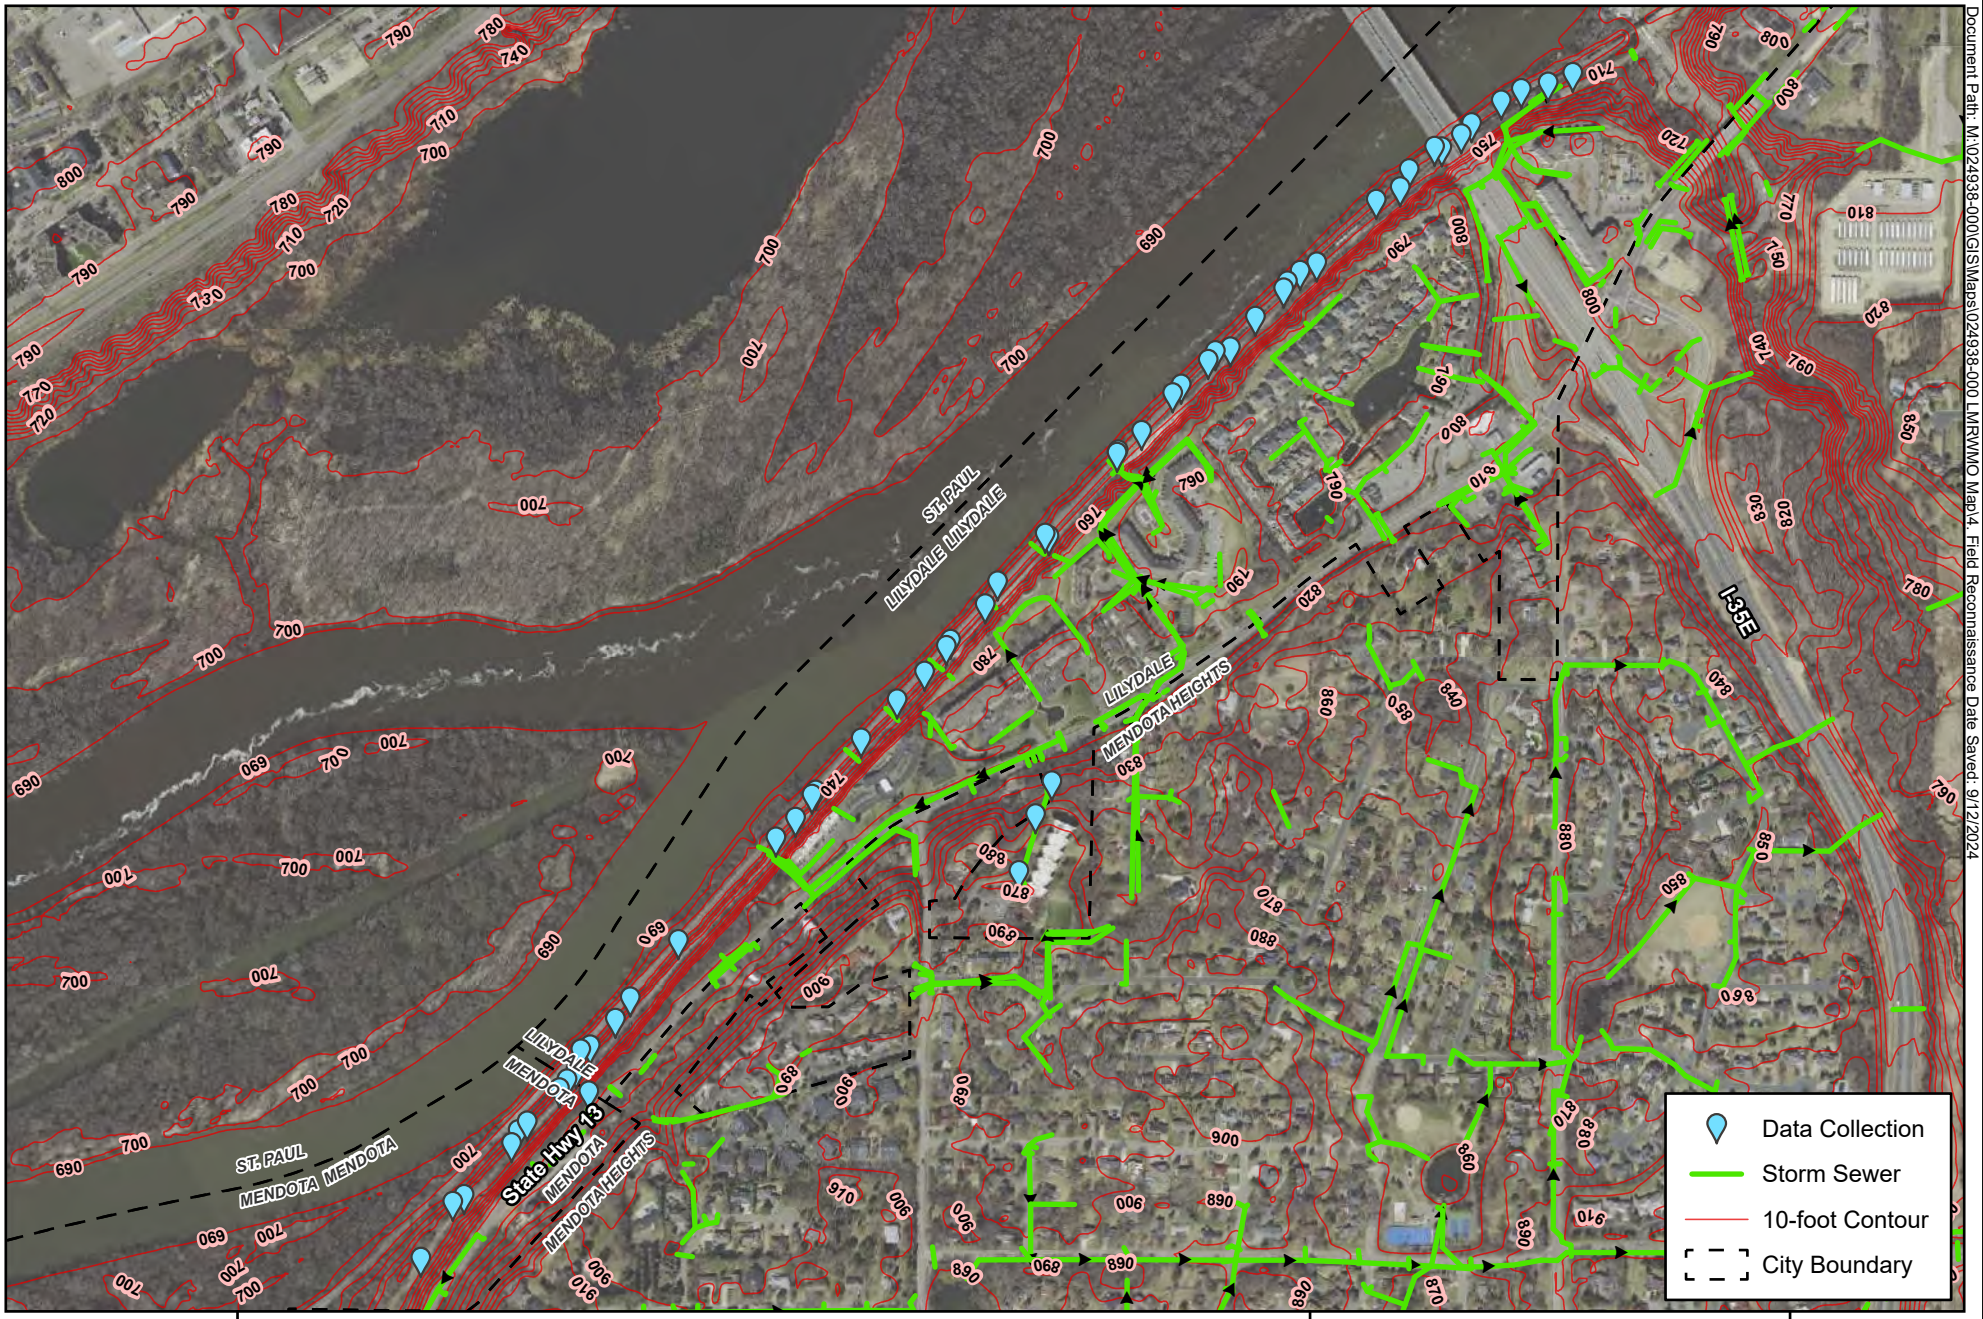
Figure 4.4.2 - Highway 13 Bluff Inspections

2024 and focused on outfall locations which were posted to the webmap by City staff. Figure 4.4.2 shows the length of bluffs inspected within the City of Lilydale as well as the locations of data collected during the inspection.
