# Seidls Lake

Citizen Assisted Monitoring Program (CAMP)

## 2020 Water Monitoring Report

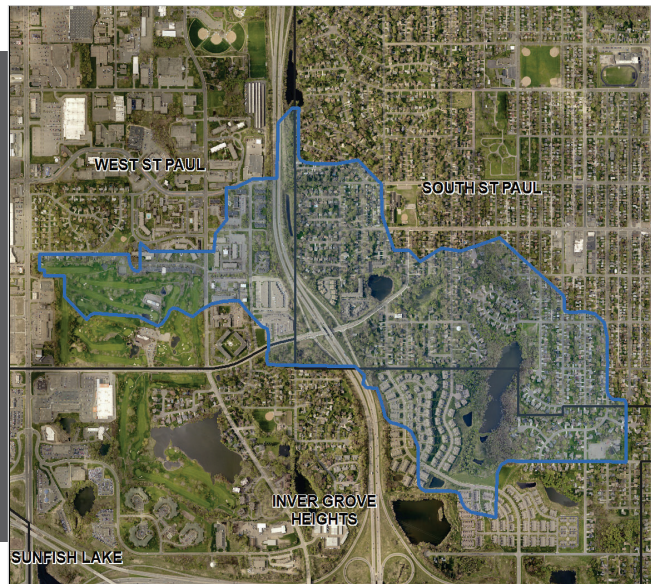
**Watershed Size (shown):** 420 acres

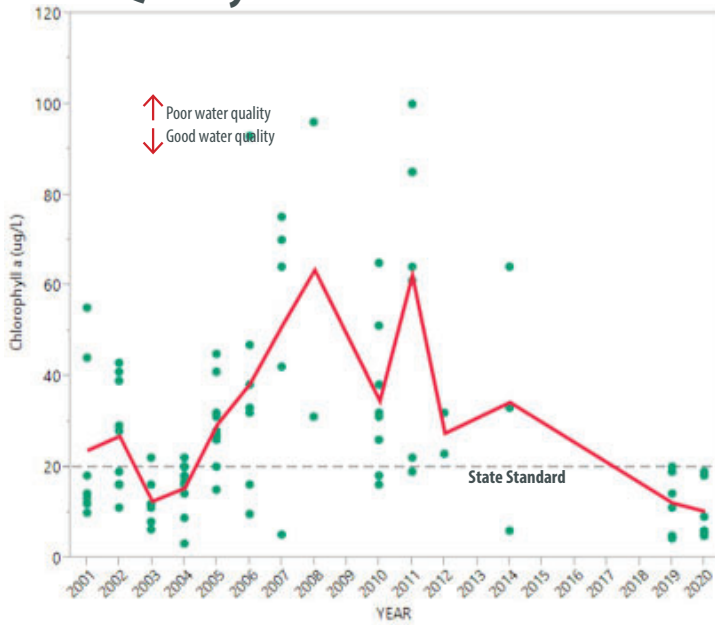
## Chlorophyll-a\*

Chlorophyll-a is the pigment that gives plants their green color. High levels indicate excessive algae from high nutrient levels in the lake. Low chlorophyll-a levels indicate good water quality. State standard is 20 ug/L (dashed line).

Following the 2018 water quality project, there are marked improvements for all three eutrophication parameters (aging process by which lakes are fertilized with nutrients) when comparing 2020 data to 2010-2014 data. The below table shows the 2020 data.

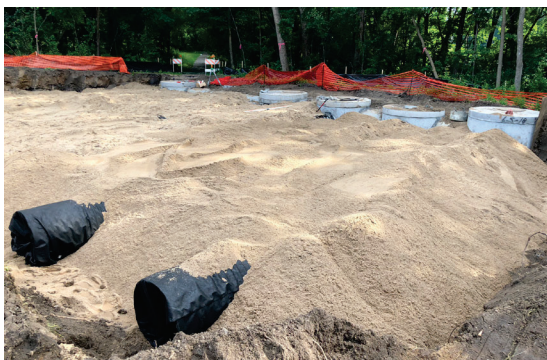
The LMRWMO partnered with the City of South St. Paul to install large underground pipe chambers to infiltrate stormwater before it enters Seidls Lake. The project was implemented with a street reconstruction project.

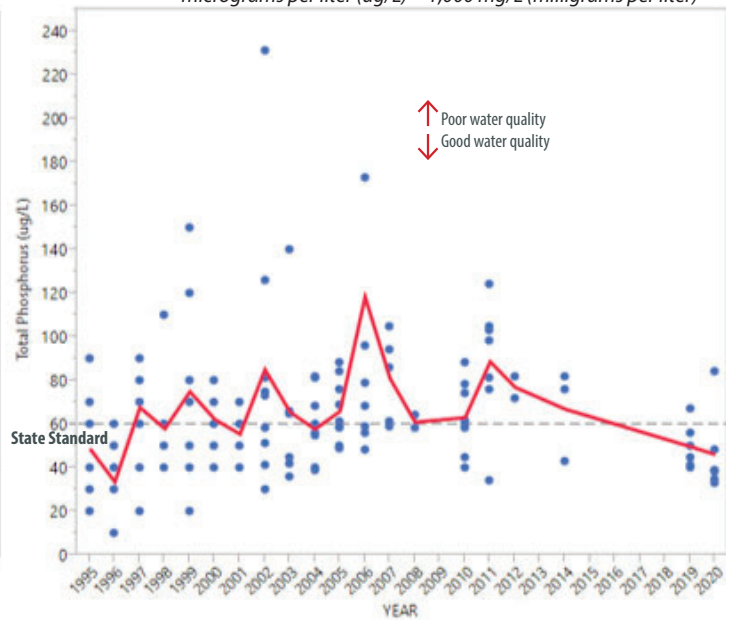
## Phosphorus\*

Phosphorus is a nutrient required for plant growth. High phosphorus levels can lead to algae blooms, turning water green. Low phosphorus levels indicate good water quality. State standard is 60 ug/L (dashed line).

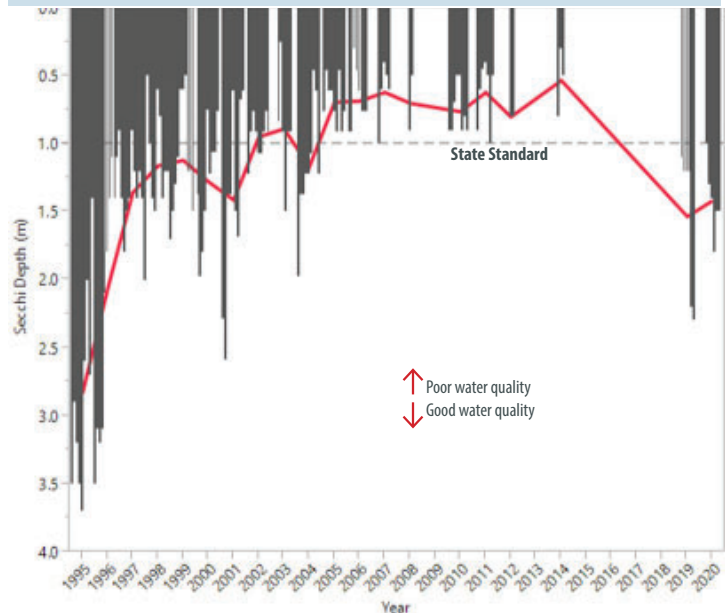
## Secchi Depth

A black and white secchi disc is lowered into the water until no longer visible and measures water clarity. High secchi disc depths indicate good water quality. State standard is 1 m (dashed line).
