Sunfish Lake

2024 Water Monitoring Report

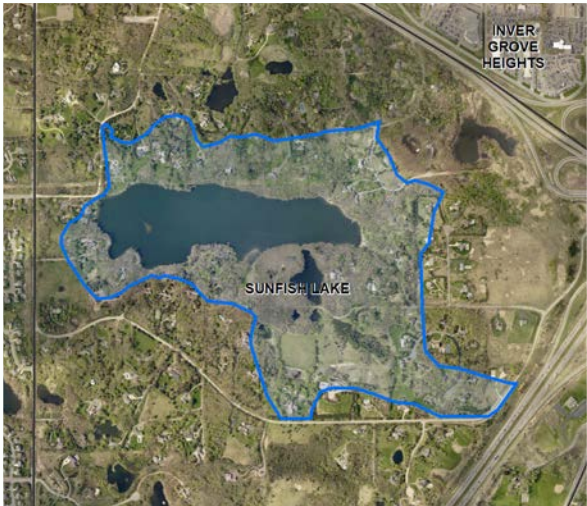
- Max Depth: 32 feet
- Watershed Size (shown): 235 acres
- Major Watershed: Mississippi River
- MPCA Lake Classification: Deep
- Met Council Lake Grade (2024): **A**
